MCP79410 Hours Alarm Issue

Amond Lin
2024 SEP

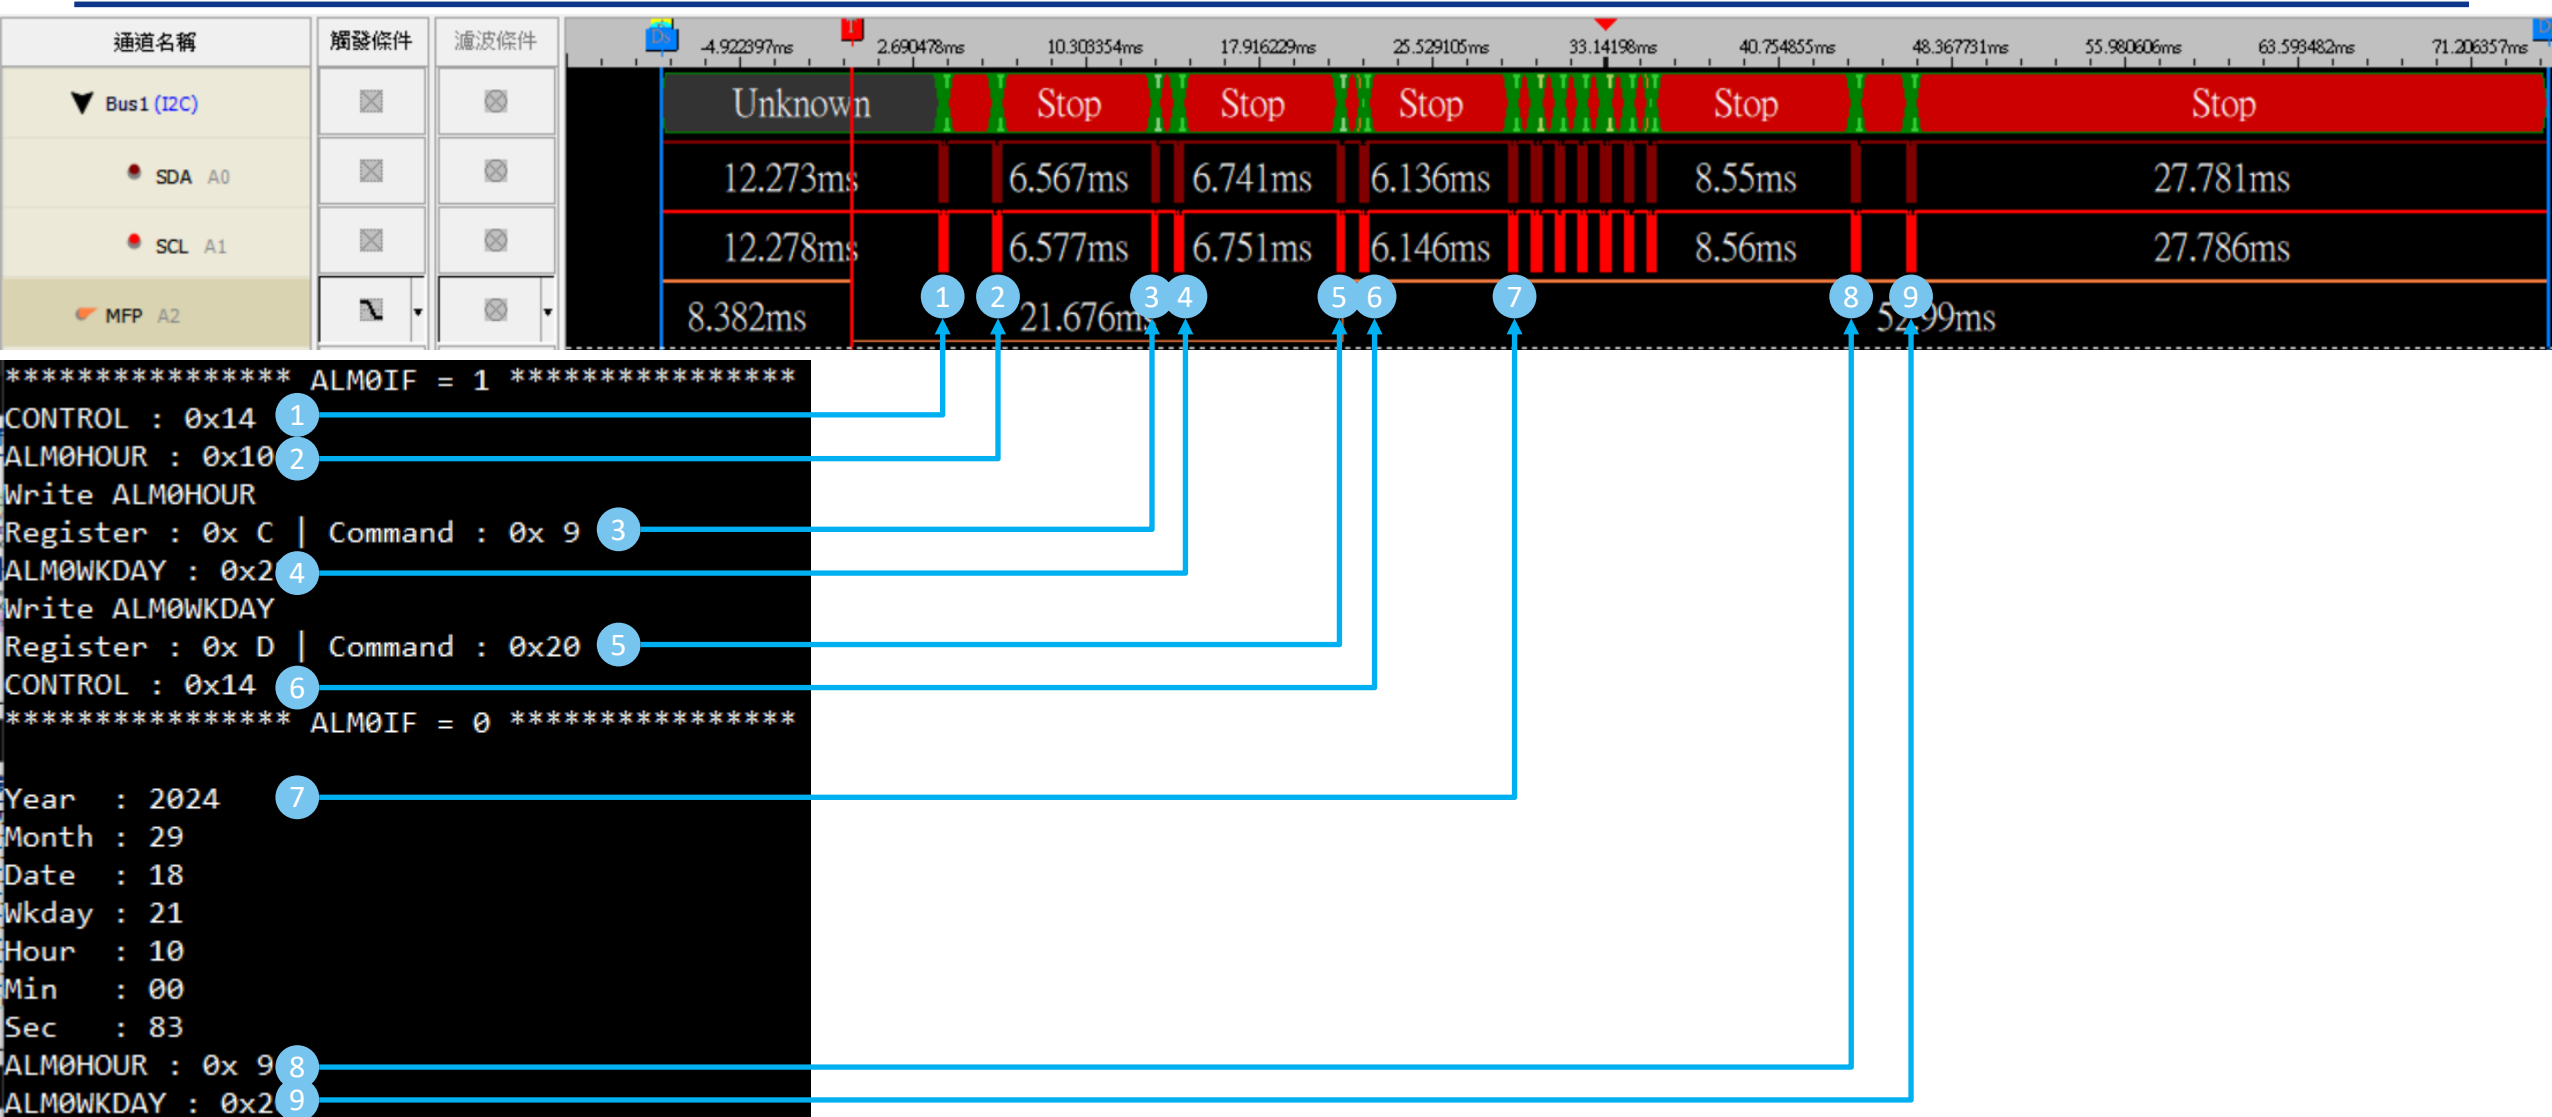
Read/Write with UART print info

Data packet (Duplicated on EVM, not from client)

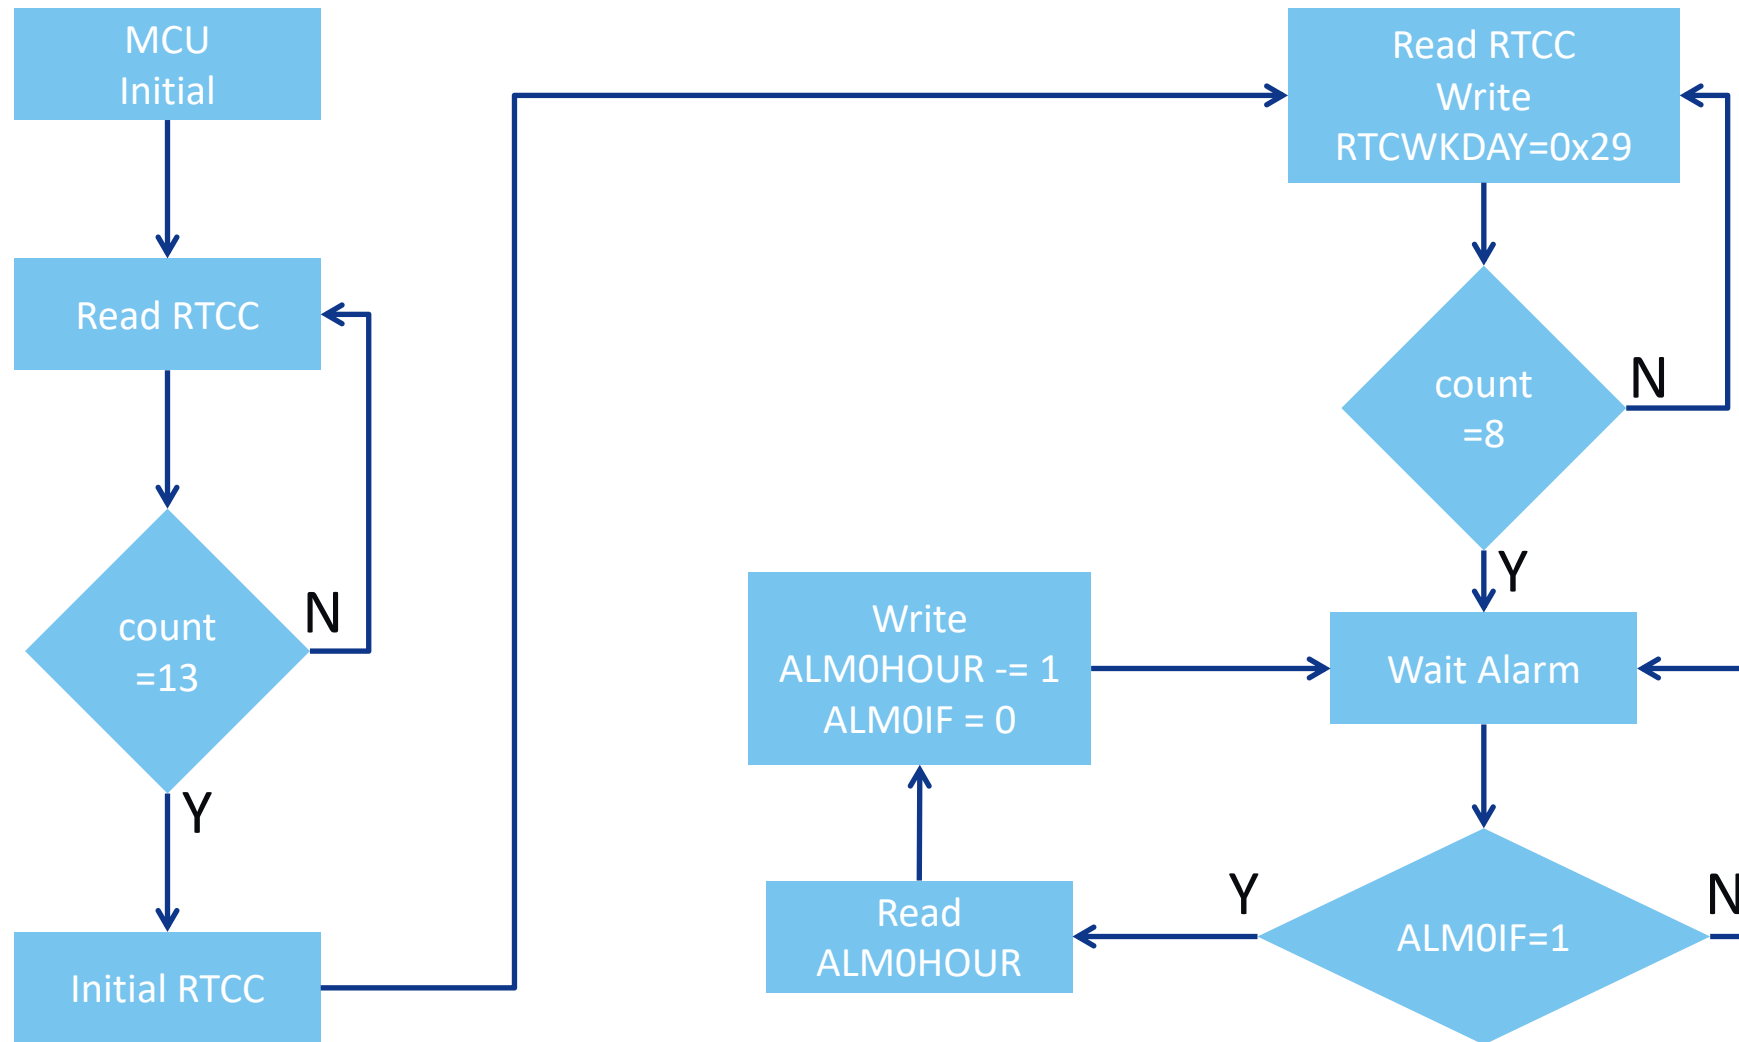
Calibration Flowchart

- We programed the MCU and then disconnected the USB cable. Once VDD of the MCU and RTCC dropped to zero, the USB cable was connected again to check the initial flow.

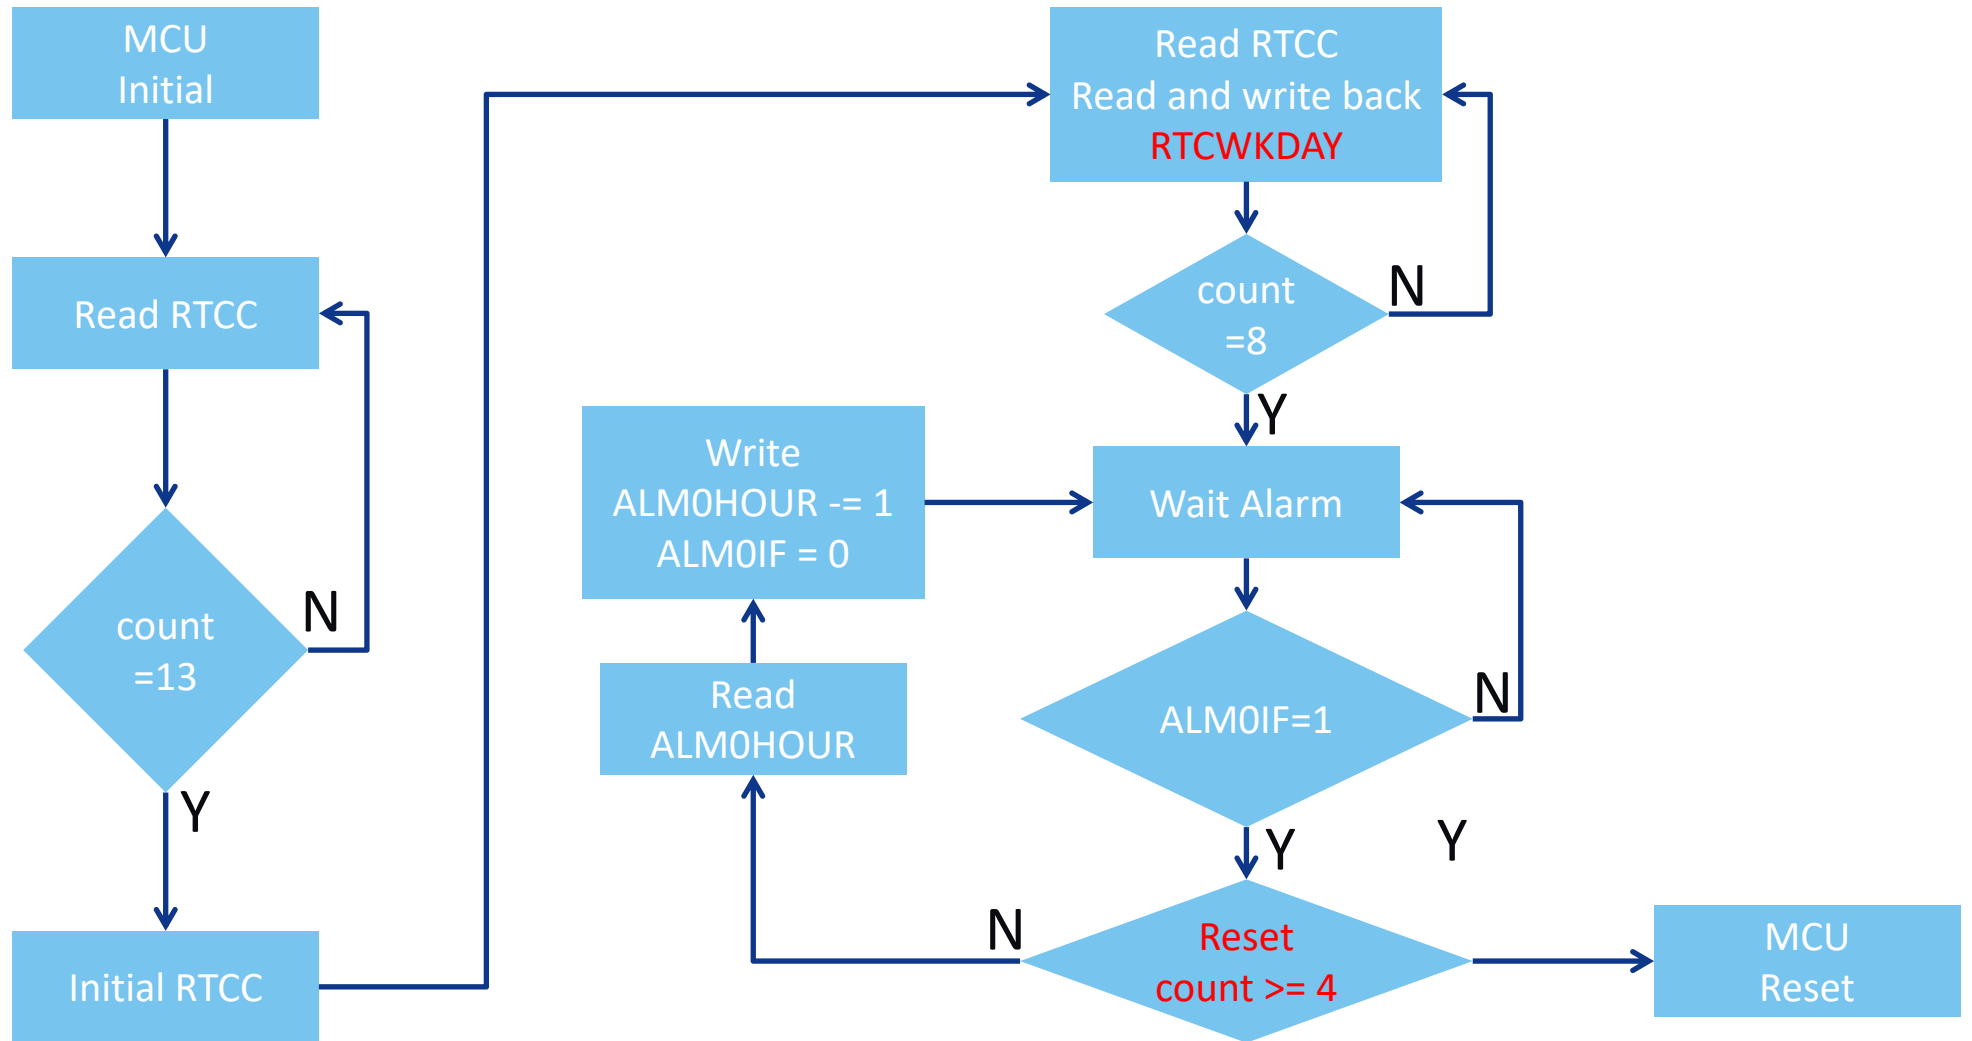
Calibration Flowchart : Modified to match actual process

Upon reading the RTCC for the second time, we wrote RTCWKDAY=0x29 and found that ALM0IF had been set.
