Technical Service Bulletin

No.LTB00078
13 August 2007

Subject/Concern:	Defender - ABS/TC Warning Lamps Illuminated. (Updated to include ABS Modulator Lower-Level Repair)
-------------------------	--

Models:		
Defender (LD)	1999 on, with ABS	1999 on, with ABS VIN- range: 159810 Onwards

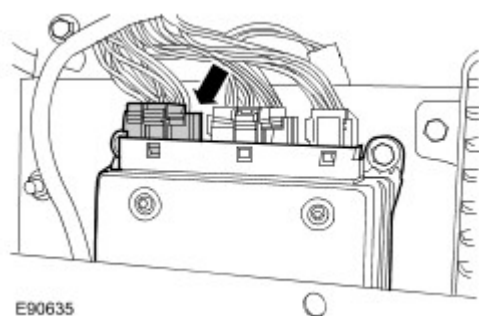
4 . Referenced illustration (see above).

Disconnect the 13 pin connector at the ABS modulator (right-hand drive = C0501, left-hand drive = C1591 – Graphic E90634) and the 15 pin connector at the ABS control module (C0506 – see Illustration E90635 below) and check for moisture.

1 . If moisture or corrosion is present, clean, dry and repair connectors as necessary.
