Inspection Report

Property Address:
xxxxxx xxxL AVE, WHITE ROCK

ANTECH HOME SOLUTIONS

**LEO ZHANG BC HOME INSPECTOR#51809
6055 NELSON AVE
BURNABY, BC V5H 4L4
778-8559588**

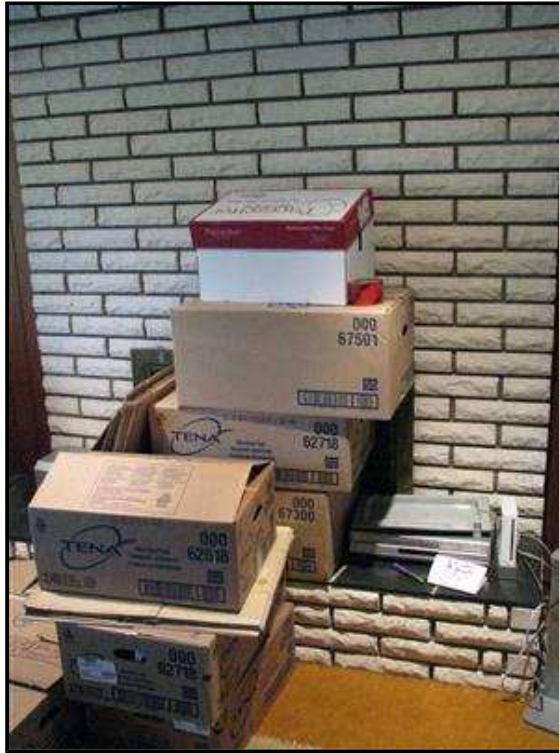
7.6 Picture 1

blocked by owner's stuff

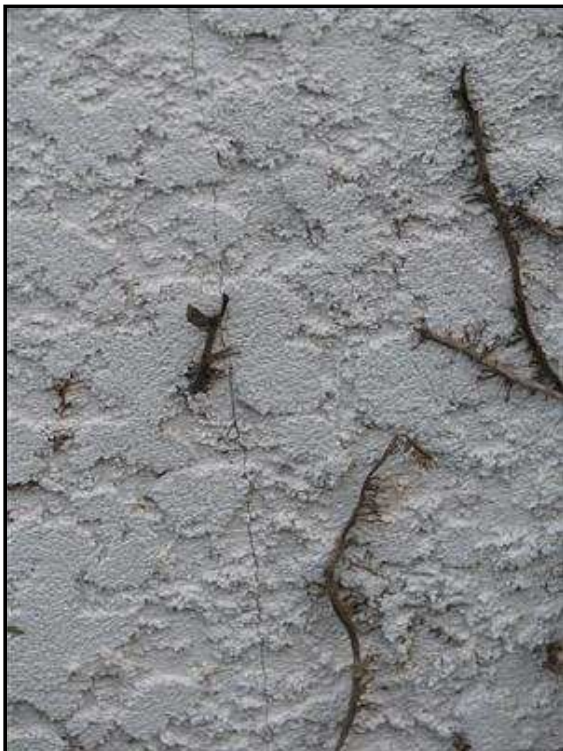
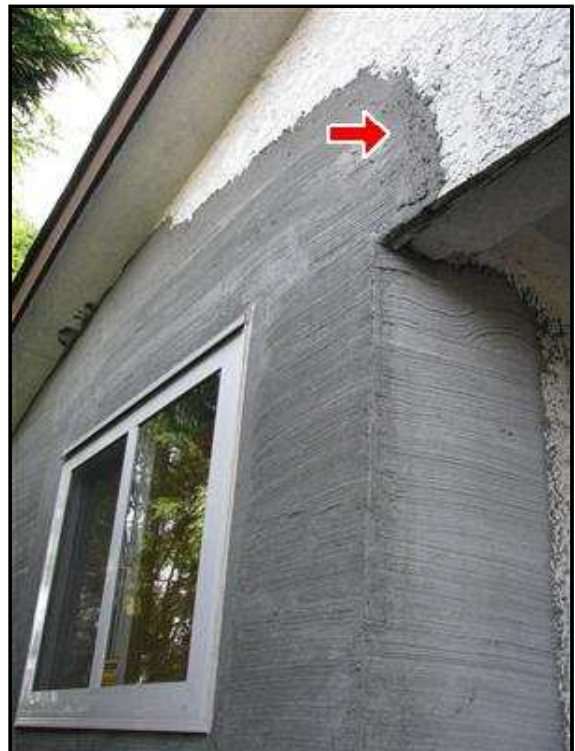
1.0 Picture 1

(1) Common cracking noted. Seal any openings to prevent moisture damage to exterior/interiors walls. the left side(facing front)stucco was replaced recently but no paint on it noted, paint is desired.

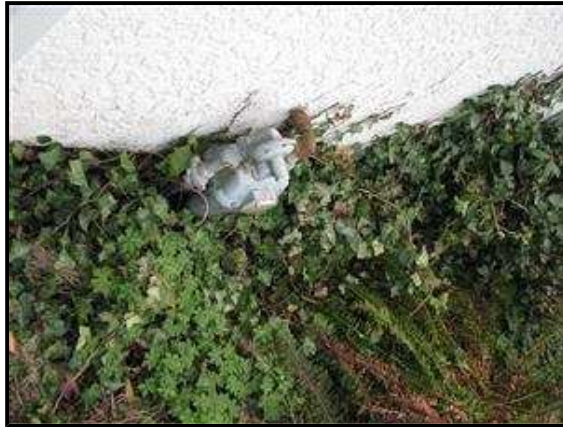
1.0 Picture 3

Siding below grade level will remain moist and be a path for the entrance of Wood Destroying Insects (WDI).

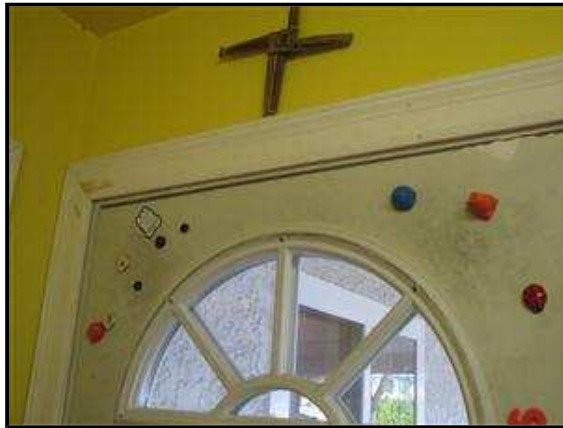
1.1 Picture 1

(1) no door closer noted.

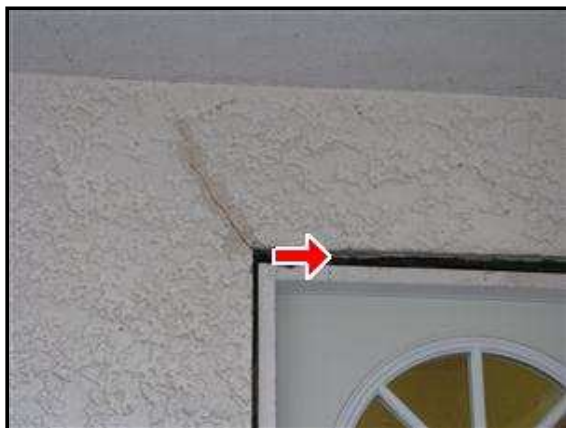
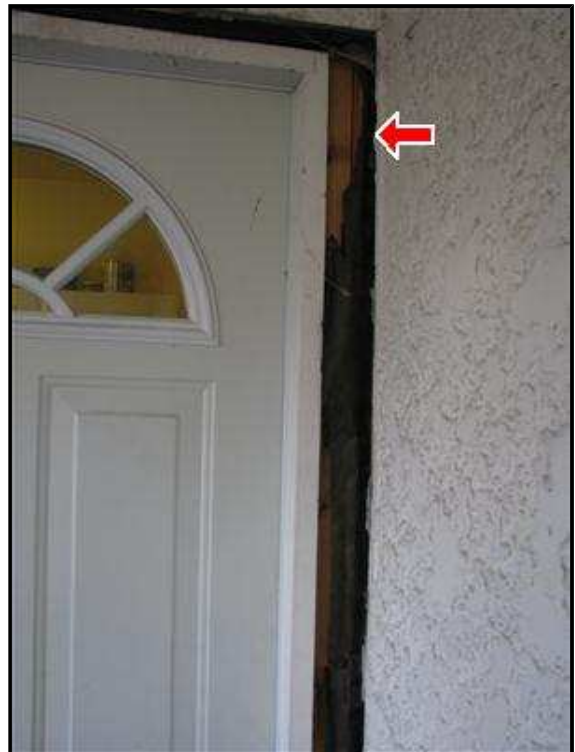
1.1 Picture 2

(2) the new installed door at the left front entrance door, has a gap between the frame and sidling, exposed wood noted. Seal the gap and repair are needed.

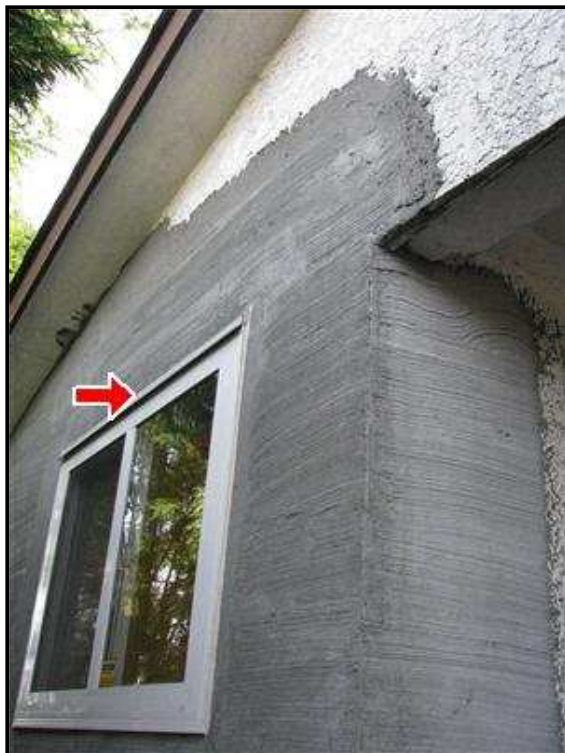
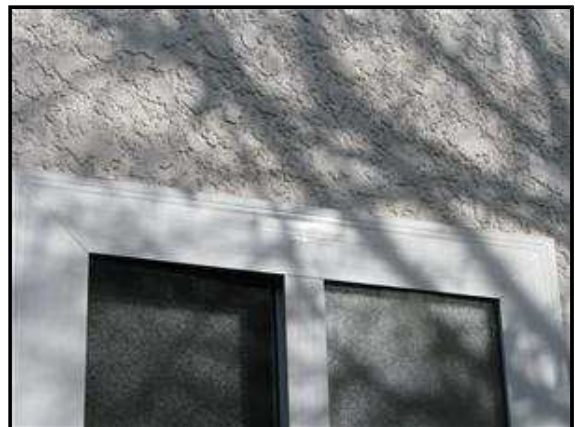
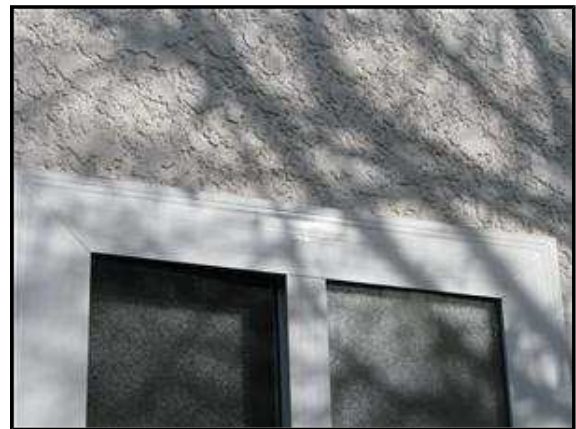
1.2 Picture 1

new windows were replaced but No drip flashings installed. This may allow moisture ingress if exposed to wind driven rain.

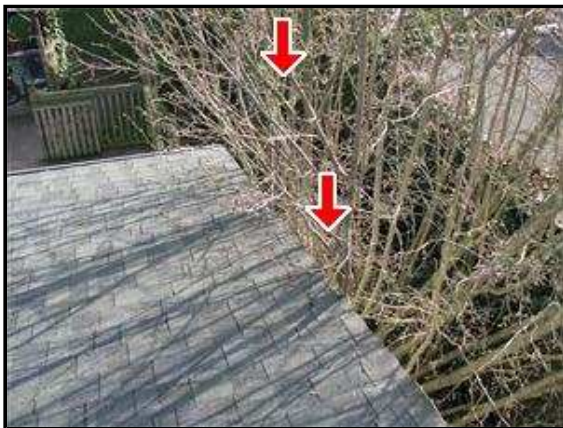
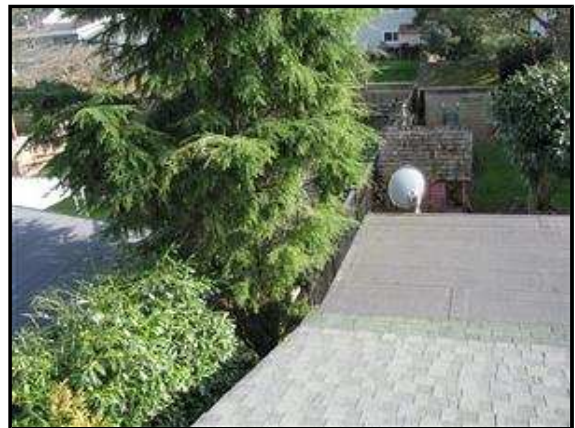
1.4 Picture 1

There are tree limbs overgrowing the residence that should be trimmed or monitored, to insure that they do not impact or damage the wall or roof or its components

✍Vegetation is encroaching on the structure, and should be kept a minimum of twelve inches away for the general welfare of the walls and foundation

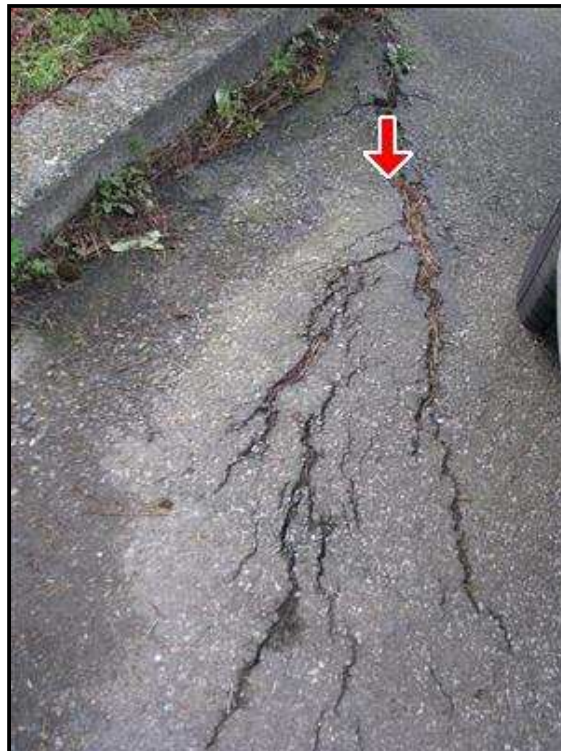
1.4 Picture 3

(2) the driveway is damaged by the roots, a trip hazard is noted.

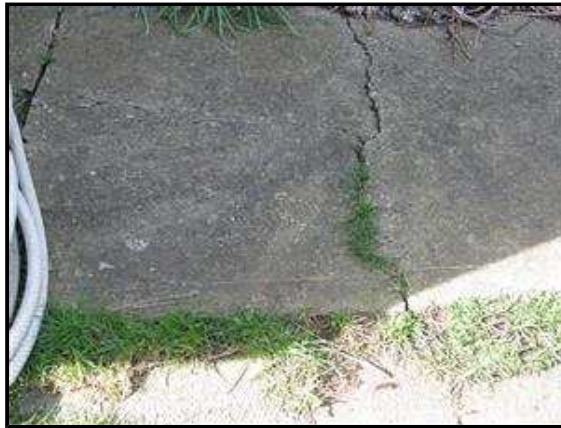
1.4 Picture 4

(3) The walk has cracks and is uneven. Tripping hazard present. I recommend repair by a qualified contractor

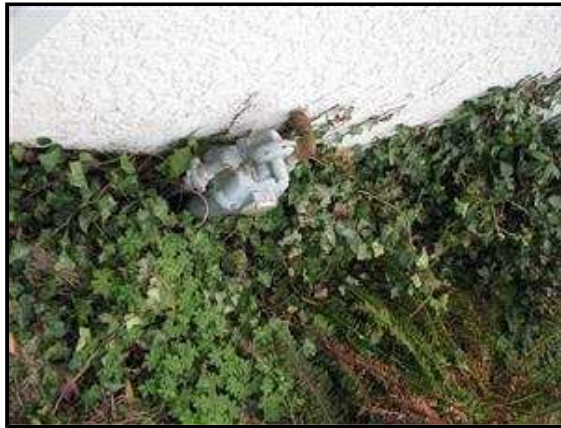
1.4 Picture 5

(4) There are various plants and or bushes next to the exterior wall(s). Trim or prune all vegetation in such a way as to allow a minimum of 12 inches of clearance between the plant and the exterior wall. This is necessary in order to prevent damage to the exterior and to inhibit the ability of insects to migrate into the building structure.

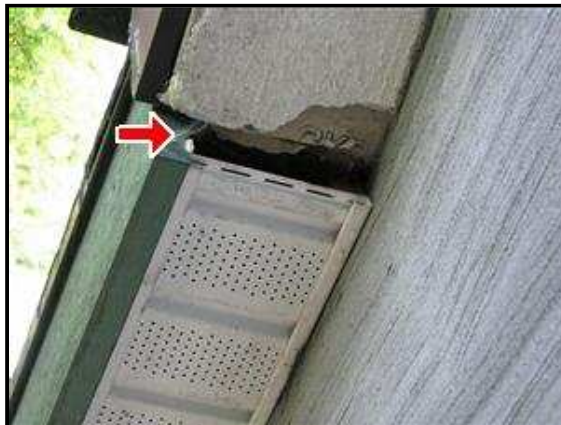
1.5 Picture 1

between the old soffit and new added room soffit, a gap is noted; the front side soffit has a missing parts. This gaps/hole exists which allows insects or bees to enter attic.

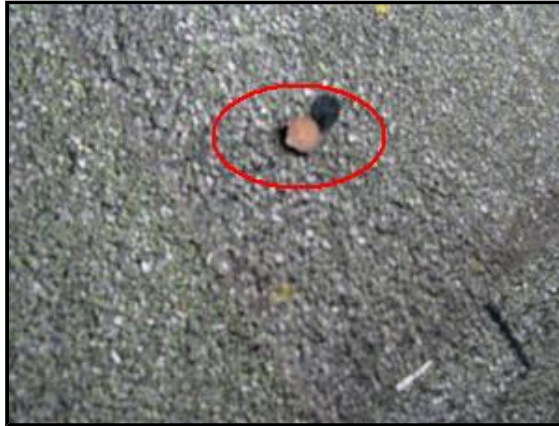
2.0 Picture 1

(1) popped out nail noted, re-seal is desired.

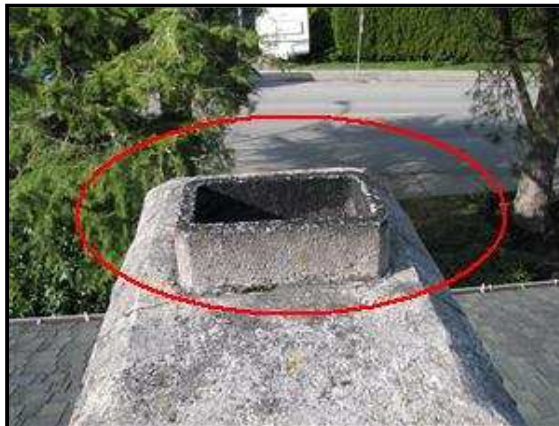
2.2 Picture 1

a chimney cap and screen was recommended to install

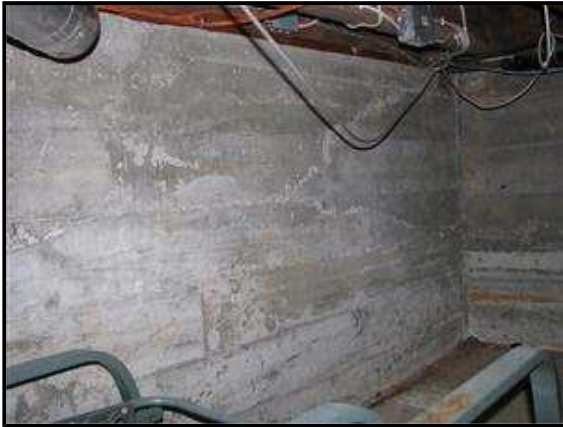
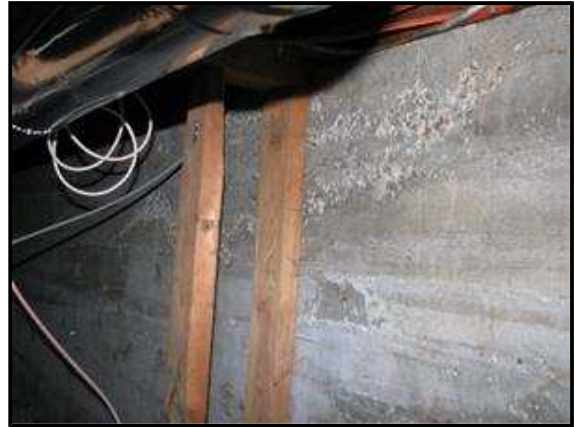
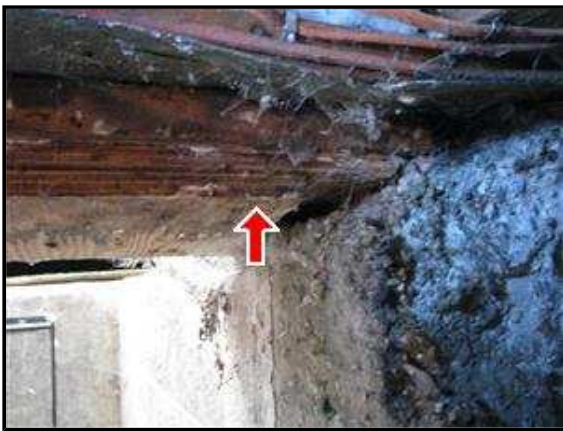
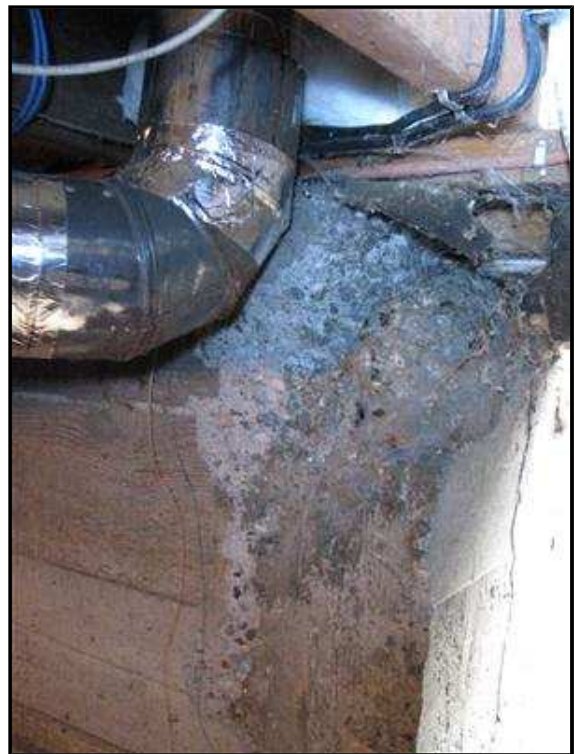
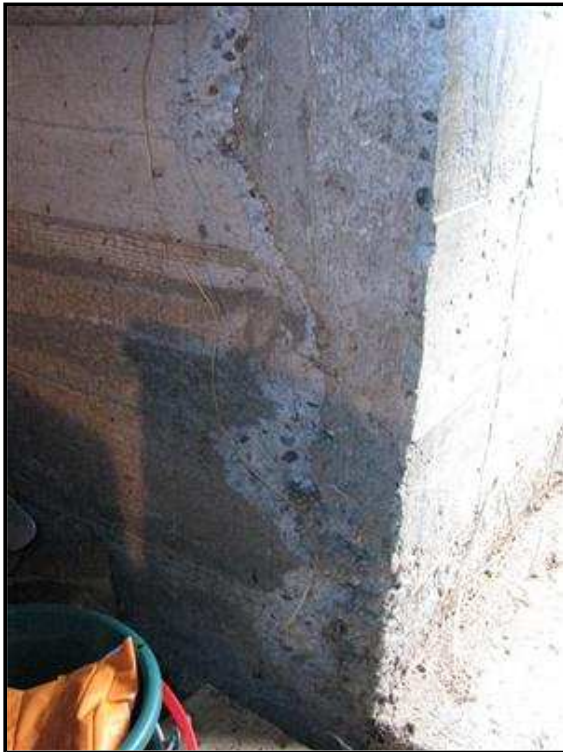
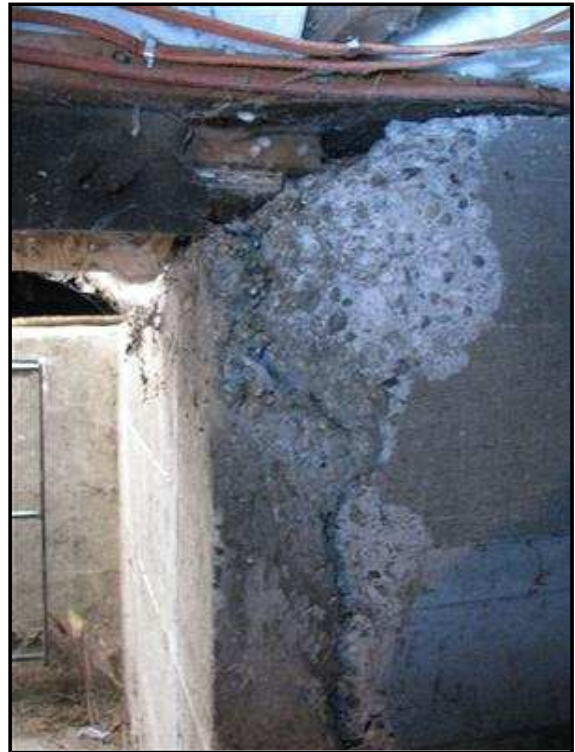
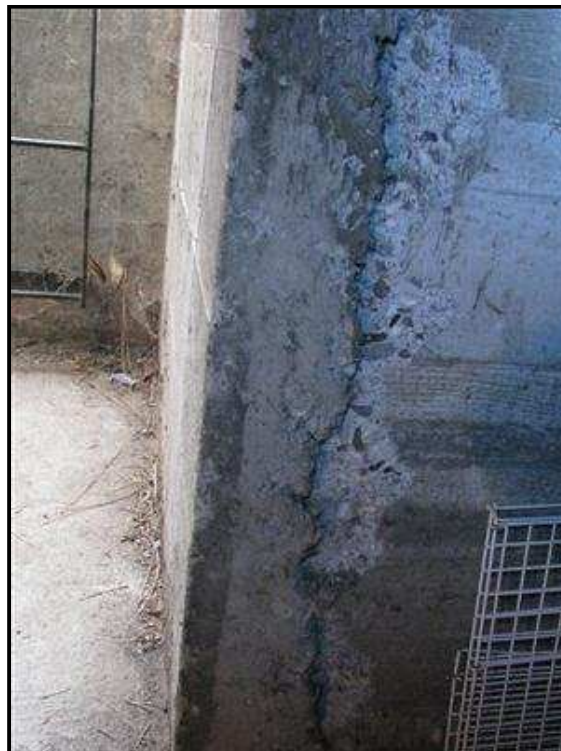
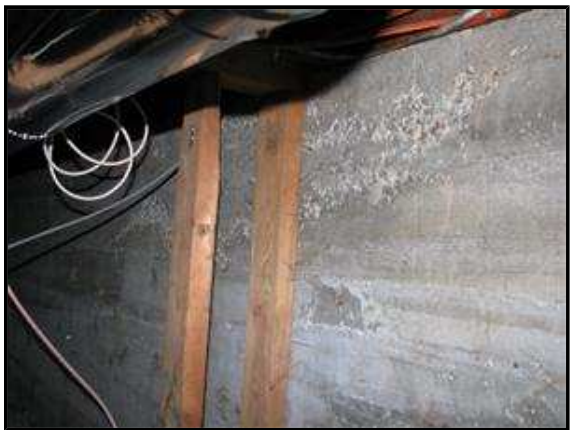
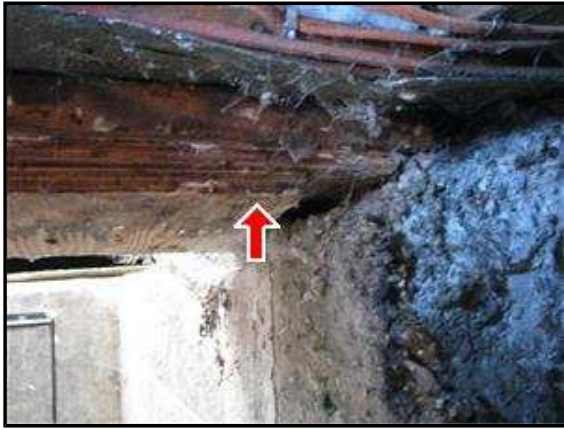
cold poured concrete noted in the crawl space, the entrance well looks liked added later than the foundation made, cracks and sister sills were installed not properly noted. repair are needed.

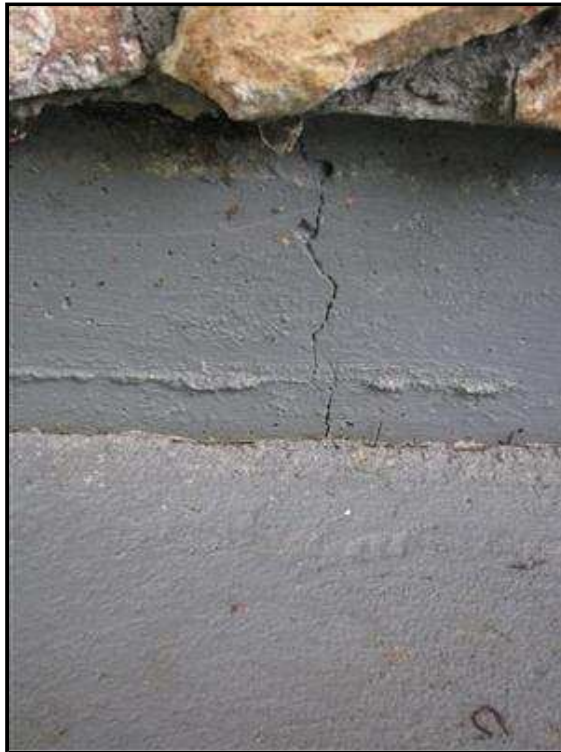
3.1 Picture 1

✍ There are hairline cracks on the concrete foundation at rear side of the house which could be caused by concrete cure & should be normal. We suggest owner monitor & caulk the crack including the possibility of moisture intrusion into the crawlspace. Re-grade service needed if necessary

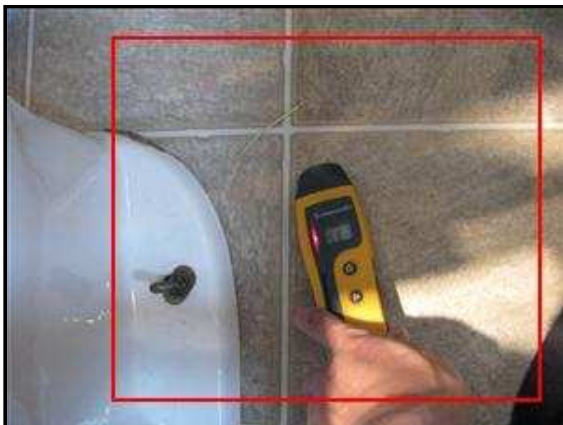
4.2 Picture 1

I found indications of water beneath the floor covering around the toilet. And the toilet bowl is loose. I checked underneath the bath in the crawl space, no current leak noted but old water stains noted.

I recommend further investigation and repairs as necessary.

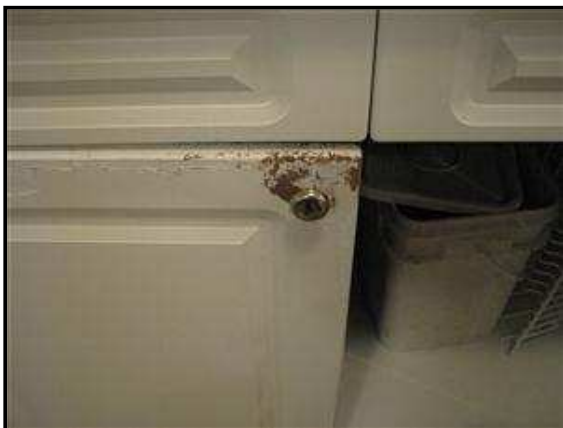
4.4 Picture 1

aged and peeled out paint noted on the kitchen cabinet, also some doors hardware need to be adjusted.

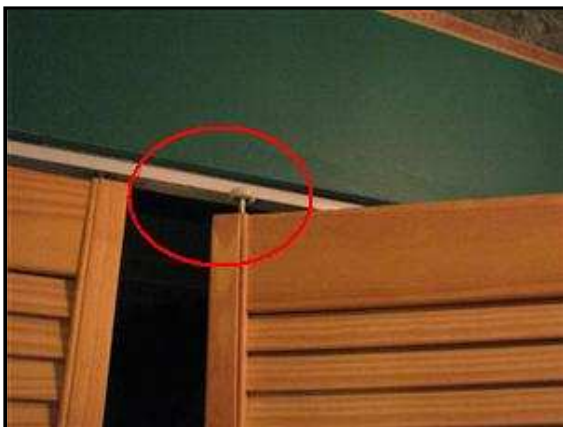
4.5 Picture 1

some closets doors are out of track or missing parts, repair is needed.

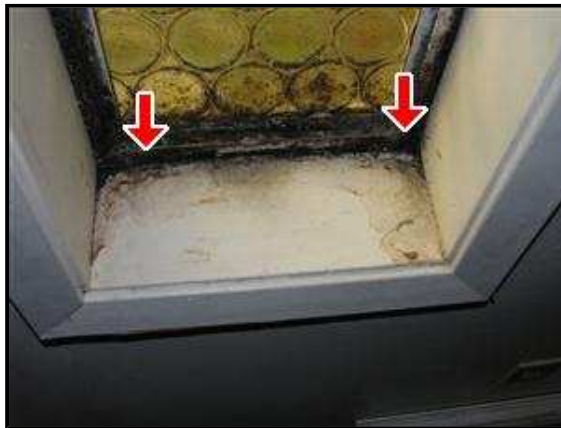
4.6 Picture 1

single pane original window noted by the main entrance, high moisture damaged frame and sill noted. repair is desired.

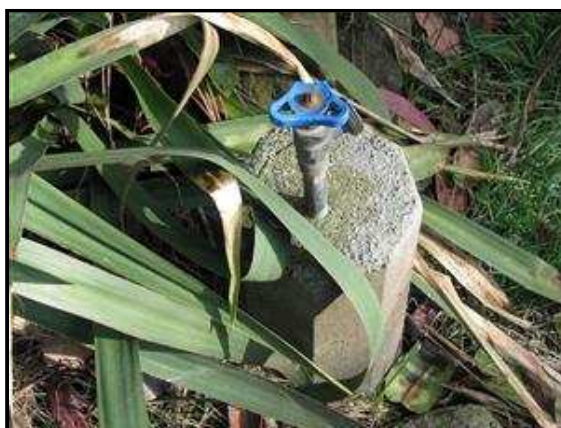
5.1 Picture 1

back yard the water valve no water noted.

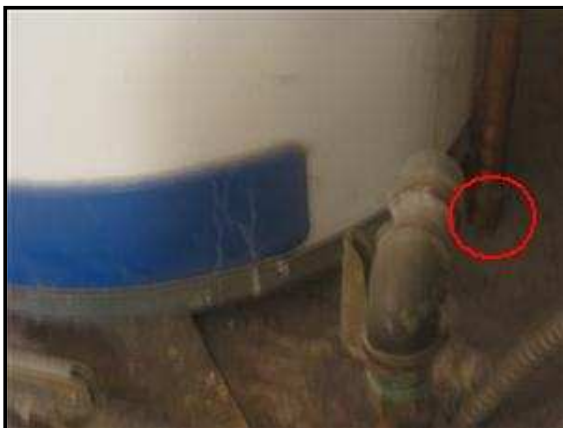
5.2 Picture 1

Pressure & temperature relief valve installed as a safety feature. A discharge pipe on pressure & temperature relief valve is installed BUT the valve is not close properly, the water dripping directly on to the duck in the crawl space and will rust the duck and add extra moisture to the space.

Recommend repair immediately. Recommend strapping the hot water tank securely to prevent tipping or moving excessively during an earthquake. This may help prevent gas or water lines from cracking or breaking during

a significant earthquake.

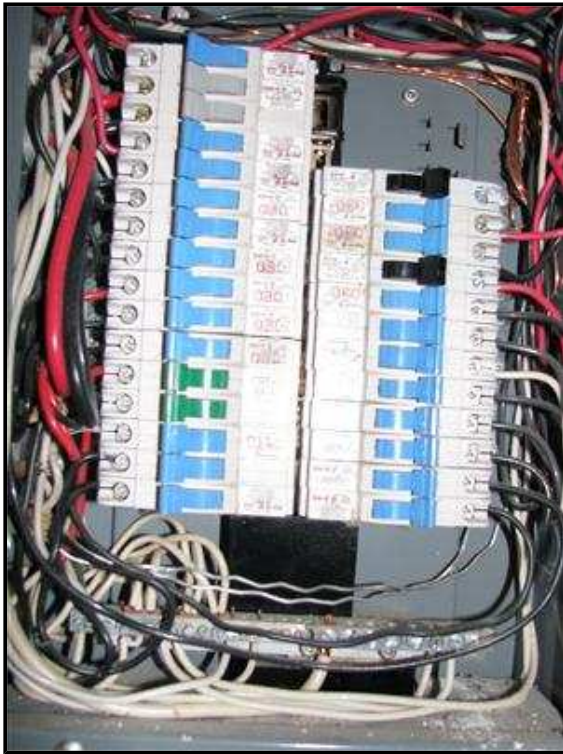
6.2 Picture 1

Aluminum wire is installed on 120 VAC branch electrical circuits in the subject house. These single strand, branch circuit aluminum wires were used widely in houses during the mid 1960s and 1970s. According to the U.S. Consumer Product Safety Commission, problems due to expansion can cause overheating at connections between the wire and devices (switches and outlets) or at splices, which has resulted in fires. For further information on aluminum wiring contact the U.S. Consumer Product Safety Commission via the Internet at

<http://www.cpsc.gov/> . It is recommended that the electrical system be evaluated by a licensed electrical contractor.

. This type of wiring was standard at the time of construction. Client should consult with a qualified electrician to ensure proper and safe installation. Some home insurance require that aluminium wiring be checked and/or upgraded as a condition to granting fire insurance.

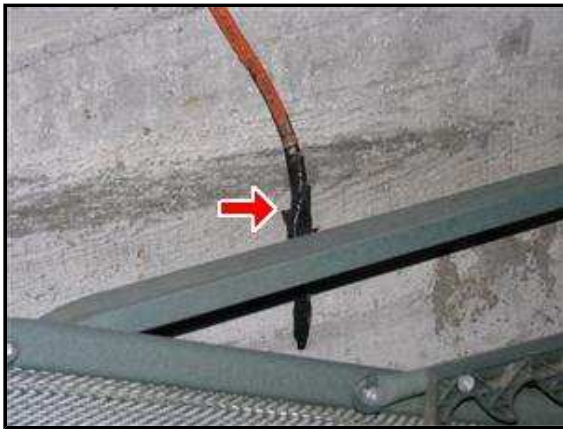
6.3 Picture 1

exposed wires and junction box noted in crawl space, the old wire need to be removed or covered properly.

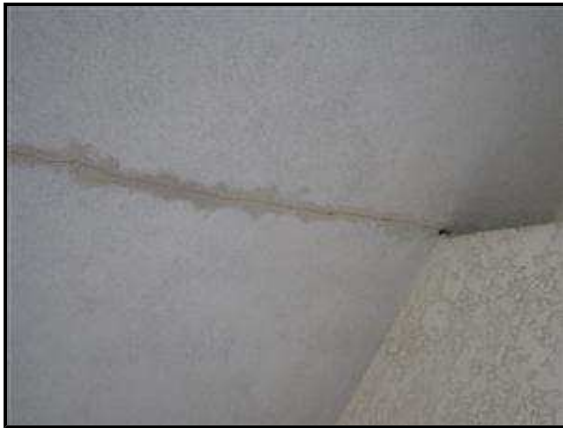
10.0 Picture 1

cracks and patching noted in the car porch
