# Technical Publication

Direction 5831660-1EN

## **Revolution™ Maxima/Revolution™ Ace Application Tips and Work-Arounds**

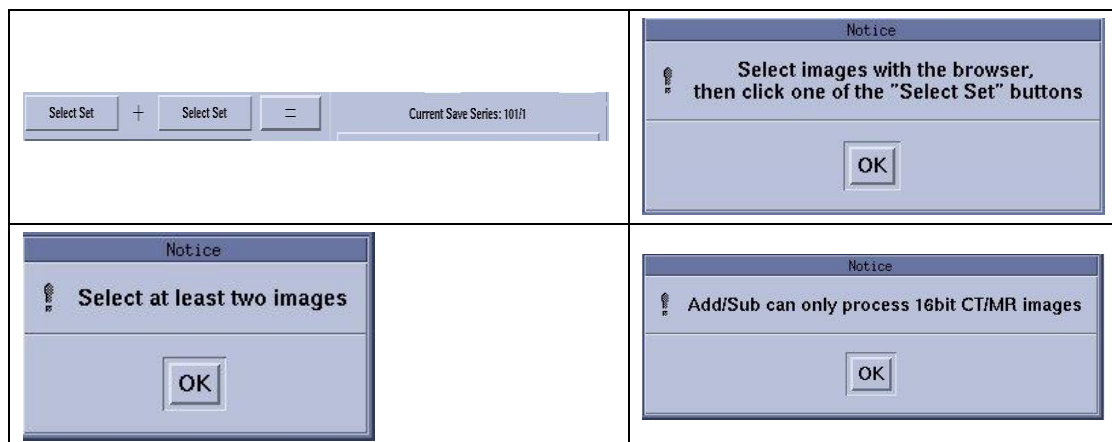
## English Screen Captures

- o Perfusion4D/ 4DNeuro
- In Add Subtract when the system is configured in a language other than English, the Select Set and Current Save Series text on the user interface revert back to English after selecting the button. To get the translated text to display again, Quit Add/Sub and launch Add/Sub again. The English screens are included for your reference.

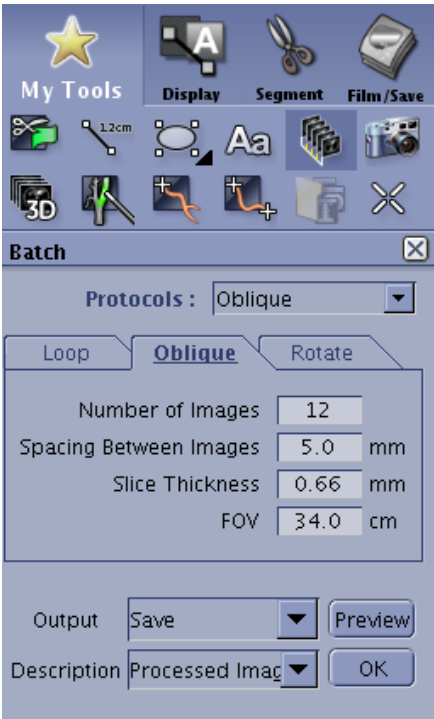
<p>The information displayed window for the pull-down menus may be truncated. Click on the pull-down to see the full information.</p> <p>The names of protocols may still appear truncated. When you name protocols consider the name length so it can easily be identified.</p>	
--	--	--
