BRAKTOOTH: Causing Havoc on Bluetooth Link Manager

VULNERABILITY DISCLOSURE REPORT

August 31, 2021

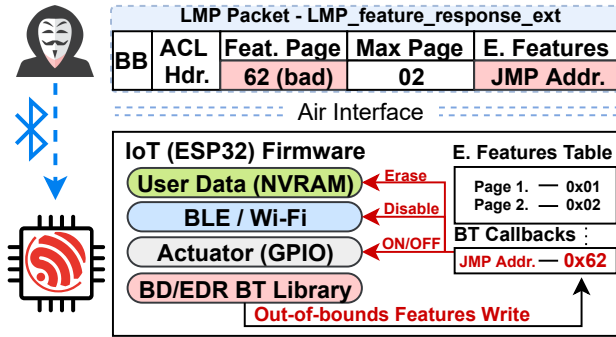
The most critical vulnerability (V1 in Table 2 - 8.1) affects *ESP32* SoC [37], which is used in many Wi-Fi and Bluetooth IoT appliances such as Industry Automation, Smart Home, Fitness, etc. The attack is illustrated in Figure 3. A lack of out-of-bounds check in *ESP32 BT Library* [11] allows the reception of a *mutated LMP_feature_response_ext*. This results in the injection of eight bytes of arbitrary data outside the bounds of *Extended Feature Page Table* ("E. Features Table" in Figure 3). An attacker, which knows the firmware layout of a target device, can write a known function address (*JMP Addr.*) to the offset pointed by *Features Page* ("Feat. Page" in the *LMP_feature_response_ext* packet) field. It turns out that the *BT Library* stores some callback pointers within the out-of-bounds *Features Page* offset and such a callback is eventually invoked during the BT connection. While exploiting this vulnerability, we forced *ESP32* into erasing its NVRAM data (normally written during product manufacturing) by setting *JMP Addr.* to the address of *nvs_flash_erase*. Such erase function is always included in *ESP32* SDK [9] and therefore, it is present in any *ESP32* firmware. Similarly, disabling BT or BLE can be done via *esp_bt_controller_disable* and Wi-Fi via *disable_wifi_agc*. Additionally, general-purpose input/output (GPIO) can be controlled if the attacker knows addresses to functions controlling actuators attached to *ESP32*. As expected, this has serious implications if such an attack is applied to Bluetooth-enabled Smart Home products.

Figure 3: An Illustration of CVE-2021-28138.
