## No. 51/09 Marine Version 3

### Transmittal

**Title: Introduction of Leaffield GIST hose assembly, c/w bayonet termination at both ends. Applies only to new build and Non-Operationally Packed new build liferafts.**

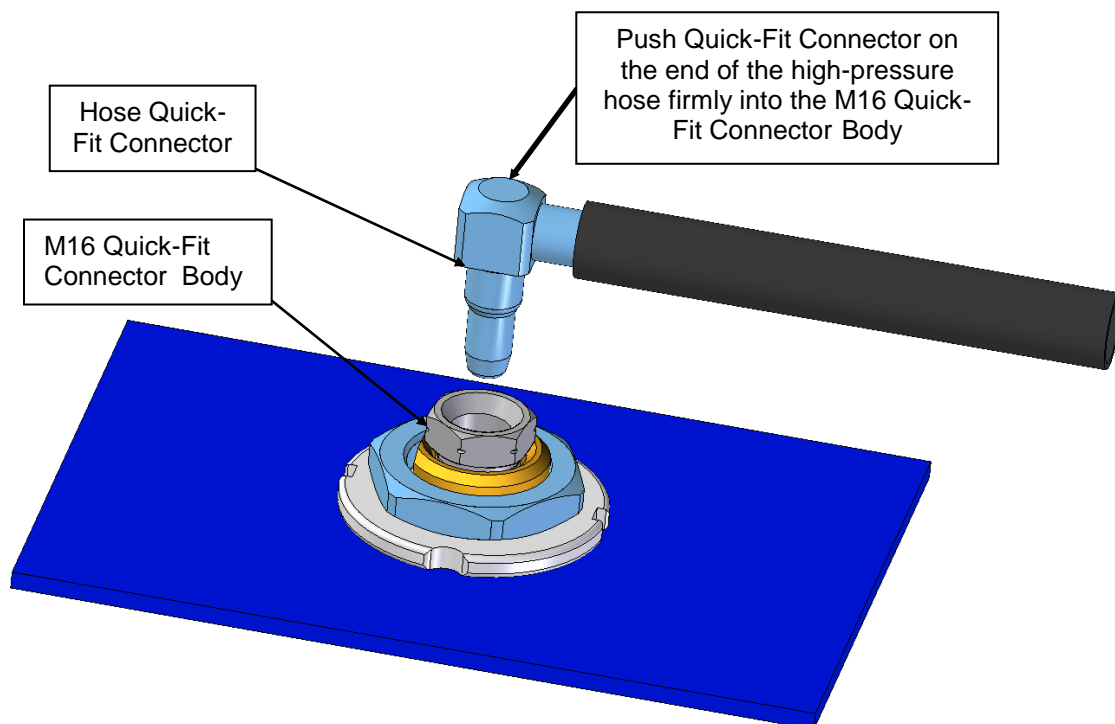
7. If the hose has not been correctly snapped into place it may blow out during inflation. In this case check that the 'O' Ring is still in place in the M16 Quick-Fit Connector Body before pushing together as described above. If it is not present replace the M16 Quick-Fit Connector Body. (See item 3.1.6 below.)

5. Locate a 33mm A/F socket and torque wrench on the M24 nut. Tighten the M24 nut to a torque of 30Nm (22.1 ft/lbs).
6. Remove the red plastic dust cap from the top thread of the inlet valve. The valve is now ready to accept the quick fit connector on the end of the high-pressure hose. Push the connector firmly into the hole, make sure a click is heard and then rotate through 90 degrees. Check that the connection has been correctly made by pulling the hose connector firmly upwards, away from the valve.

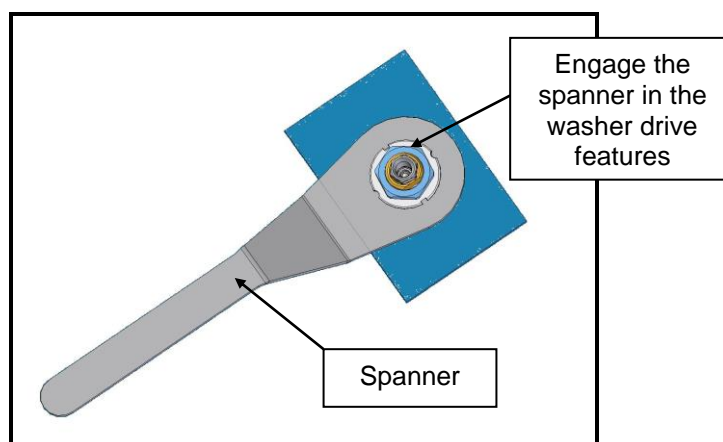
This type of leakage occurs if the valve has become loose in the fabric. To identify this type of leak cover the area around the washer with soapy water and watch for bubbles. To rectify this type of leak, carry out the following procedure.

1. Locate the flat spanner into the 4 features on the washer.

2. Locate a 33mm A/F socket and torque wrench on the M24 nut. Rotate the spanner to align the jets along the axis of the tube using the 2 direction indicator arrows on the spanner. Tighten the M24 nut to a torque of 30Nm (22.1 ft/lbs).
3. Inflate the tube and check that the leak has stopped by applying some soapy water around the washer. If the valve is still leaking bubbling will be apparent and the washer should be replaced.
