## New Machine Setup Report

Machine	: Laser Marking	Reference No.	: CMR-S1609-902-003
Section	: CP PX Line	Report By	: Zulhisham Tan
Control No.	: -	Date	: 30th Sept '2005
Subject	: Control Point	Sheets	: 1

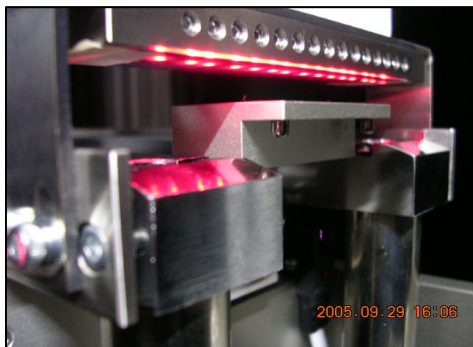
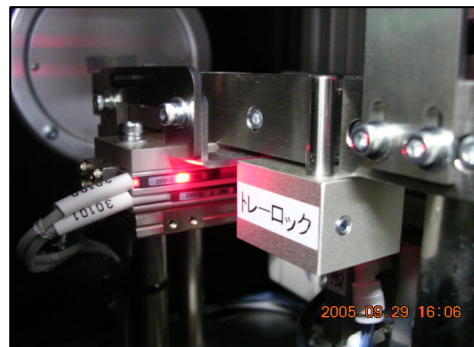
The machine was designed in order to operate at fully Auto condition. The additional item were added with compare to the previous machine such as :

1. Magazine Loader Unit
2. Transport Unit
3. Tray Lock Unit
4. Workpiece detection sensor
