MECH 428: INTRODUCTION TO AEROSPACE ENGINEERING

Investigation of TWA Flight 800 Boeing 747 Crash

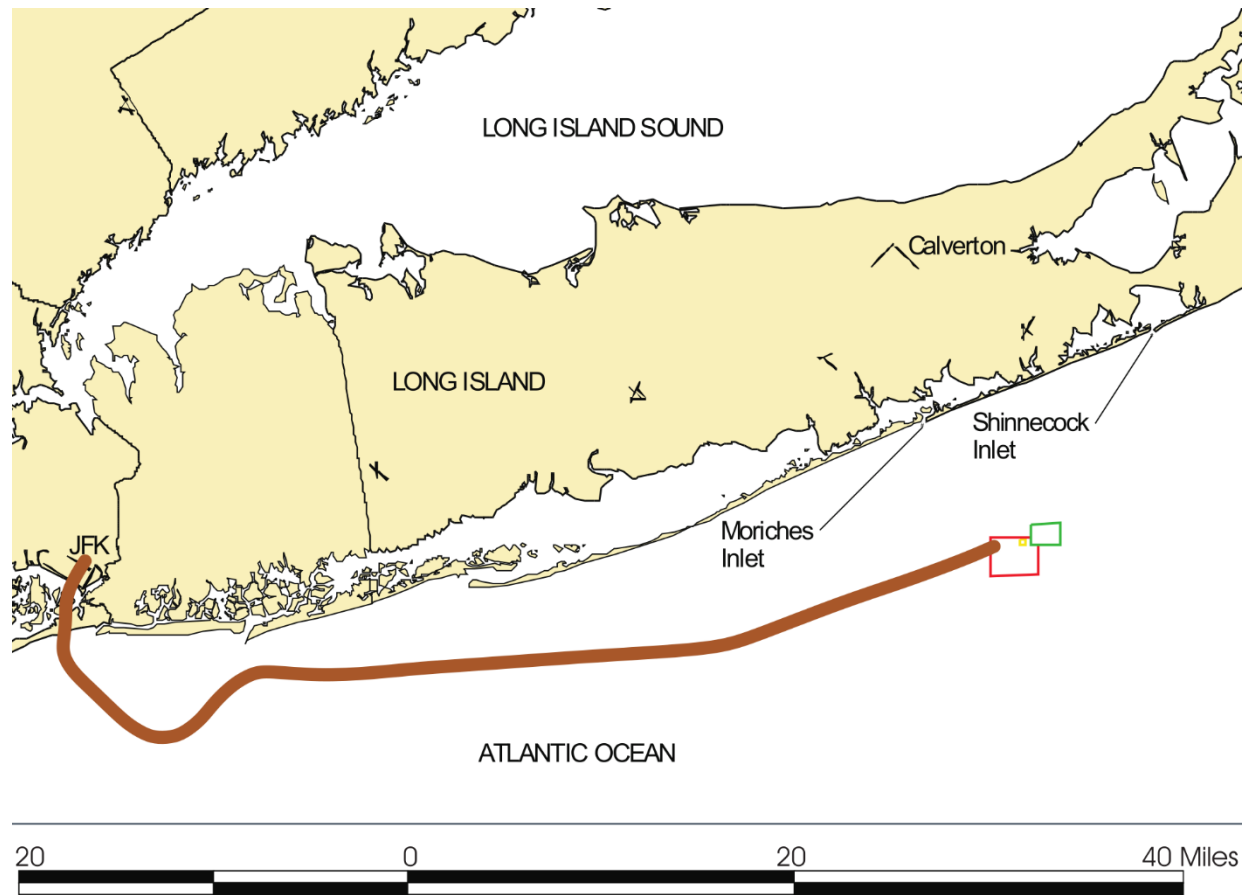
It has been stated in the introduction paragraph that TWA Flight 800 took off from JFK Airport in New York to CDG International Airport in Paris. At 20:17:18, the air traffic control records from the CVR showed that the aircraft got in heavy turbulence and started to feel the effects of turbulent air. However, later investigations that will be extensively discussed did not associate the accident with any turbulence or malpractice regarding the pilots preferred flight conditions. Nevertheless, it is meaningful to mention that ATC recommended and informed the pilots of TWA flight 800 that the wind was out of 240° at 8 knots and cleared flight 800 for take-off on runway 22R [9]. The airplane reached 13,000 feet at 20:27:54. Later, with the instruction of the air traffic control, the pilots increased the engine power then the aircraft reached approximately 15,000 feet 20:30:18. The last radar message was taken at 20:31:12 when the plane was at 13,760 feet, already in decline. The pieces of the wreckage were discovered 8 miles south of East Moriches, New York. The main wreckage was found between 40° 37' 42" and 40° 40' 12" north latitude and 72° 40' 48" and 72° 35' 38" west longitude [9].

Figure 3: Location of Airplane Wreckage [9].

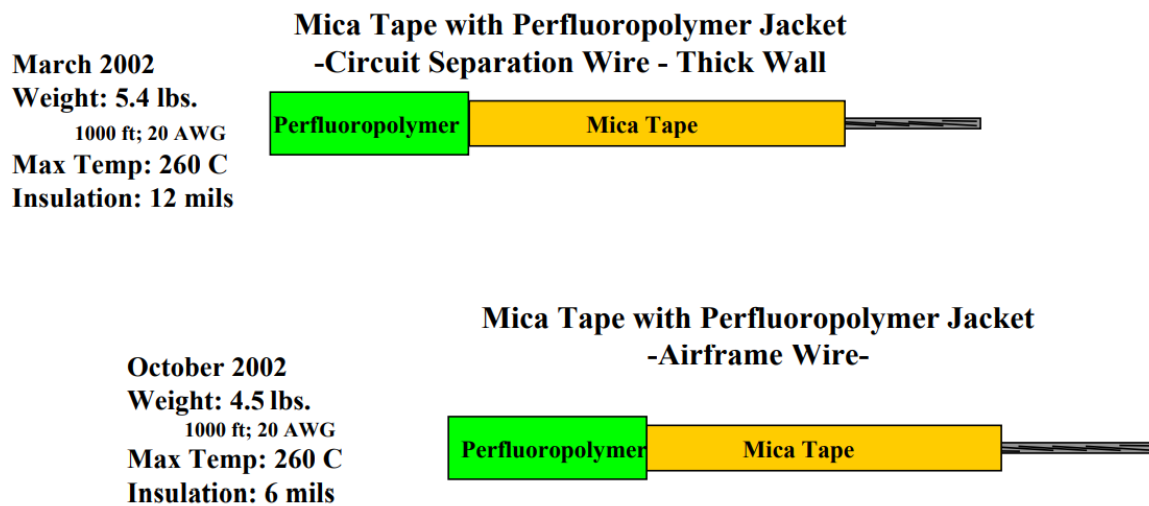
After the Boeing 747 accident, the wire designs have undergone a major change. The association of wire designs and their insulations with the specific accident will be explained in Section 3. The vulnerability of the system as it pertains to our case is also explained in that section. Observe the below figure to see the new designs of the wire to isolate circuits.

Figure 11: The Applied Circuit Separation for Better Isolation on the Wires [8].
