Damage to monumental masonry buildings in Hatay and Osmaniye following the 2023 Turkey-Syria earthquakes: the role of wall geometry, construction quality and material properties

Abstract This paper reports on the findings of an investigation on 29 historic stone masonry buildings located in the cities of Hatay and Osmaniye following the recent Turkey-Syria earthquakes. The earthquake couplet on 6 February (with moment magnitudes 7.8 and 7.5) and the following aftershocks (including an event on 20 February with a moment magnitude of 6.3) resulted in significant damage to the buildings. To understand why, the examined buildings were assigned an EMS-98 damage level (ranging from 1 to 5) and descriptive response categories (masonry disaggregation, local mechanism and global response). Overall damage statistics indicated that masonry disaggregation was common and coterminous with local mechanism response. Wall geometry and construction quality indices were then investigated to explore why these were the dominant damage mechanisms. Wall geometry indices highlighted insufficient amount of walls to resist the local seismic demands, particularly in the transverse (e.g. short) direction of

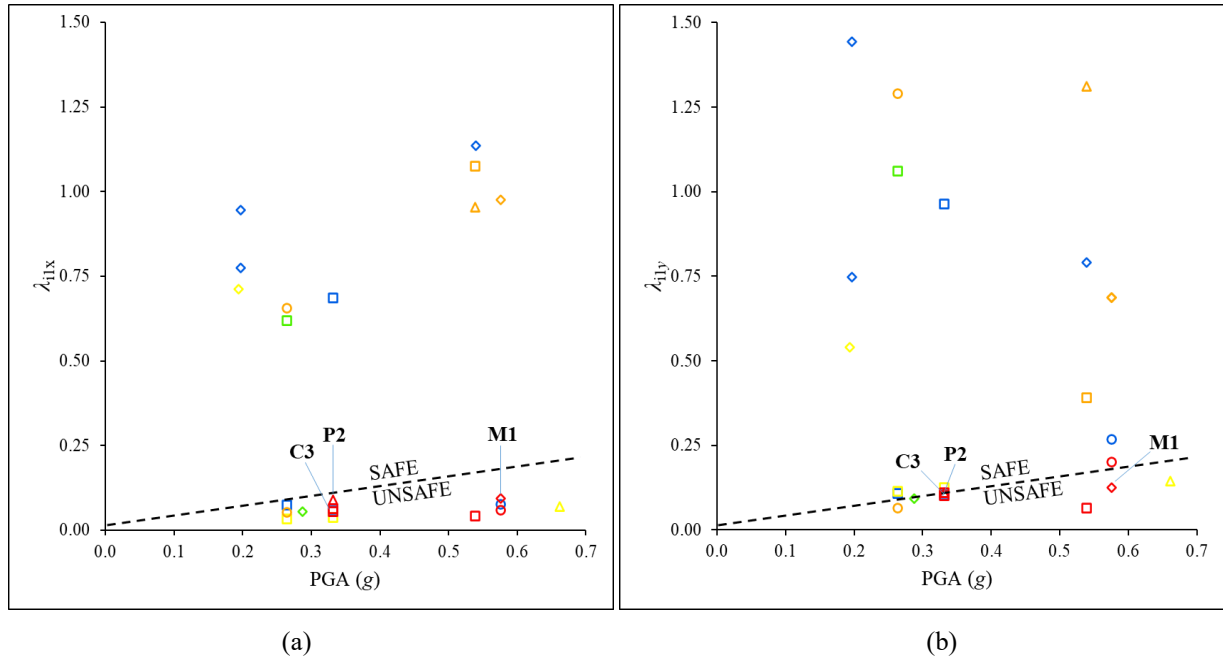
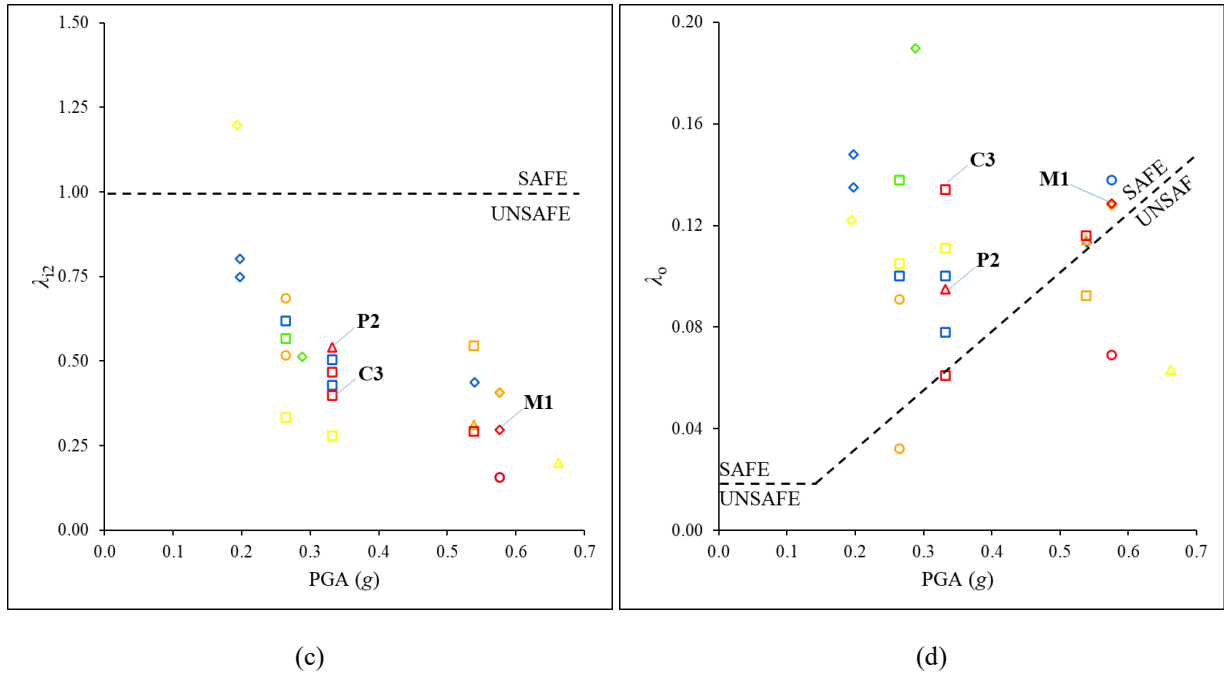
Fig.4. Relationship between a) λ_{i1x} and PGA b) λ_{i1y} and PGA c) λ_{i2} and PGA d) λ_o and PGA (\square : church, \diamond : mosque, Δ : public, \circ : residential, blue: DG1, green: DG2, yellow: DG3, orange: DG4, red: DG5 according to EMS-98)

The results for the second in-plane index in the transverse direction in Fig.4c indicate that only one building is in the safe region. All buildings with DG levels 1 and 2 are located in unsafe areas. This indicates that in its current form, the second in-plane index in-plane provides a conservative assessment of safety. This is to be expected since important factors such as the contribution of material resistance (due to cohesion and tensile capacity) and other load distribution systems (such as rigid diaphragms, see concrete floors in P1 Fig.3b, or transverse arched frames in church naves, see C6 in Fig.3c) are neglected in the index calculations. However, the large percentage of unsafe classifications in the in-plane indices highlight a potential deficit for the examined structures in terms of their wall area to resist the earthquakes. The fact that all collapsed structures (DG5) are located in the unsafe regions of Figs.4a-c corroborates this statement.

(including C3, M1 and P2) was due to local mechanism formation and out-of-plane motion of walls in the building transverse direction (see Fig. 3). To evaluate the vulnerability of walls to overturning instability during out-of-plane motion, Fig.4d explores the relationship between λ_o and PGA. According to Fig.4d, only 5 of the buildings have unsafe walls, indicating that the walls of structures were, in general, sufficiently thick to prevent out of plane instability. However, several building walls in the safe zone of Fig.4d (including C3, M1 and P2) collapsed in the out-of-plane direction.

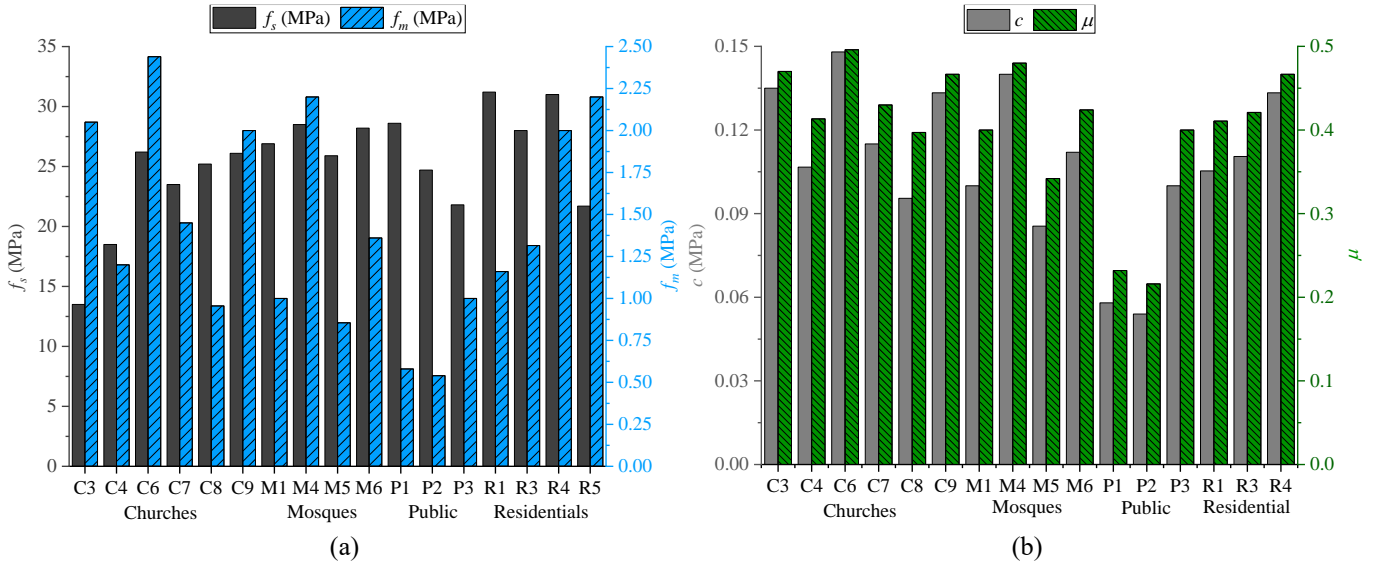
Average stone and mortar compressive strength values are plotted in Fig.11a. Other key parameters that may be used in numerical investigations include the cohesion (c) and the coefficient of friction of mortar (μ). c and μ were estimated using the average f_m values in Table 7 and interpolating the NZSEE recommendations (see Table 8) for non-cohesive, soft and firm historic masonry mortar properties (Ghiassi et al., 2019). The resulting values are shown in Fig.11b, where the values of c and μ vary between 0.05-0.15 MPa and 0.2-0.5, respectively.

Fig.11. a) Compressive strength values for stone and mortar b) tangent of friction angle and cohesion values

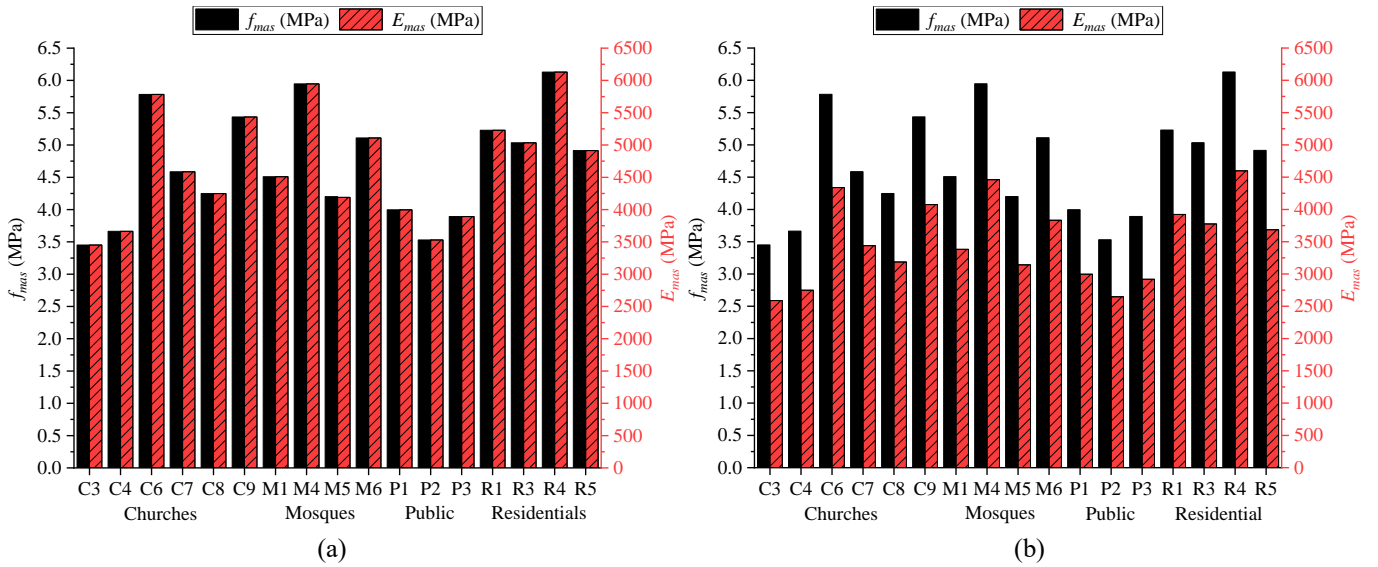
Fig.12. Compressive strength and elastic modulus values for masonry a) using EC6 equations b) using TBEC2018 equations

Using Eqs.(10-11), the f_{mas} and E_{mas} values are calculated. These are presented in Figs.12a-b for EC6 and TBEC2018. f_{mas} ranges between 3.4 and 6.2 MPa according to EC6 and TBEC2018, while E_{mas} varies between 3450-6130 MPa and 2585-4600 for EC6 and TBEC2018, respectively.
