**RENAULT Twingo**

41 NEW POSITION OF BATTERY*Other sub-section concerned :***42****Basic manual : M.R. 306**

41 SPECIAL POINTS FOR VEHICLES EQUIPPED WITH AN AIRBAG**Basic manual : M.R. 306**

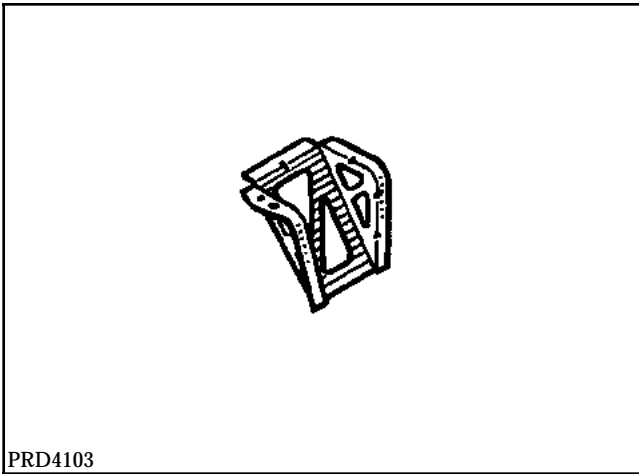
CONNECTION WITH SIDE MEMBER

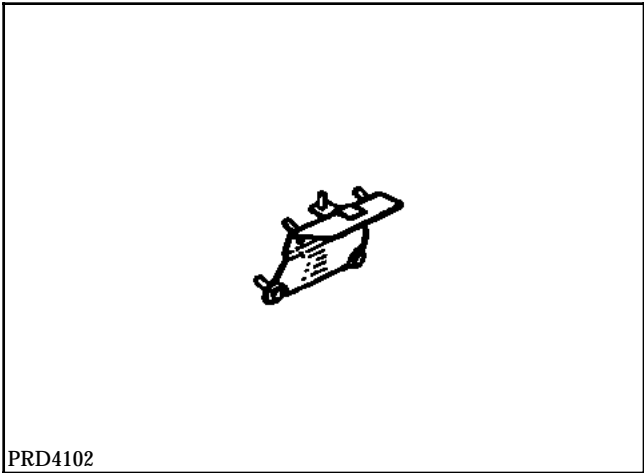
1 CONNECTION WITH CENTRAL FLOOR PANEL

NOTE: When carrying out a complete bodywork replacement, the connection can be made using **4.8 mm** dia. sealed-type rivets **10 mm** long.
