## **Evaluation of the Tank Bottom Corrosion and CP Effectiveness at a Saudi Aramco Crude Oil Tank Farm**

Xianming (Andy) Yu  
Saudi Arabian Oil Company  
P. O. Box 4151  
Ras Tanura, Saudi Arabia 31311  
Fax: +966 3 6733143  
Email: [xianming.yu@aramco.com](mailto:xianming.yu@aramco.com)

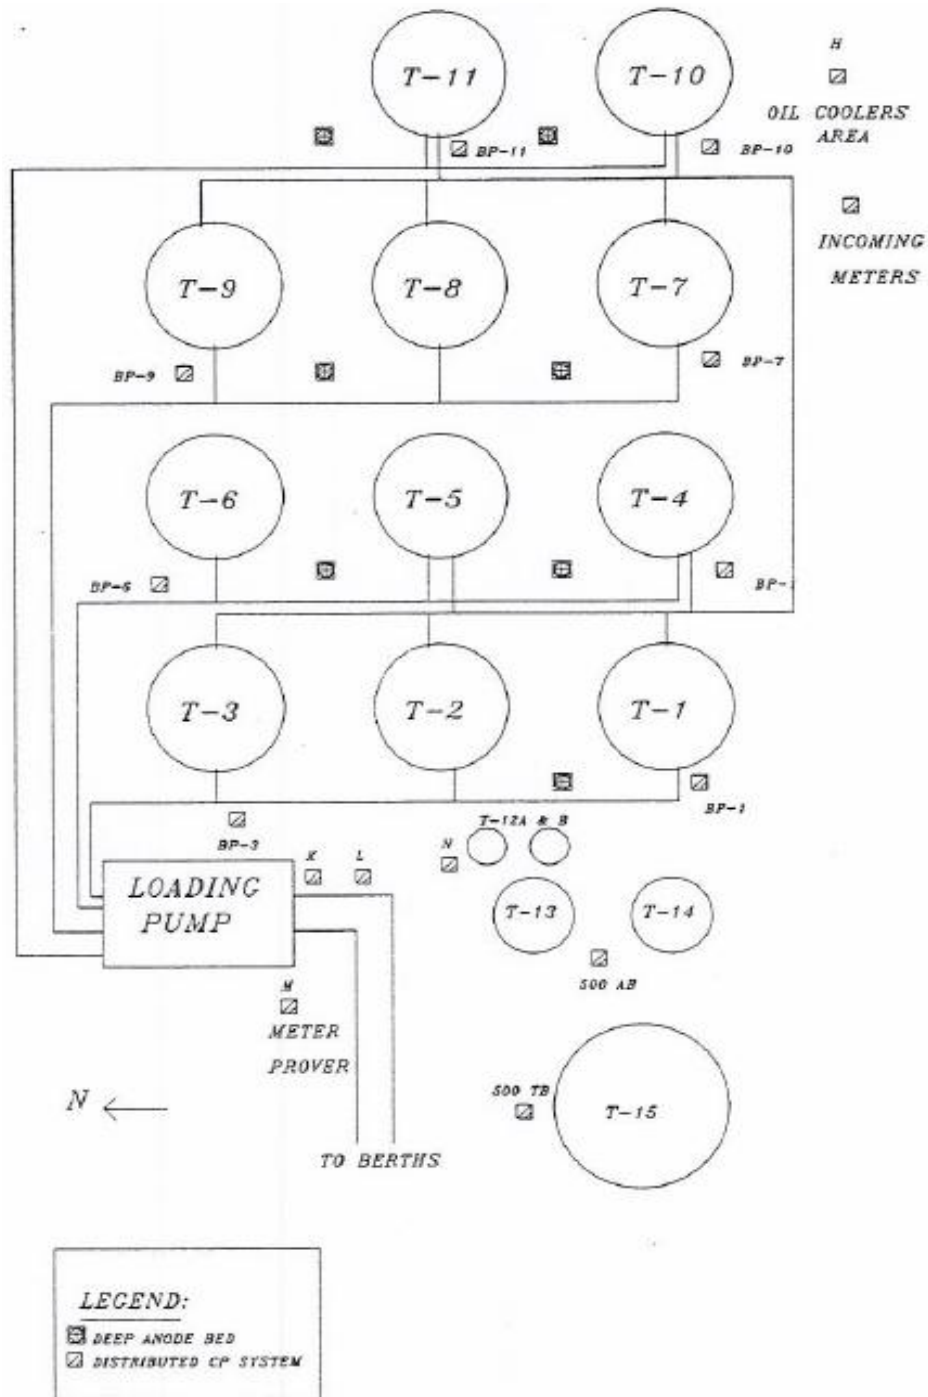
**Figure 1** – Locations of the CP systems at the COTF

Tank T-08 at a Saudi Aramco Crude Oil Tank Farm (COTF) was built in 1981 for storing crude oil. The tank with a nominal diameter of 360 ft (109.7 m) was constructed on oily sand pads. Impressed current cathodic protection (CP) systems were utilized to protect the underside surfaces of the 16 oil tanks and associated buried pipelines at the tank farm. The CP system included a combination of the remote deep anode beds and distributed anode beds. The anodes were LIDA® type, mixed metal oxide (MMO) anodes. The bottom underside surface of T-08 was primarily protected with four (4) remote deep anode beds surrounding the tank (Figure 1).
