# Demolition / Refurbishment Asbestos Survey Report

Birtley House Group Ltd

Birtley House

11<sup>th</sup> April 2015

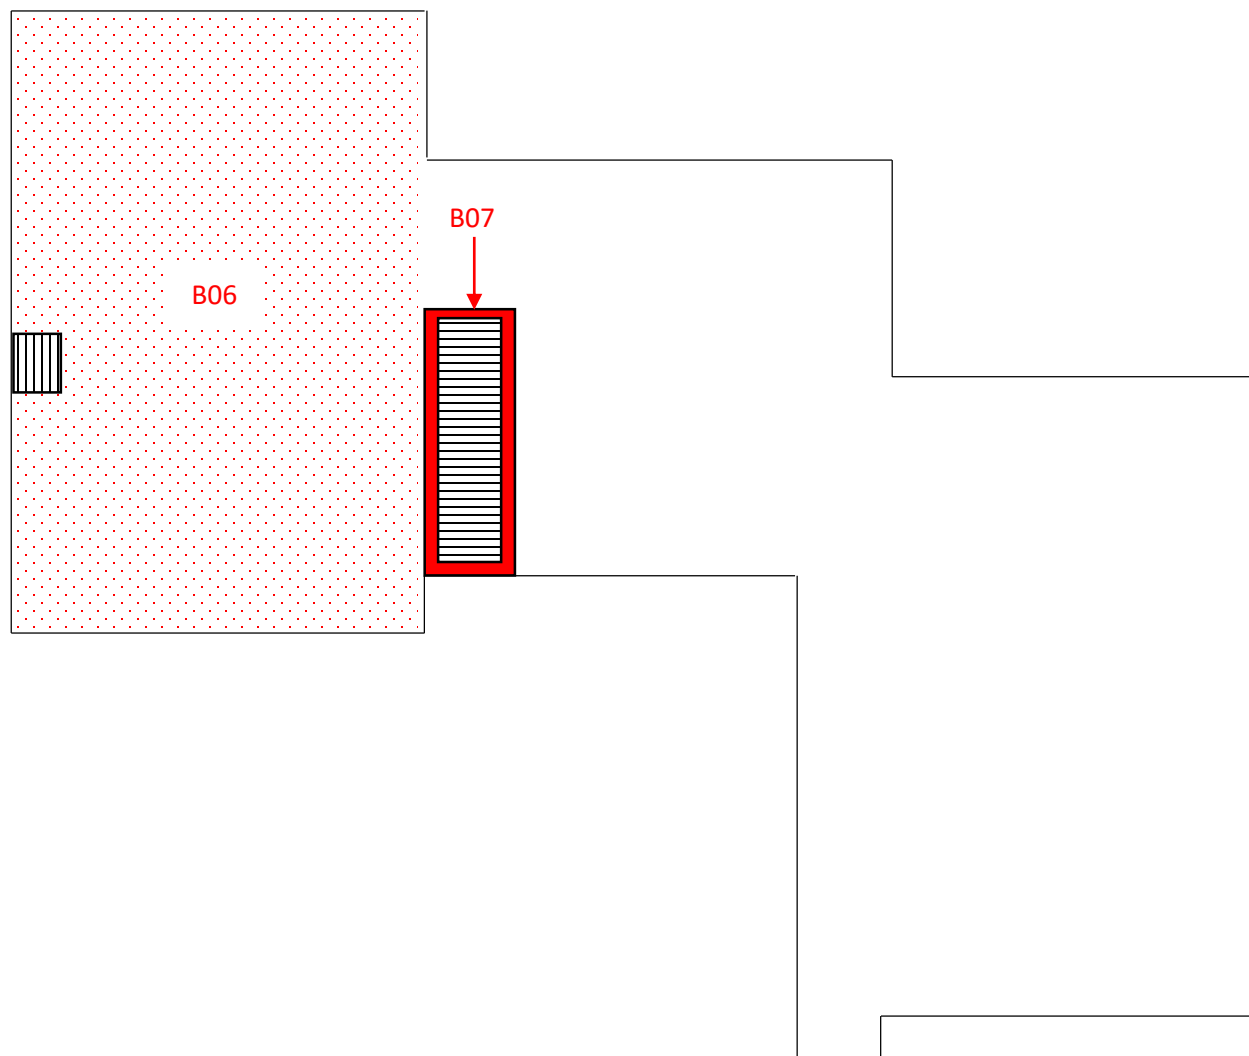
## Asbestos Location Plan

- 1.11 Asbestos location plans presented in Appendix D if supplied by client at the time of the survey, shows the locations of all materials found to contain Asbestos (ACM's). Additionally areas of no access, if applicable, will be highlighted on the plans.
