VIBRATION ASSESSMENT OF UNIT 55 PIPEWORK

LOCATION: SOKU GAS PLANT

REPORT NO: STATIC VIB/2022/EA/SGP-001

SURVEY PERIOD: 29th October – 3rd November 2022

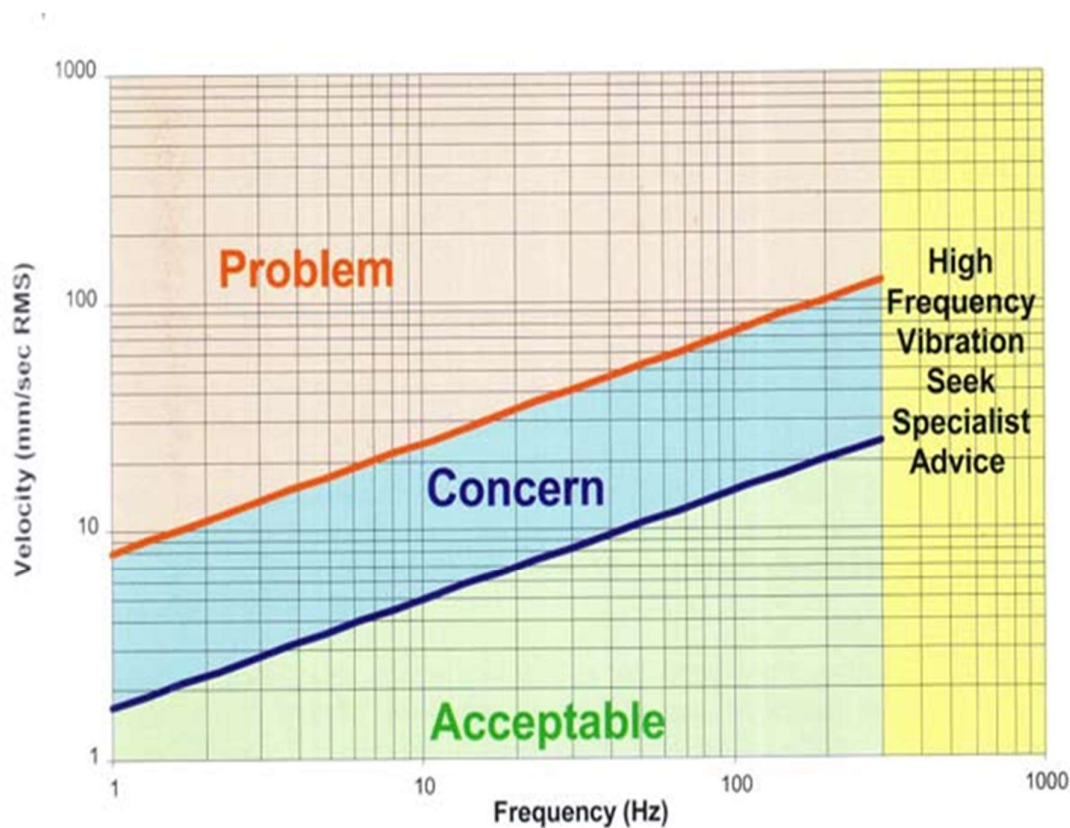
The vibration assessment criteria for both the main pipe and small-bore connection are given below, using the measured RMS levels and the peak frequency of the measured response.
