# **XT1225/XT1254 BASEBAND TROUBLESHOOTING GUIDE**

**Sept 18, 2014**

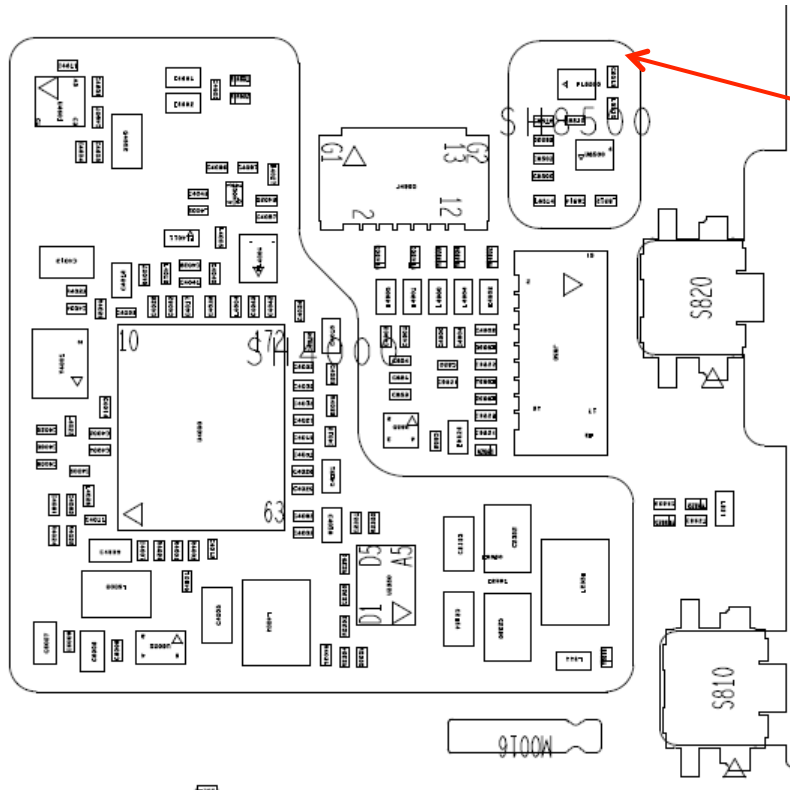
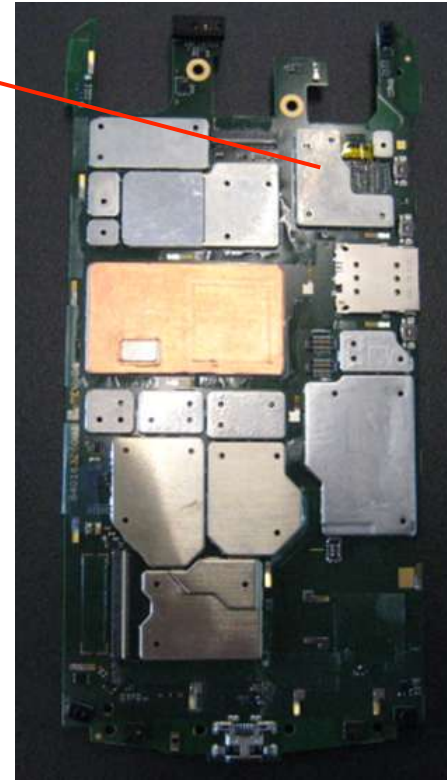
Location on board

# BT/WiFi – Schematic (cont.)

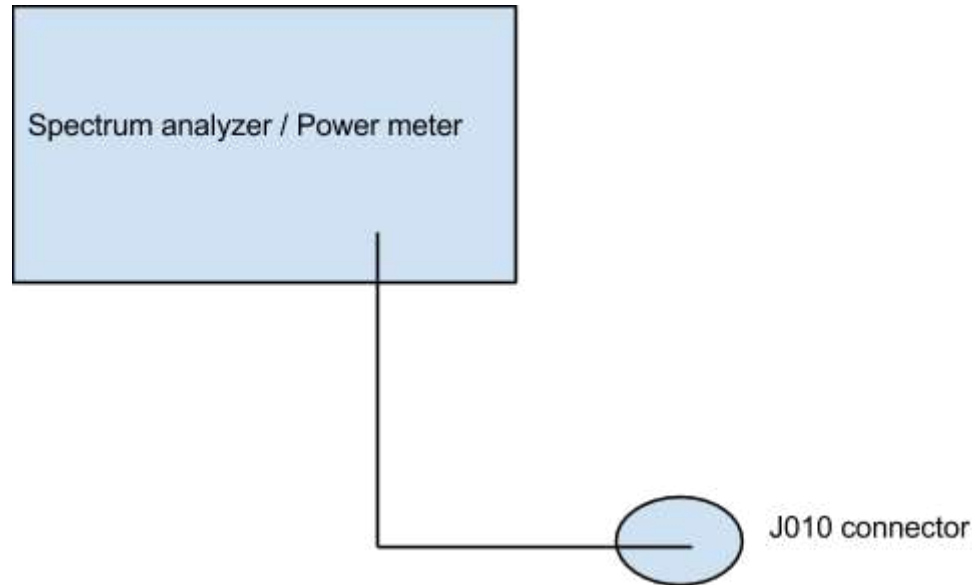
# BT/WiFi – Measure Power on Bench

Just connect the spectrum analyzer or power meter directly to J010 connector as following:

The WiFi signal is 20 MHz wide. If you use a spectrum analyzer, you should pick a wide enough span to measure the channel power across 20 MHz. Or if your spectrum analyzer can support 20 MHz resolution bandwidth, you can just use zero span.

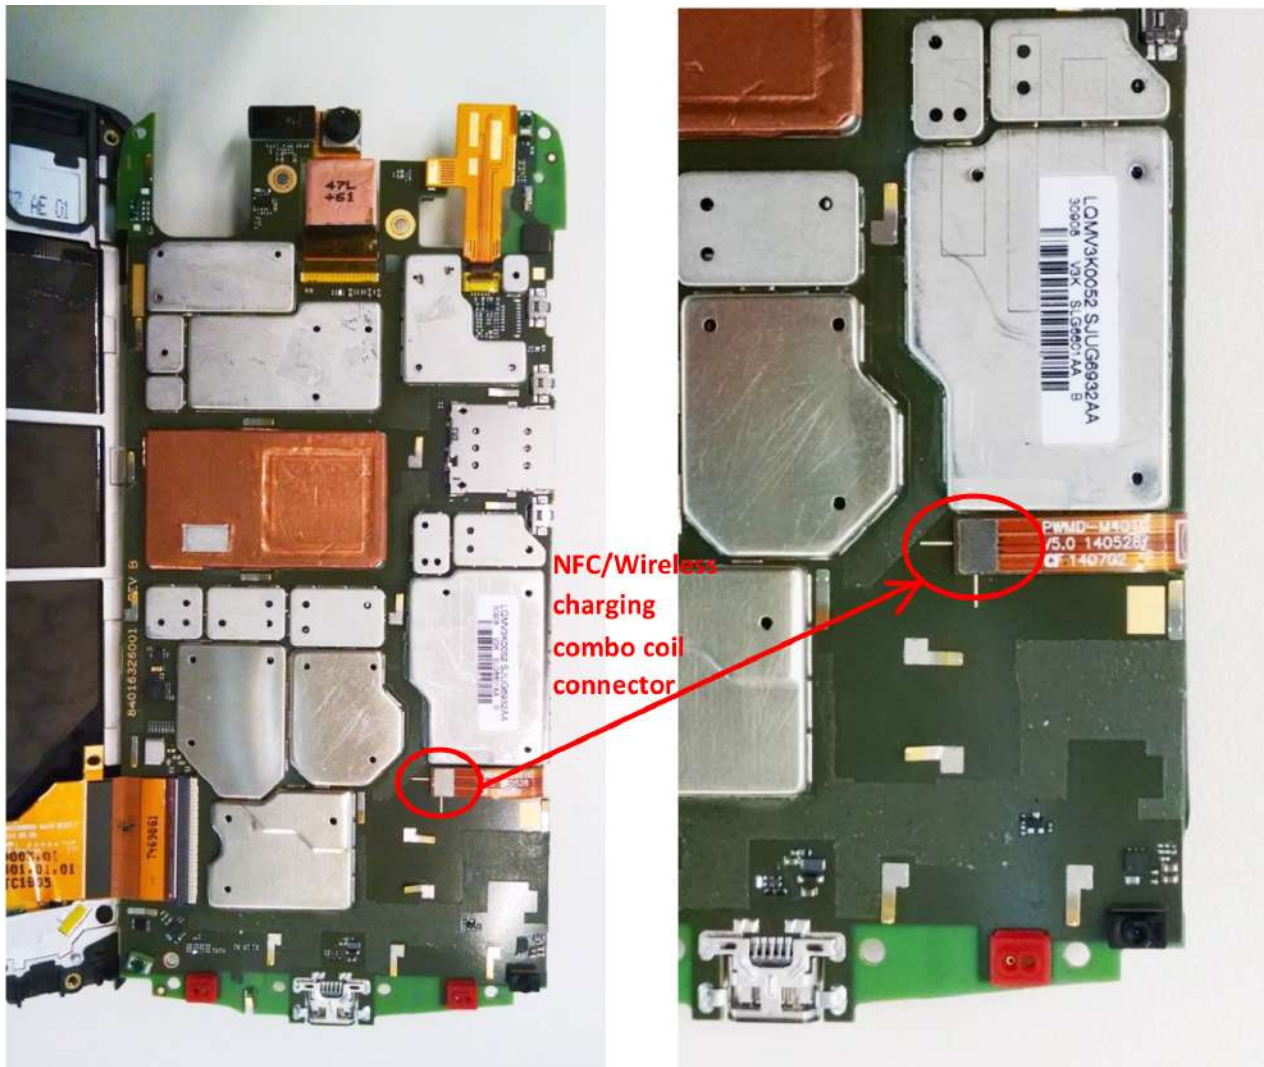
# NFC – Debugging Procedure (cont.)

2. Verify NFC antenna connector is not damaged on flex or on PCB. There may be soldering defects, such as shorts, broken pads. There may also be broken pins within the connector. Often broken pins can occur through improper insertion of connector.

3. Replace NFC antenna to see if it follows antenna itself.
4. Ensure NFC antenna matching components are not damaged.
