Baxter	DIVISION OR FUNCTION:	DOCUMENT No.: 35022-SVC	ISSUE DATE: See Stamp
	Service	REVISION: D	EFFECTIVE DATE: SEE STAMP
	OWNING GROUP: Service	DOCUMENT TYPE: ITP	
TITLE: Visual Component Inspection of a SIGMA Model Spectrum Pump			PAGE 1 OF 33

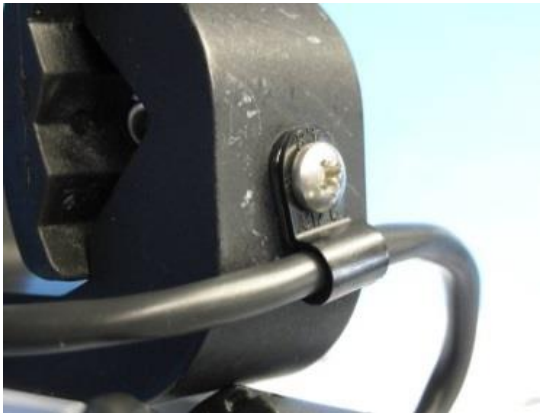
<p>6.1 Inspect the Pole Clamp for threaded hole for the Cord Clip installation.</p> <p>6.2 Reject Pole Clamp if threaded hole does not exist for processing as per SWI 010.</p>

<p>Pole clamp with cord clip installed</p>
<p>6.3 Acceptable Pole Clamp Assembly includes:</p> <p>6.3.1 Uniform flat black in color.</p> <p>6.3.2 Pole clamps without corrosion or discoloration, has all components but has wear on the edges because of usage</p>	<div style="display: flex; justify-content: space-around;"> <div data-bbox="889 905 1182 1331">

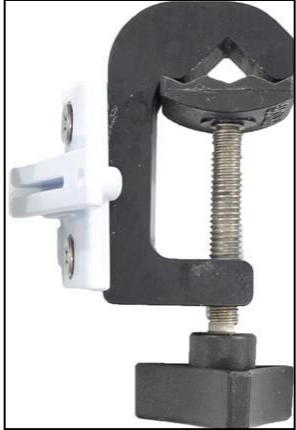
<p>Flat black pole clamp</p> </div> <div data-bbox="1268 877 1451 1331">

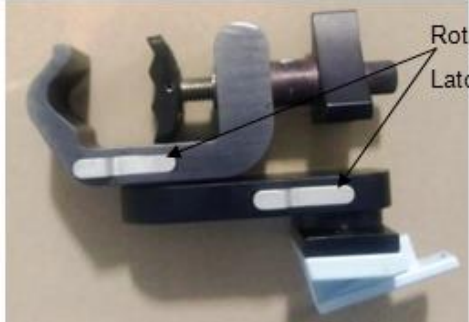
<p>Rotation Latches</p> <p>Pole Clamp Assembly</p>

<p>7.8 Ensure proper movement (90°) of the Position Arm or Position Wheel while depressing the Trigger Lever 1 or Trigger Lever 2.</p> <p>7.9 If movement is limited or non-functional, then the pole clamp may be reworked per 42049.</p>

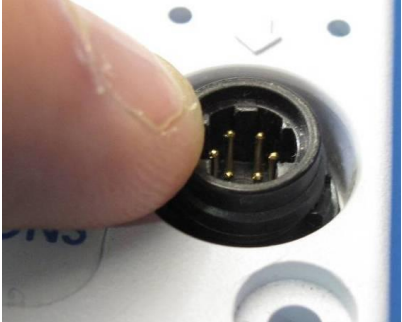
<p>9.5 Using your finger, ensure the bolus connector is tight and visually inspect the pins to ensure all 6 are present, not bent or corroded.</p> <p>9.6 Replace or rework the Rear Case if condition exists.</p>

<p>Figure 19: Pump side power adaptor with all 6 pins intact and undamaged</p>

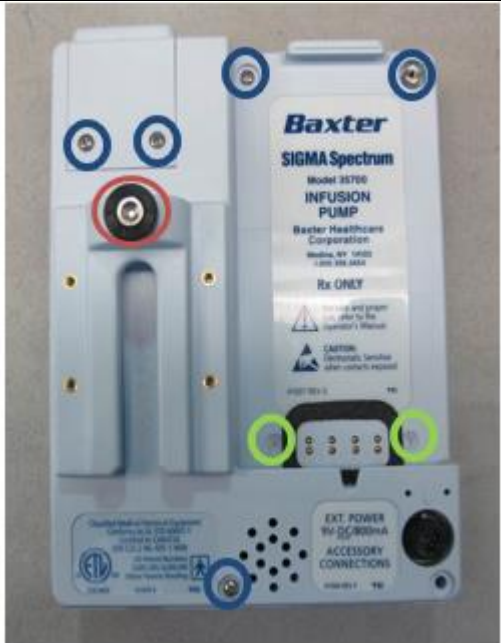
<p>9.10 Ensure the following Rear case screws are present and seated properly.</p> <p>9.10.1 Thumb Screw</p> <p>9.10.1.1 Ensure the thumb screw moves freely, without backing all the way out (1 ½ to 2 turns) by hand in both directions.</p> <p>9.10.1.2 If stuck, attempt to loosen to normal operation (see above), with a 9/64" hex driver.</p> <p>9.10.2 Back Flex Nylon screws</p> <p>9.11 Replace or rework the pump side adaptor and Back Flex nylon screws as required.</p>

<p>Thumb screw (Red circle), Nylon Screws (Green circles), Rear Case (Blue circles)</p>
<p>9.12 If applicable, inspect the scanner bracket window for debris, such as solder or glue.</p> <p>9.13 Chipped case by scanner window – Reject. Any chips in the rear case that expose internal components could adversely affect essential requirements of Withstand ESD, Withstand Fluid Ingress, and Withstand RF/EMI.</p> <p>NOTE: Scratches to the scanner bracket window does not warrant a replacement.</p> <p>9.14 Remove or replace the Scanner Bracket Window as applicable.</p>

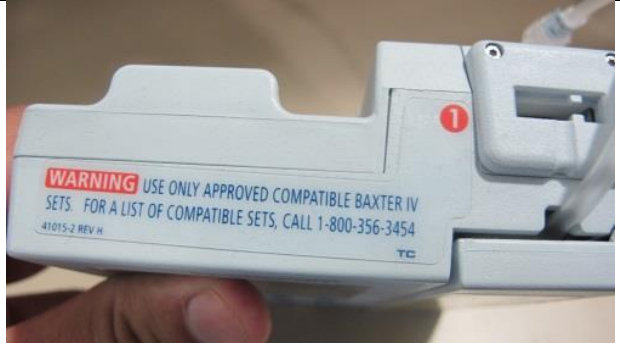
<p>Properly attached Tubing ID Label.</p>

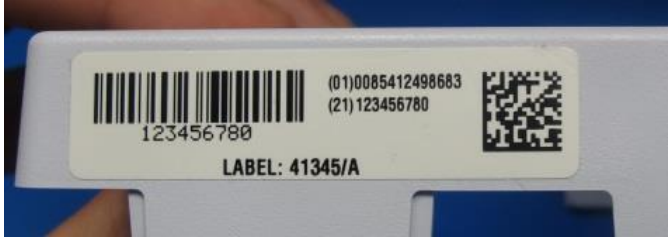
<p>Properly attached Serial Number Label Serial Number Label with 1D and 2D Barcodes shown above</p>

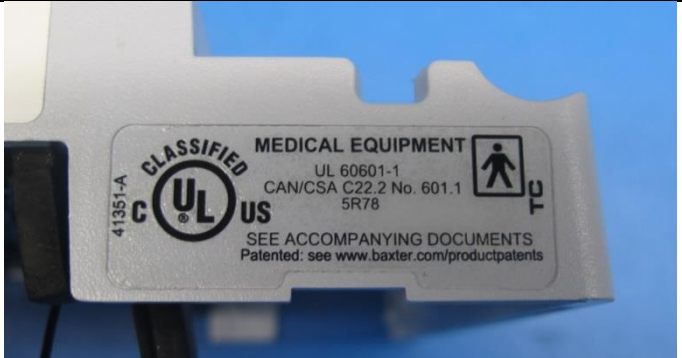
<p>10.8 Applicable to 35700BAX2, ensure the certification label is in place and adhered properly.</p> <p>10.9 Ensure that the label is not covering the tubing channel or weep hole.</p> <p>10.10 Replace all torn, missing, and improperly adhered labels.</p>

<p>Properly attached Certification Label</p>

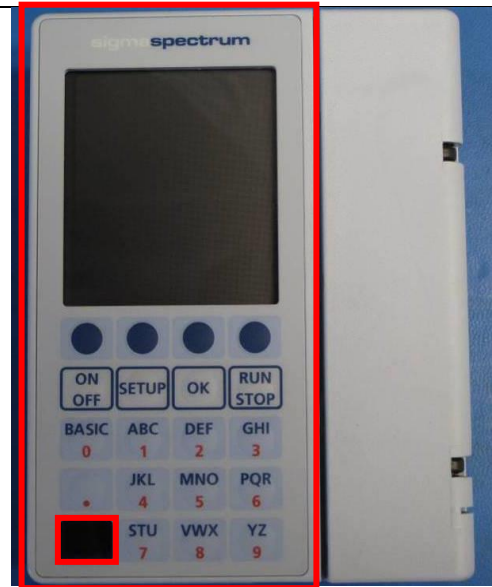
Keypad located correctly within the Front Case recess

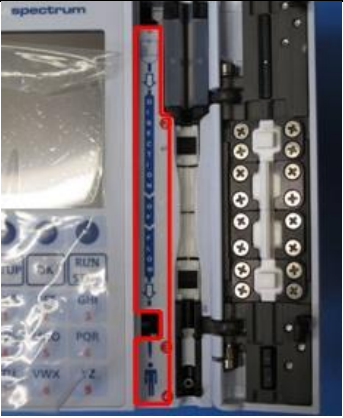
<p>Direction of Flow Label</p>
<p>10.14 Ensure the Top Door Spacer Label is present, printed clearly, and adhered properly.</p> <p>10.15 Replace the Top Door Spacer if the above criterion is not met or if debris is found under the label.</p>

<p>10.12 Ensure the Direction of Flow Label and Shim are present, printed clearly, and adhered properly.</p> <p>10.13 Replace the Direction of Flow Label or Shim if either label is found to have debris under the label or is adhered incorrectly.</p>

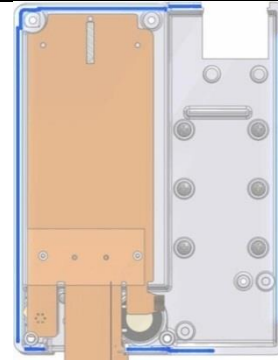
<p>Tongue portion of rear case plastic</p>

<p>14.1 Inspect the screw holes and Tongue portion of Rear Case Plastic for chips and or breaks.</p> <p>14.2 Discard the Rear Case if breaks or cracks in the plastic prevent proper case closing.</p> <p>14.3 Damaged tongue – Conditionally accept, with the criteria as follows: if the damage does not impact case closing, the rear case is acceptable. A 0.016" feeler gauge can be used during final acceptance testing, to determine efficacy of case closing.</p> <p>14.4 Impression, screw through holes – Conditionally accept, with the criteria as follows: if the damage does not impact case closing, the rear case is acceptable. A 0.016" feeler gauge can be used during final acceptance testing, to determine efficacy of case closing.</p> <p>14.5 Cracked PEM Boss (1 or 2) – Accept. PEM Bosses are not customer facing and are not linked to any essential requirements/functions for the pump.</p>

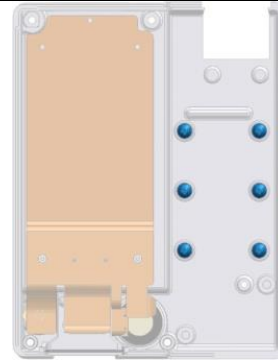
<p>Pump side power adaptor screws</p>

<p>14.6 Ensure all 6 Pump Side Adapter screws are present and seated properly.</p> <p>14.7 Cracks by screws for pump side adaptor – Accept. Internal cracks did not affect essential requirement of Mount the LVP.</p>

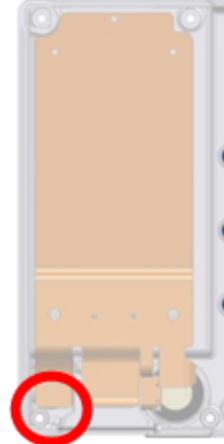
<p>Jumper wire location</p>
---	---

<p>14.8 Inspect the Backflex ASSY number. The numbers (35149) or (35149-1) will be on the top right corner of the Backflex.</p> <p>14.8.1 If the ASSY is 35149 then inspect the REV letter.</p> <p>14.8.1.1 If REV H, then inspect for jumper wire on the six pin connector. If wire is not there, then replace Rear Case.</p> <p>14.8.1.2 If REV F, then replace the rear case assembly.</p> <p>14.8.2 Cracks on 6-pin mount. – Accept. Interior cracks on the 6-pin mount do not adversely affect any pump requirement/function.</p>

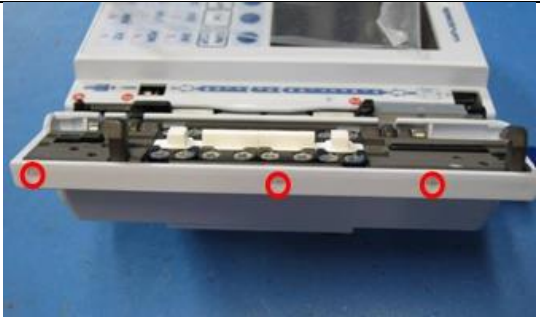
<p>15.1 If attached to the door, ensure the (3) nylon screws along the edge of the door are present and secured flush.</p> <p>15.2 Replace nylon screw if required. If Screw is found broken, then remove the door cover and broken screw per SWI 107.</p>

<p>Nylon screws on edge of door</p>
<p>15.3 The Door Cover must have ribs on the interior, hinge side, per ECN 18707.</p> <p>15.4 Replace Door Cover if ribs are not present.</p>

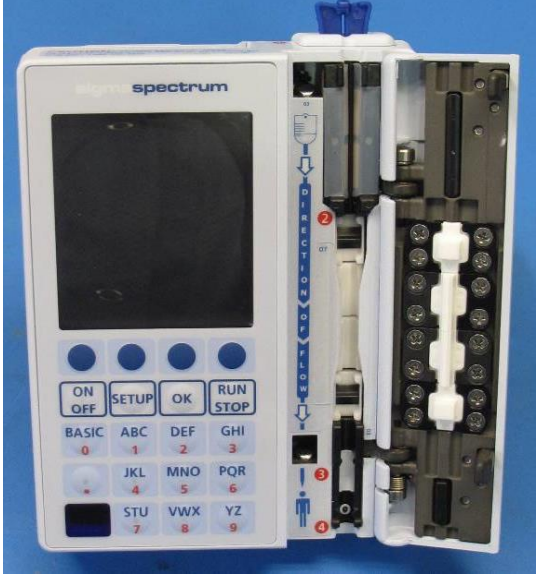
<p>16.1 Insert the appropriate slide clamp into the keyhole assembly. Door must open completely and without delay, when slide clamp is pressed.</p> <p>16.2 Any delay or failure to open must be evaluated and repaired as required.</p>

<p>Pump with door open</p>
<p>16.3 All (16) Pressure Plate Holder screws must be present and installed securely.</p> <p>16.4 Finger and Valve pressure plates must be free of breaks and cracks.</p>

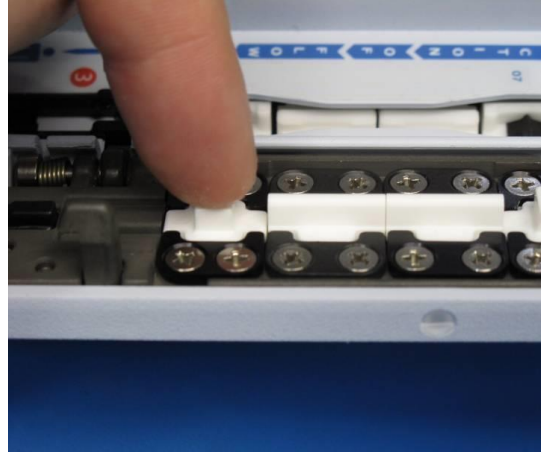
- 16.7 Depress the Valve Pressure Plates and Finger Pressure Plates multiple times to ensure they move freely.
- 16.7.1 If any Valve or Finger Pressure Plates fail to move, then rework or replace the Valve/Finger pressure plates.

Depressing a valve pressure plate

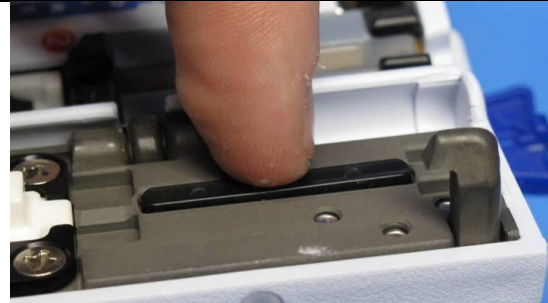
Upstream Pusher

- 16.8 Inspect the Upstream and Downstream pushers by:
- 16.8.1 Ensuring they are in place and secure
 - 16.8.2 The screws securing the pushers shall NOT protrude above the pusher.
 - 16.8.3 Pusher should not have any abnormalities.
- 16.9 Replace one or both of the pushers if the above criteria are not met.

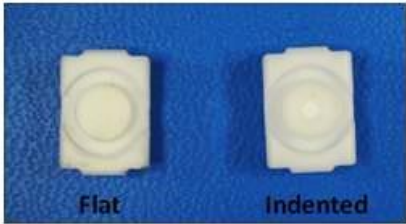
<p>16.10 Inspect the Hooks for:</p> <p>16.10.1 Six screws are present and flush</p> <p>16.10.2 Breaks, bends and/or cracks</p> <p>16.11 Replace the screws or Hooks as required</p>	
<p>16.12 Inspect the Pressure plates for indentation on the backside.</p> <p>16.13 Replace all Pressure Plates where the indent does NOT exist.</p>

<p>Flat Indented</p> <p>Comparison of flat and indented pressure plates</p>

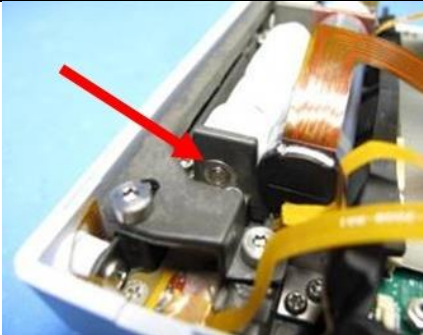
<p>Lower Bearing</p>

<p>17.1 Inspect lower Bearing to verify sealed bearings (55139) are installed on the mechanism assembly.</p> <p>17.2 If Sealed Bearings (55139) are not installed, then replace the bearings and lower bearing mount.</p>

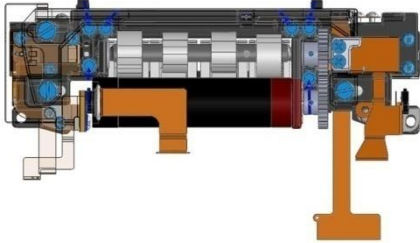
<p>Mechanism Hardware highlighted in blue</p>	
<p>17.6 Inspect the nylon cheesehead screws holding the motor to the Upper Bearing Mount. The nylon screws must be present and fully installed.</p> <p>17.6.1 Replace any missing or broken screws.</p>

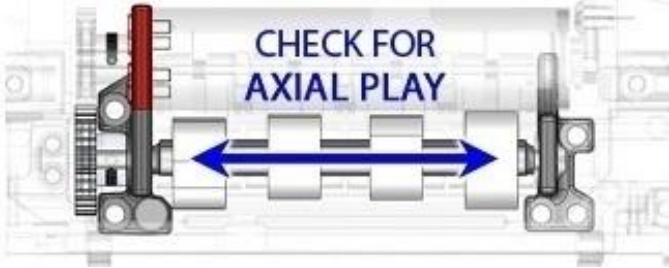
<p>17.17 Inspect for lateral movement of the cam shaft.</p> <p>17.18 If lateral movement does not exist, then replace determine the cause and replace the associated component.</p>

<p>CHECK FOR AXIAL PLAY</p> <p>Motor assembly with axial play noted</p>
<p>17.19 Press on the link to ensure it moves freely and the door opens.</p> <p>17.19.1 Rework as required if link does not move freely, or door does not open.</p>

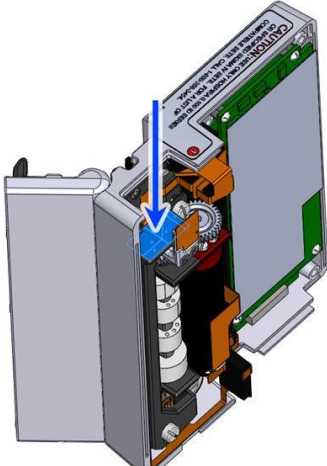
<p>Top of link highlighted blue</p>
<p>17.20 If present, inspect the ESD Barrier for:</p> <p>17.20.1 Cracks</p> <p>17.20.2 Breaks</p> <p>17.20.3 Crushed areas</p> <p>17.21 Replace if Cracks, Breaks or if the barrier is crushed.</p>

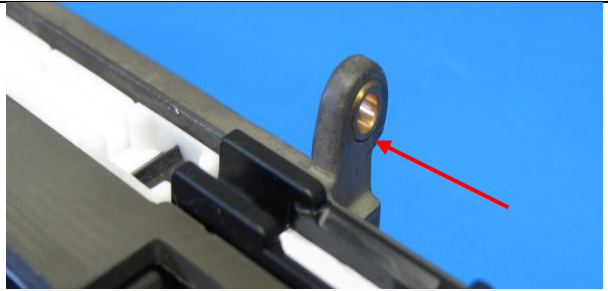
<p>Intact Hinge Bushing</p>
21.6 Inspect the Front Panel for two dots next to the bottom of the Downstream Tubing Guide. <ul style="list-style-type: none"> 21.6.1 Mechanisms that contain these dots cannot fit the latest revision. Downstream Tubing Guide. 21.7 If tubing guide replacement is required, replace the Mechanism sub-assembly.

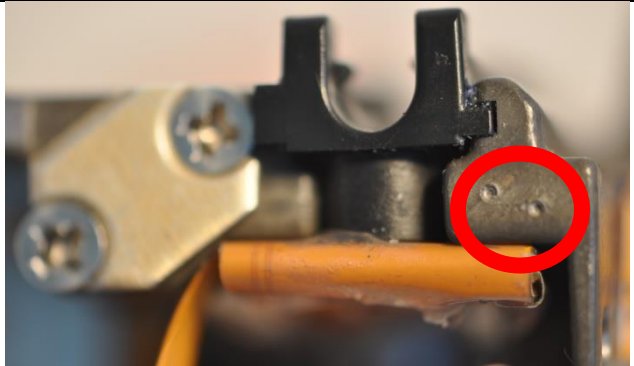
<p>Mechanism with 2 dots present</p>

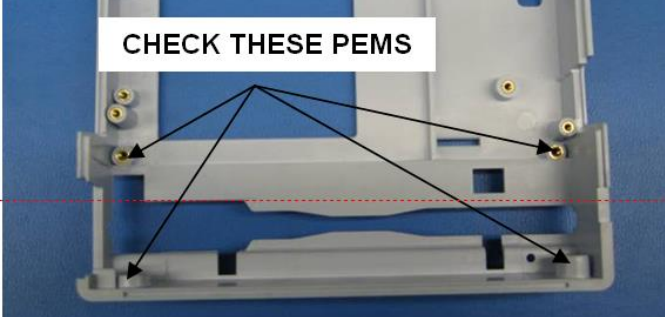
<p>22.1 Inspect the Mechanism mounting PEMS of the Front Case:</p> <p>22.1.1 PEMS shall be in place and secure</p> <p>22.1.2 PEM Boss shall be free of cracks that cause the PEM insert to become loose.</p> <p>22.2 Replace the Front Case if PEMS are not secure or missing.</p> <p>22.3 If unsure whether cracked boss affects security of PEM, this can be checked with an installed mechanism by attempting to close the door with a fluid-filled set.</p> <p>22.3.1 If the door can close with the fluid filled set, the case will not require replacement for the Mech Mounting PEM Boss crack.</p> <p>22.4 Cracked PEM Boss (Mechanism Installation) – Conditionally Accept, with the condition as follows: if the Mechanism is able to be lifted from the front case, the front case must be replaced for the brass insert moving freely. This is a like symptom to failure to install mechanism mounting screw, which may cause issues related to door closing. If the mechanism is firmly secured to the front case PEMs and the door can close, fully engaging the switches, no replacement is required. This can be tested by loading a fluid filled set and closing the door.</p>

<p>Pem locations within front case</p>
