# CAMERON

HOME INSPECTION

1234 ANYWHERE STREET

NASHVILLE, TENNESSEE 37221

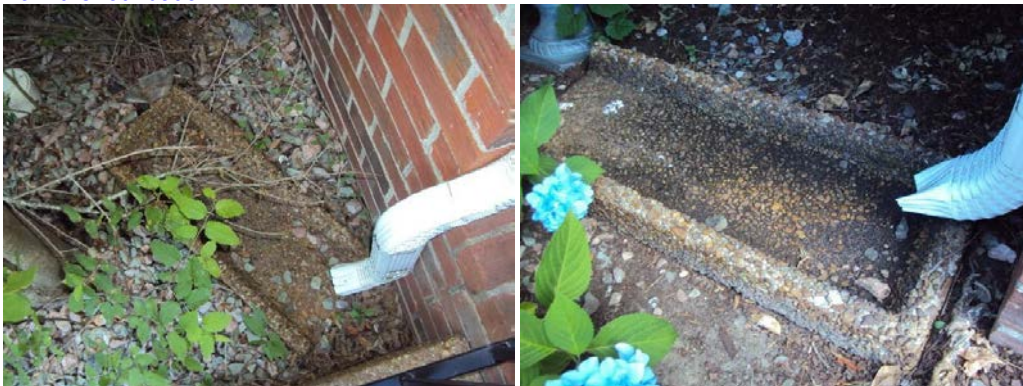
1. **Method of Inspection:** On roof
2. Acceptable **Material:** Asphalt shingle - Asphalt shingles are used on nearly 80% of all roofs. They require little maintenance and are generally expected to last 15-20 yrs. The architectural style shingles on this roof are generally expected to last 20-25 yrs.
3. **Type:** Gable
4. **Approximate Age:** Less than 5 yrs.
5. Acceptable **Flashing:**
6. Acceptable **Valleys:**
7. Acceptable **Plumbing Vents:**
8. Not Present **Electrical Mast:** Underground utilities
9. Acceptable **Gutters:**
10. Acceptable **Downspouts:**
11. Acceptable **Leader/Extension:** Ineffective and/or missing splash block(s) noted. Suggest that splash blocks be altered and/or replaced with buried leaders to better facilitate the run off and evacuation of water to a distance of at least 6' from the foundation.
