Incident ID: [TS-00339998](#)

J47451. Shipping sorter (CB4000) Broken collector brush

Product: [Intellisort CB 4000](#)

Category: [Conductor Rail](#)

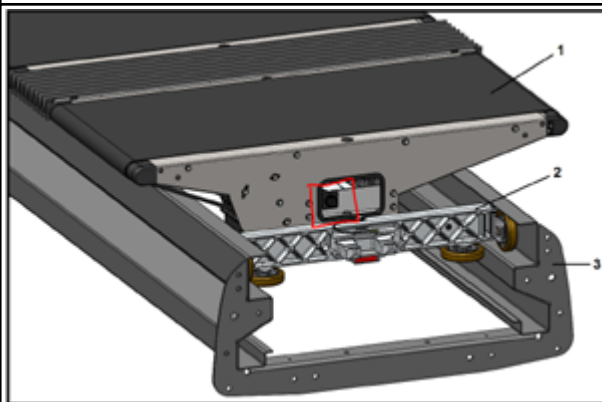
Figure 14

A bad connection was found and corrected. The reported carrier was 656 but this was not 100% positive to the correct cart number. The section that was reading 498 ohms, is now reading 0.8 ohms.

Site found a bad carrier connection (Carrier 656). The high resistance measurement (498 Ohms) taken between carriers 628-700 might have been a result of the bad connection.

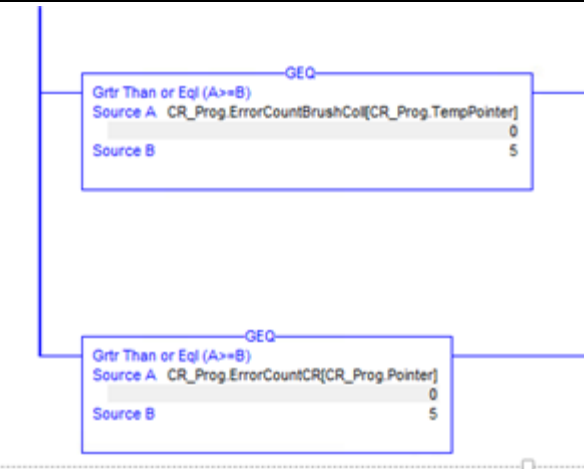
Figure 29

Since carriers 581-662 are reporting program mode (this occurs if they have low voltage), this suspected carrier is this section. I have asked the site to remove the brush assemblies on carriers 616, 628, 640, and 652 and remove the power cable between carriers 663/664. The max failed brushes configuration in the PLC was set to 5 as well and the max CTB/CRB failure was set to 120 carriers instead of 12. These two instructions in rung 13 of CR_Supervision needed to be increased to 5 instead of 2.
(see Figure 30)

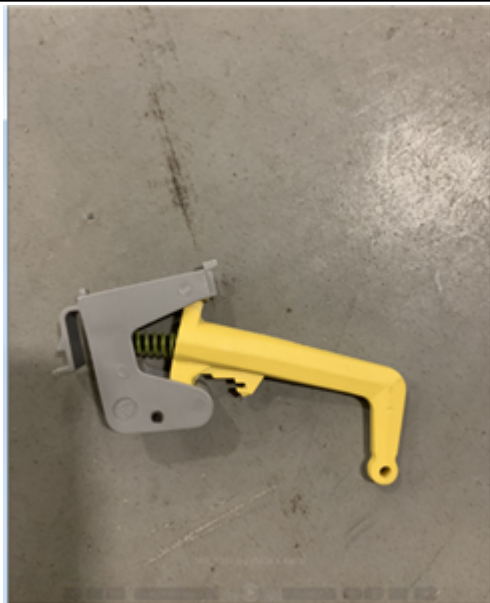
Figure 35

Missing fin found:
(see Figure 35)

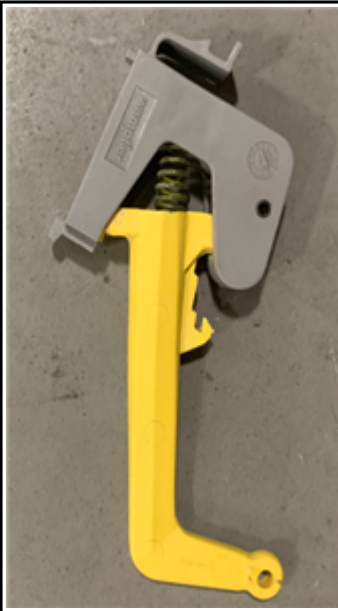
Figure 36

site found the missing brush section between carrier 78 and 79 (carrier 465 at CPU) around the area of conductor rail 7

the recent broken brush found in this situation. Site is inspecting to find the missing piece. Currently in CR7 to inspect.
