# The Therac 25

## A case study in safety failure

Nancy Leveson and Clark Turner, “The Investigation of the Therac-25 Accidents”, Computer, 26, 7 (July 1993) pp 18-41.

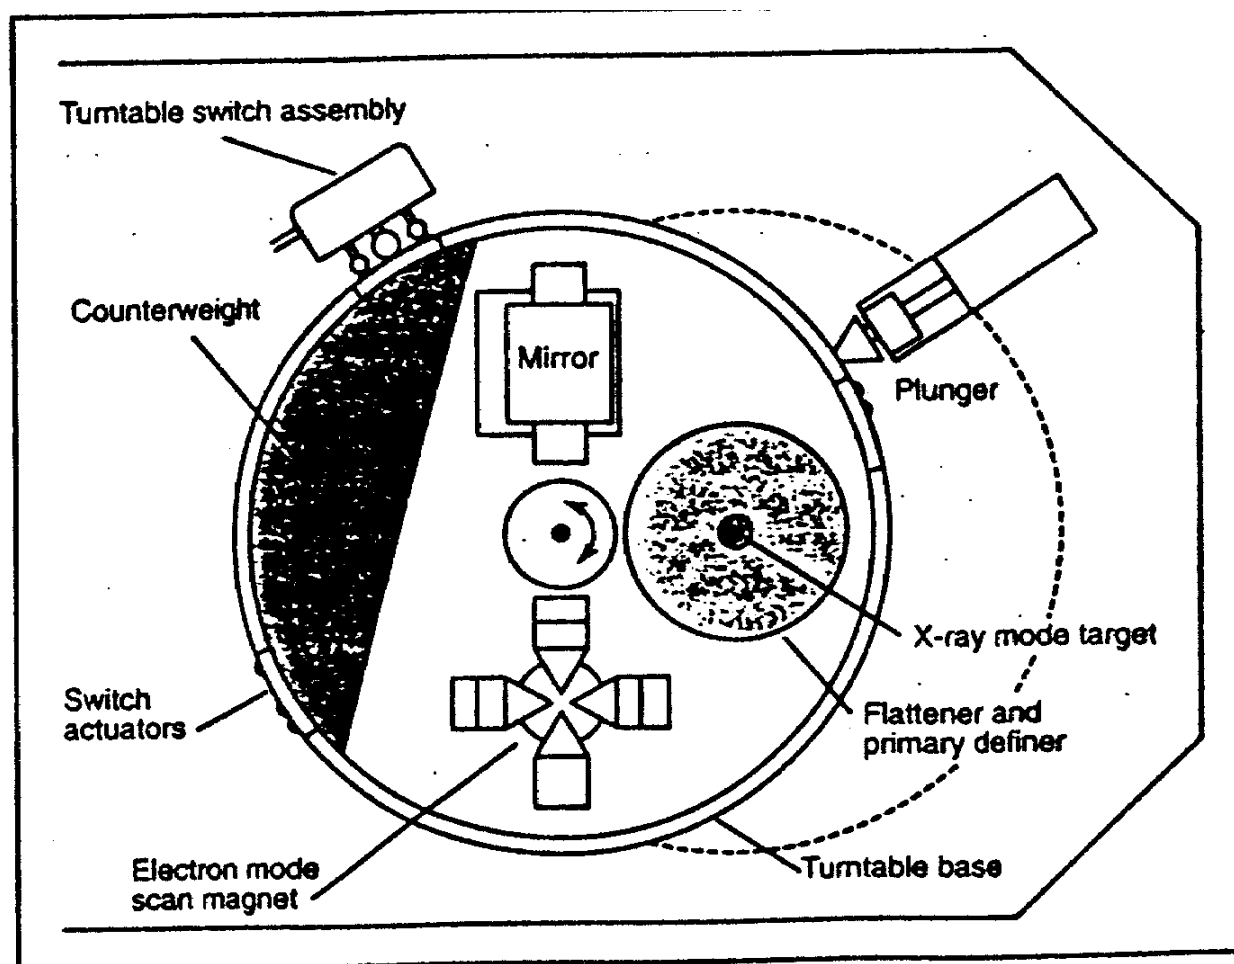
Figure B. Upper turntable assembly.

- Electron mode
  - 5-25 MEV
  - Magnets spread beam
  - Ion chamber monitor
- X-ray mode
  - 25 MEV electrons hit target
  - “Beam flattener” attenuates
  - 100x beam current
  - Ion chamber monitor
- Field-light mode
  - No current
  - Mirror & light used to check alignment
  - No ion chamber (since not treating)
