## THE 2019 E-DEFENSE SHAKE-TABLE TEST OF A LARGE-SCALE 3-STORY DISASTER MANAGEMENT CENTER

**Abstract:** In December 2019, shake-table tests of a 3-story disaster management center were performed at E-Defense in Japan as part of the Tokyo Metropolitan Resilience Project. This large-scale test was a collaboration between universities and research institutes in Japan and the US NHERI Natural Hazards Reconnaissance (RAPID) facility. Research objectives include validating resilient structural and non-structural element detailing and verifying the accuracy of a newly proposed structural health monitoring technique.

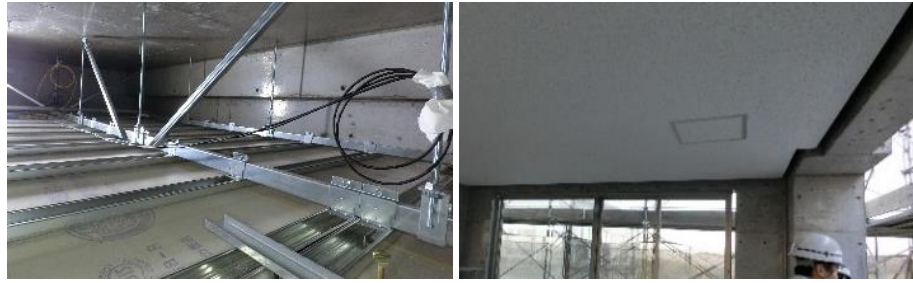
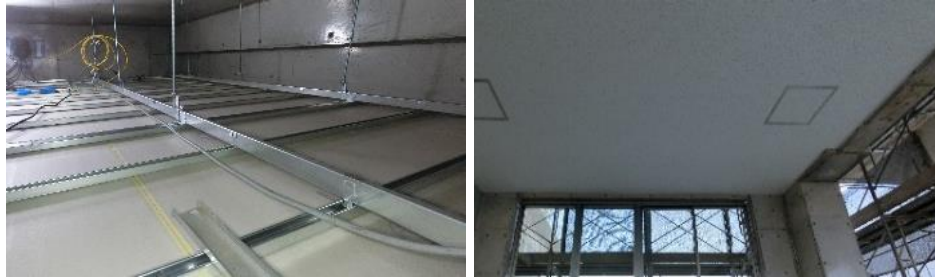
(a) behind the ceiling (b) ceiling (3<sup>rd</sup> floor)*Figure 9. Photos of the ceiling systems.*

The visual observation showed no particular damage to the ceilings on the second and third floors after the 100% input. After the first 150% input, it was confirmed that the corners of the ceiling on the second floor were slightly deformed. This is thought to be due to the end colliding with the beam. After 160% input, this deformation occurred on the entire side of the ceiling, and it was confirmed that there was a gap between the beam and the ceiling. Deformation of the board was also confirmed around the inspection port.
