here's a quick follow up report on the legacy shower issue The temperature was originally set to app. 125 deg and today the average was about 135 degree which may shift shower # 6 out of a decent temperature control range.

“Legacy BC showers water temp increase”

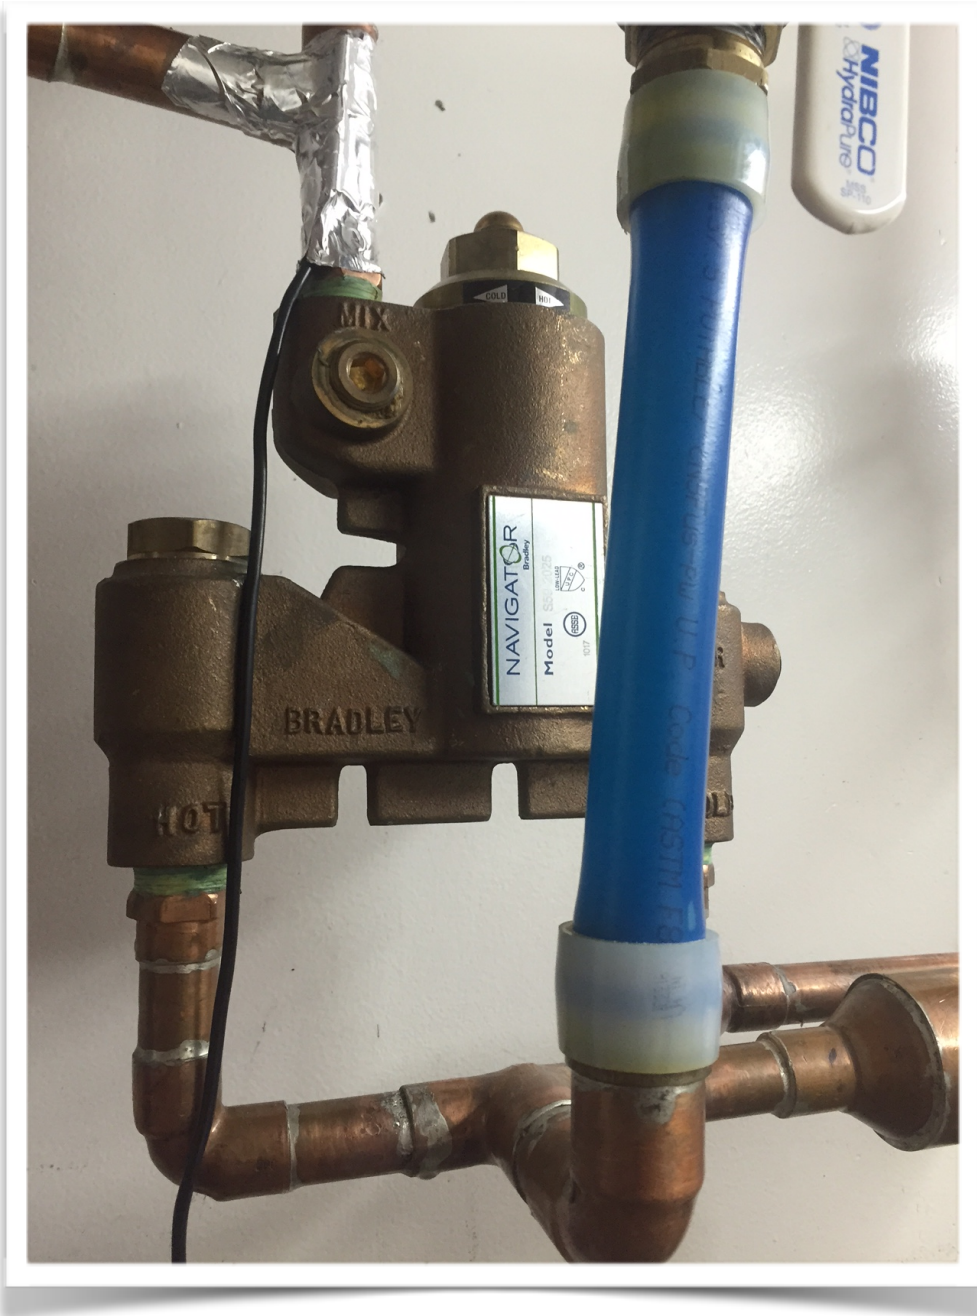
At the cold supply it is likely not from a boosted source and **may be as low as 20 + 10 psi** (head) and inadequate to operate the mixer at this a large variation

Call it another design flaw and getting away with it. Cold and hot need to be at app. the same supply pressure or boosted equally or it cannot work reliably with a poor water feed from the source.

A TMV data sheet is included.
