Degradation analysis of a photovoltaic generator after operating for 15 years in southern Brazil

José Eduardo Ferreira da Fonseca*, Fernando Schuck de Oliveira, César Wilhelm Massen Prieb, Arno Krenzinger

Federal University of Rio Grande do Sul, Brazil

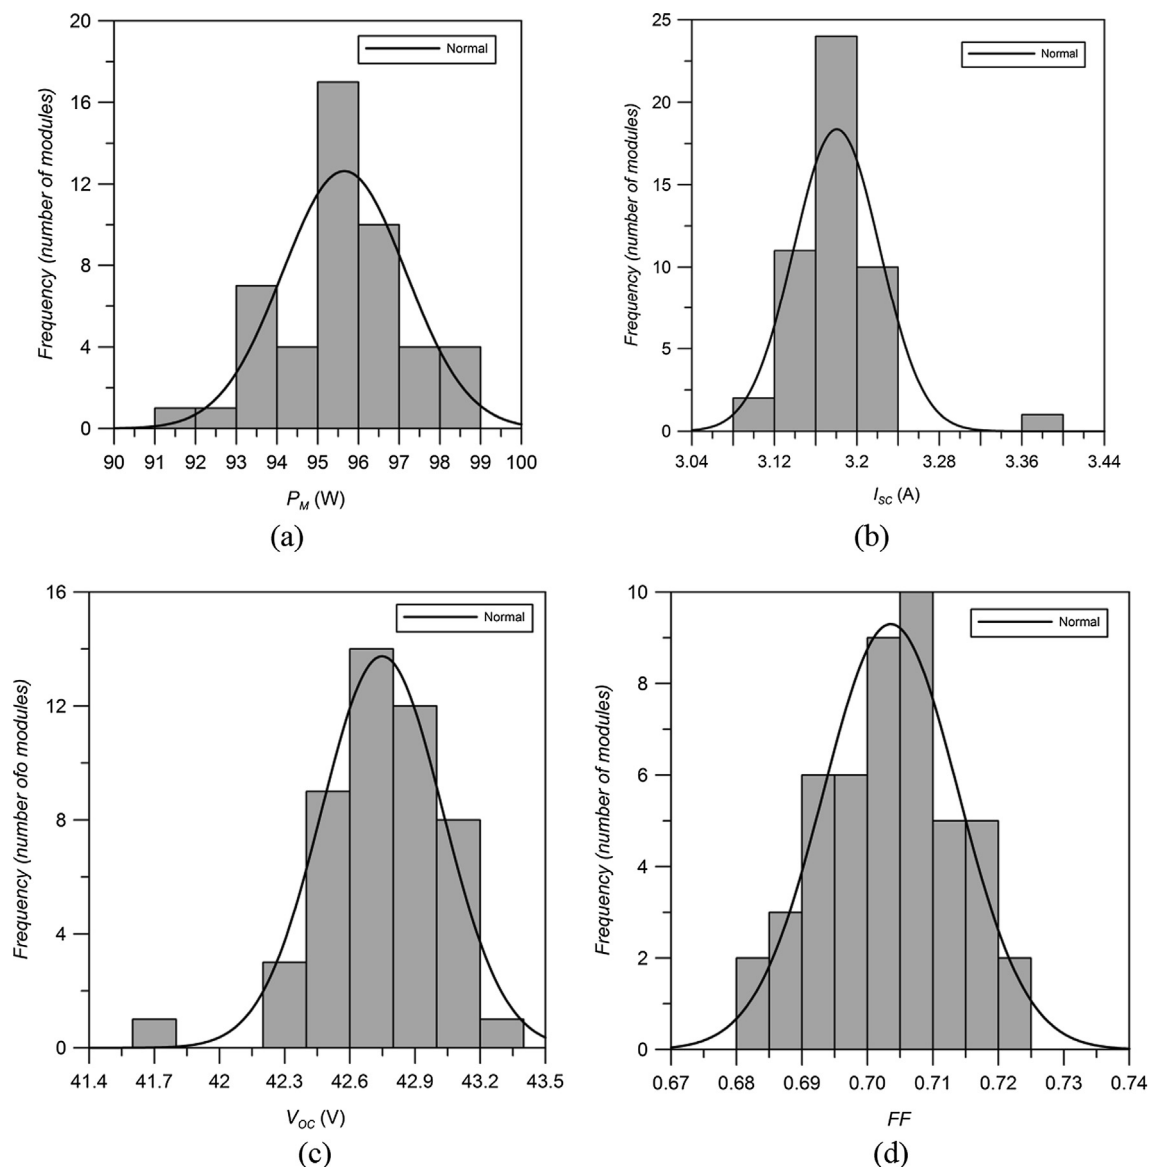
The histograms in Fig. 2 were built with the data from the I - V curves taken in 2004. These curves were measured with irradiance between 940 and 1070 W/m² and cell temperature between 53 and 64 °C, later translated to the standard condition. In the figure, (a) represents the maximum power, (b) the short circuit current, (c) the open circuit voltage and (d) the fill factor.

Fig. 2. Dispersion of the electric parameters before installation: (a) maximum power, (b) short circuit current, (c) open circuit voltage and (d) fill factor.

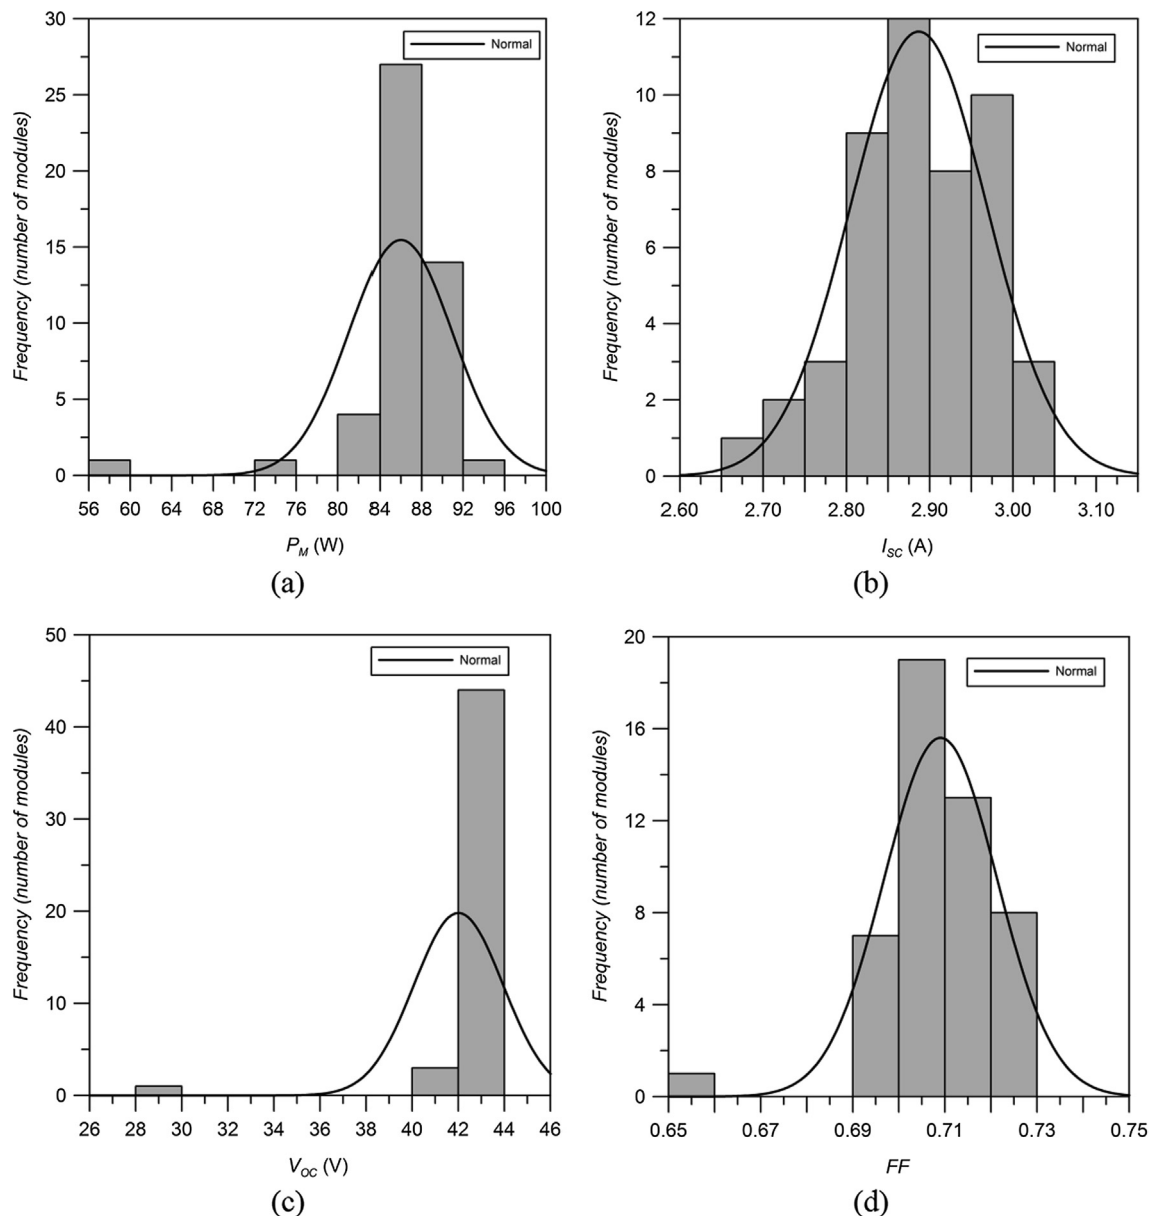
Similar histograms, shown in Fig. 3 were made from the I - V curves obtained after 15 years of operation. They represent the dispersion of

Analyzing the histogram of V_{OC} in Fig. 3, one can notice a module that has a much lower voltage, about 2/3 of the other modules. This particular module, which I - V curve is shown in Fig. 4, was found to have two of its six series of cells inactive due to a failure in an internal connection. This failure was probably caused by moisture penetration, since this particular module (identified as EL6, the sixth module of the lower east string) had its junction box detached from the backsheet. Thus, for the analysis of degradation after 15 years of operation, this module was discarded and only 47 modules were considered.

Fig. 3. Dispersion of the electric parameters after 15 years of operation: (a) nominal power, (b) short circuit current, (c) open circuit voltage and (d) fill factor.

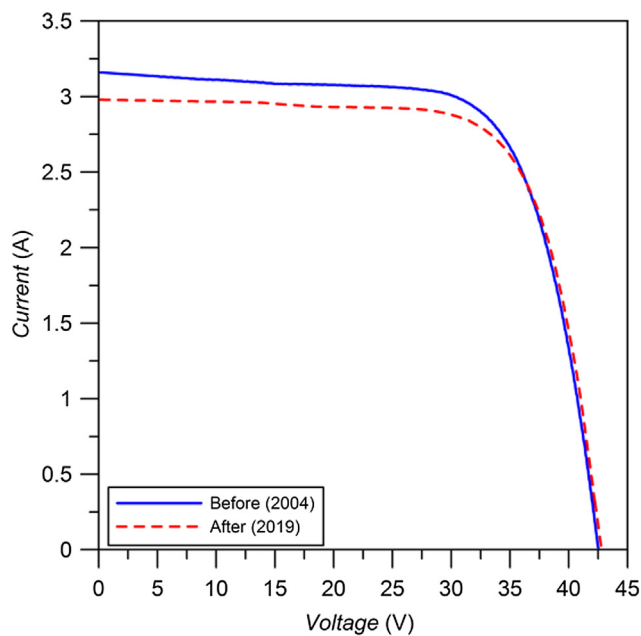
Fig. 5 shows the I - V curve of the module EH1 that presented smallest power reduction and Fig. 6 shows the I - V curve of the module CL1 that presented largest power reduction.

Fig. 5. Measured I-V curve of the module EH1 that presented smallest power reduction.

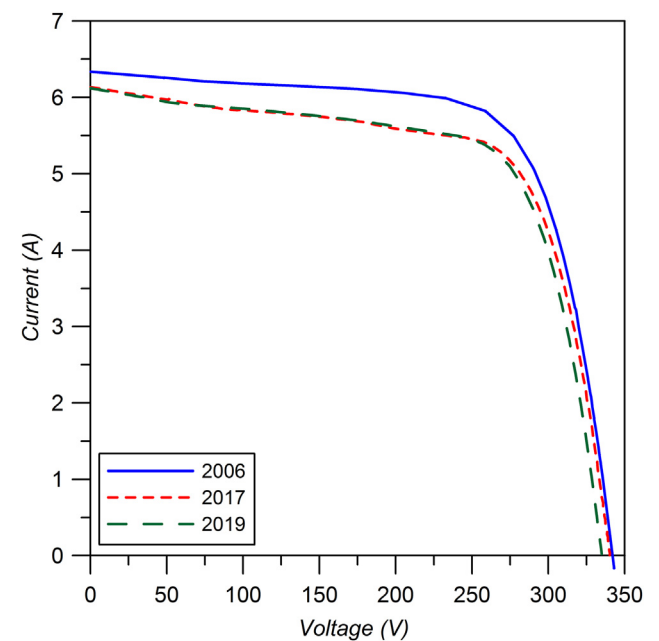
Fig. 7 shows three I - V curves of array formed by CL and WL strings connected in parallel taken in 2006, 2017 and 2019. In the graph it is possible to evaluate the power decrease over the years. Table 3 presents the electrical parameters taken from the same curves.

Fig. 7. I-V curves of the array made from CL and WL strings.
