Title: **Analysis and characterization of PV module defects by thermographic inspection**

Authors: Sara Gallardo-Saavedra, Luis Hernández-Callejo and Óscar Duque-Pérez

The PV site that has been analyzed is located in Spain, in Castilla y León region and it has a capacity of 3 MW, with 17,142 monocrystalline modules, model STREAM 175 W, and was commissioned in 2008. Each PV structure is composed of thirty-two modules, divided electrically in two arrays of sixteen modules, which are connected in parallel in the combiner box. PV structures have fixed 30° tilt structure and a general view of them can be seen in Figure 2. Each module has 72 cells (12x6).

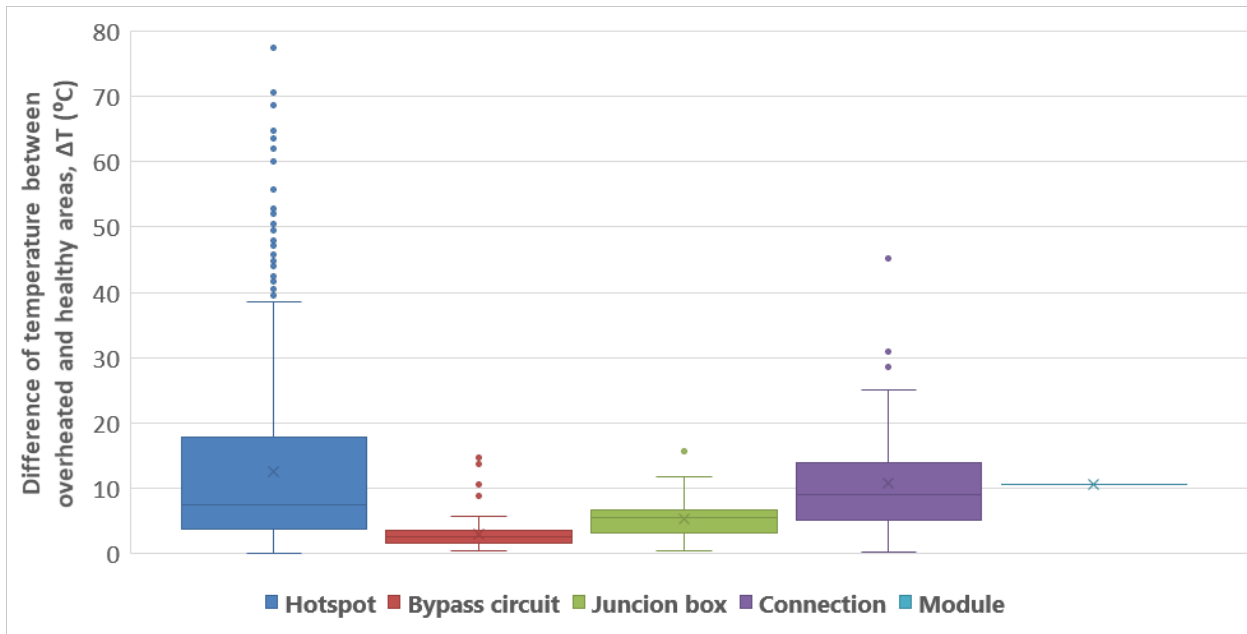
**Figure 3** Box chart showing the difference of temperature between overheated and healthy areas,  $\Delta T$ , grouped by defect type for each of the 1,140 defective modules detected.

Based on the results obtained in the tests performed, hotspot is the defect type that shows higher temperature differences, achieving up to 77.4°C between the overheated hotspot and the healthy area in one of the tested modules. The second type of defect that presents higher  $\Delta T$  is the connection, reaching 45.1°C. These two kinds of defects have some similarities. The defect area and consequently the overheated area are small, so the heat is concentrated in a smaller area. Hotspots typically appear in just one cell and the connection defects in a small busbar point. Additionally, these two kinds of defects are revealed in the front part of the module, so the thermographic camera captures directly this temperature during a regular inspection, in which the front temperature of PV modules is revised. Some plant operators sometimes perform, in addition to the front thermography of modules, an extended analysis of the back temperature of the defective modules observed in the front inspection. Nevertheless, this is not viable during aerial thermography inspections, as it is not safe that unmanned aerial vehicles (UAVs) fly at this small altitude. Therefore, in this case it would be necessary to do the post processing of the images taken during the flight and afterwards, going back to the defective modules with a manual thermal camera. However, this is not an appropriated solution, as the ambient conditions would have changed during the analysis days and the back manual thermography will not be comparable with the front aerial thermography. Additionally, performing manual thermography in the back of modules is not an easy task, due to the PV structures' tilt and to the structure posts, which covers part of the module. The angle in which the thermal images are taken will be distant from the recommended perpendicular angle and it will be difficult to capture the modules of the lower part of the PV structure, as they are not easily accessible. Following with the analysis of Figure 3, the third and fourth kinds of anomalies with higher  $\Delta T$  detected have been the junction box and bypass circuit defects, which present a similar range of  $\Delta T$  between them, with maximum  $\Delta T$  captured of 15.6°C and 15.1°C respectively. Junction boxes are in the back part of the module, which justifies that the  $\Delta T$  temperature captured from the front is smaller, as it is just measured the heat transfer that comes from the back. However, real temperature values achieved by the diodes in the junction box can be much higher than the temperature values expressed for this case in Figure 3. It will be more accurate measuring this kind of defect from the back, but it presents the inconveniences previously detailed. On the other hand, bypass circuit defects are revealed with lower temperature than other kind of faults, as the affected area in this case is larger. However, although they

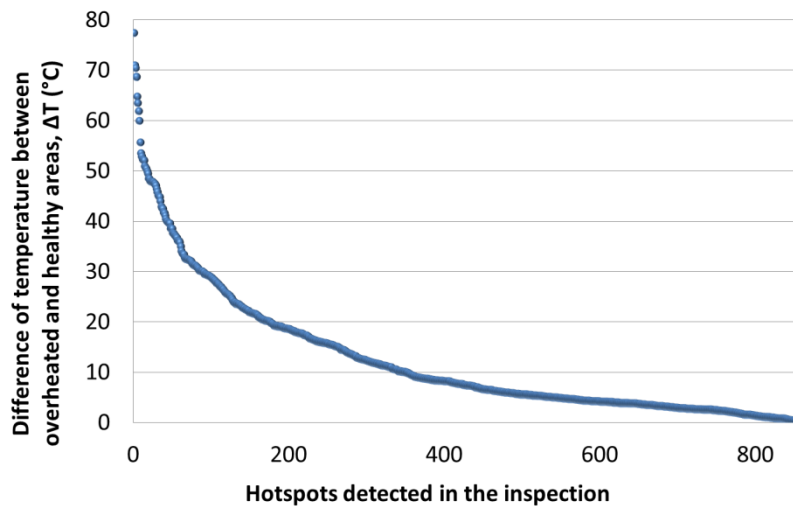
Reviewing all cells hotspot defects, it has been concluded that the pattern of this fault is an overheated cell, of approximate 15 x 15 cm<sup>2</sup> depending on the module manufacturer, located in any cell along the module. The analysis performed does not reveal any preference of appearance of the overheated cell in any of the three strings circuits. The following figure, Figure 7, presents the  $\Delta T$  of each of the 859 cell hotspots detected in the inspection in descencing  $\Delta T$  order, obtaining an average temperature of 12.4°C with a standard deviation on 12.8°C. Other relevant statistical values are the median, 7.4°C, and the first and third quartile, 3.8°C and 17.8°C, respectively.

**Figure 7**  $\Delta T$  of each hotspot detected during the inspection in order from the highest to the lowest.

As it can be seen in Figure 7, the highest  $\Delta T$  detected in the tests is  $77.4^{\circ}\text{C}$ , which supposes a cell hotspot temperature of over  $130^{\circ}\text{C}$ . Reaching high temperatures can generate a fire hazard. Authors in [39] determined that the maximum hot-spot temperature on rear surface of PV module reached to  $347^{\circ}\text{C}$  with bypass diode not turned ON condition.

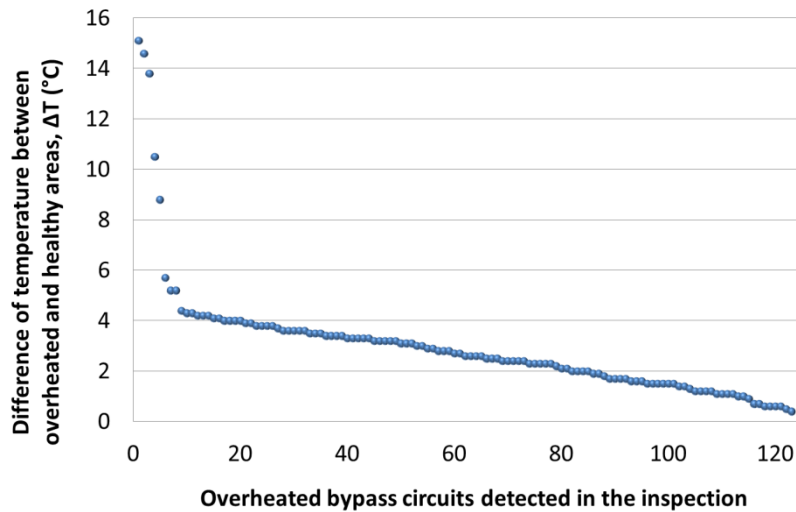
of these defects present a  $\Delta T$  under  $4^{\circ}\text{C}$ . Only 8 modules (which supposes a 6.5%) present a  $\Delta T$  over  $4^{\circ}\text{C}$  and only 4 modules (3.25%) have a  $\Delta T$  over  $10^{\circ}\text{C}$ . The maximum  $\Delta T$  detected has been  $15.1^{\circ}\text{C}$ . Other relevant statistical values are the median,  $2.6^{\circ}\text{C}$ , and the first and third quartile,  $1.7^{\circ}\text{C}$  and  $3.6^{\circ}\text{C}$ , respectively.

**Figure 9**  $\Delta T$  of each bypass circuit overheated detected during the inspection in order from the highest to the lowest.

As it can be seen in the figure, the maximum  $\Delta T$  reached in the bypass circuit cells overheated is  $15.1^{\circ}\text{C}$ . High temperatures are avoided by using bypass diodes in the modules, as the power dissipated in the fault decreases with respect to the temperature reached in a longer series of cells. However, authors in [40] conclude that the reliability of the bypass diode function remain uncertain and it is recommended to use application of specific PV modules with custom design of bypass diodes for specific applications in which high temperatures can suppose a risk hazard, as hydrocarbon industries

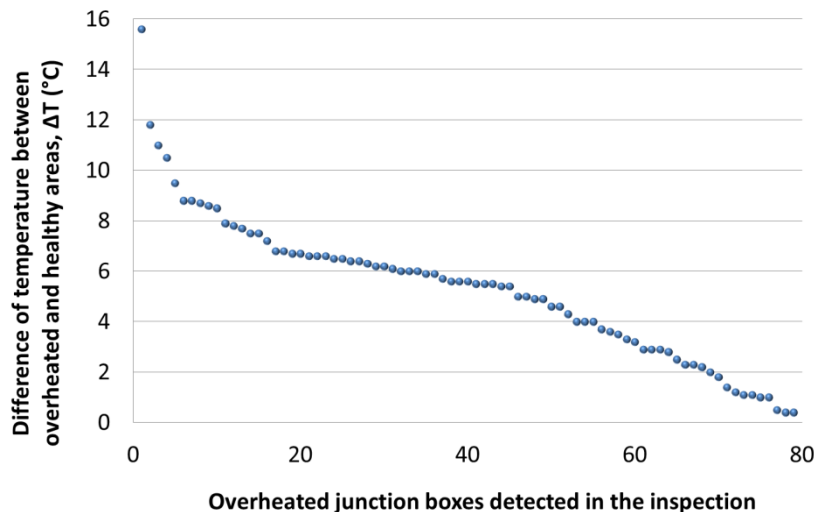
In relation with the pattern this kind of defects present, it has been shown that they are revealed as an overheated point in the middle part of the shorter side in which the box is located. This overheated point habitually appears in the middle of two different cells. In the PV plant in which the research has been performed, the modules of the upper row have the junction box underneath while the modules of the second row have the box in the upper part, as it can be seen in figure 11 and figure 12. The location of junction boxes along rows must be considered if a software must classify automatically the defects. The following figure, Figure 13, presents the  $\Delta T$  of each of the 79 overheated junction boxes detected in the inspection in descencing  $\Delta T$  order, obtaining an average temperature of 5.3°C with a standard deviation on 2.8°C. The maximum  $\Delta T$  detected has been 15.6°C. Other relevant statistical values are the median, 5.6°C, and the first and third quartile, 3.3°C and 6.7°C, respectively.

**Figure 13**  $\Delta T$  of each junction box detected during the inspection in order from the highest to the lowest.

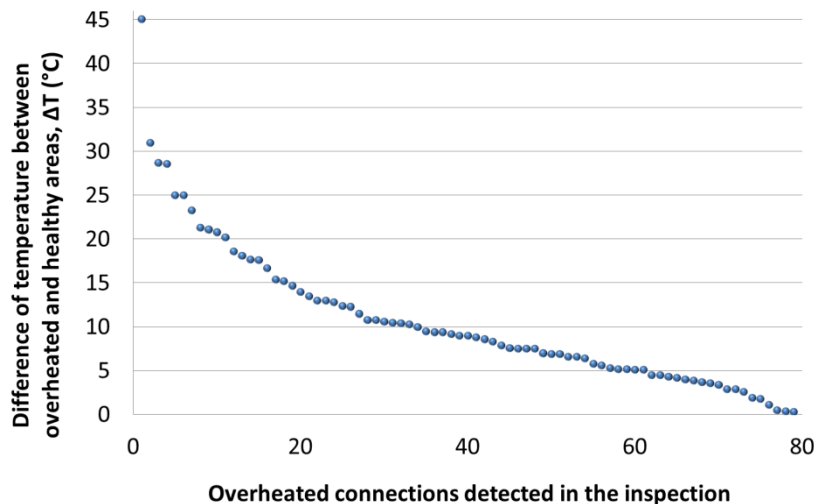
Reviewing all connection defects, it has been concluded that the pattern of this fault is an overheated point, generally smaller than a cell, located next to the frame in the same side in which the junction box is placed. The following figure, Figure 15, presents the  $\Delta T$  of each of the 78 overheated connections detected in the inspection in descending  $\Delta T$  order, obtaining an average temperature of 10.9°C with a standard deviation on 8.1°C. The maximum  $\Delta T$  detected in this case has been 45.1°C. Other relevant statistical values are the median, 9.0°C, and the first and third quartile, 5.2°C and 13.8°C, respectively.

**Figure 15**  $\Delta T$  of each overheated connections detected during the inspection in order from the highest to the lowest.
