Lessons Learned from a Lady

Source: *Science News*, Vol. 130, No. 25/26 (Dec. 20-27, 1986), pp. 392-395

Lessons Learned From a Lady

The recent Statue of Liberty restoration provided some unique research opportunities

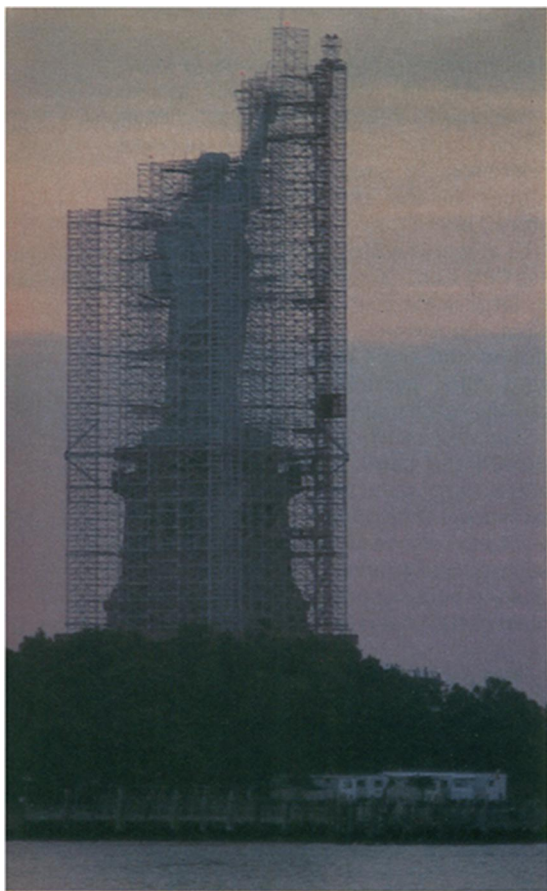
While the restoration was going on, a special aluminum scaffolding enveloped the statue.
