[SHAD-2] During execution of PTL-903900 for Osprey Battery Life testing, unable to download the database from one of the units

Status:	Risk Assessment
Project:	System and Hardware Anomaly/Defect
Component/s:	None
Affects Version/s:	None
Fix Version/s:	None

Problem Statement: During the execution of PTL-903900, it was observed that one of the 120 Maxell units was unable to complete the "Database Download" command with Quasar (SW10886). The unit was able to connect to Quasar and provide some information, but was unable to maintain a connection during the database download. The NFC tool was used to communicate with the device. The command, "0xAC" was sent to the transmitter and the response, "0xac 0x80 0x23 0x3c 0x1e 0x00 0x17 0x00 0x00 0x00 0x00 0x00 0x00 0x94", indicates that an unrecoverable error occurred on day 22 of the session and the unrecoverable error was caused by a hard reset. The unit's part number is MT-26023-72 with SW14531 v 57.192.109.37. The Serial Number is 511917828029. The transmitter was built in ER24-522.

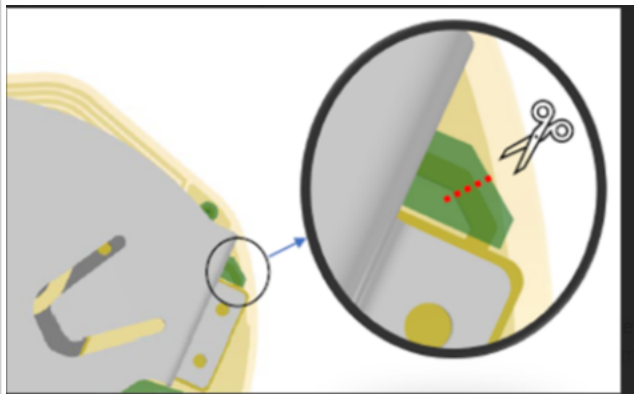
image-2025-02-18-15-41-41-761.png (86 kB)

Test Step	Value	Unit	Comment
Measure VBAT to GND before battery disconnect	0.3	V	Battery in unit as received is dead
Measure VBAT to GND after battery disconnect	0	V	Confirms successful battery disconnect rework
Bench Supply for External Power	2.99	V	Confirm supply voltage prior to connecting to DUT
Measure sleep current as is (post-session)	3.7 - 4.1	uA	Sleep current is in normal/expected range after battery disconnect
Return to FTM, erase DB, soft reset	N/A	N/A	NFC commands: 0x4d -> 0x42 -> 0x31
Measure storage current in FTM	175 - 225	nA	Storage current is in normal/expected range
Measure sleep current in FTM	3.7 - 4.1	uA	Sleep current is in normal/expected range
FTM complete	N/A	N/A	NFC commands: 0x7c 5 to FTM complete
Measure storage current	175 - 225	nA	Storage current is in normal/expected range
Wake unit via NFC	N/A	N/A	NFC commands: 0x54 used to wake device up
Measure sleep current in session	3.7 - 4.1	uA	Sleep current is in normal/expected range
