Lightning Damage to Wind Turbine Blades From Wind Farms in U.S.

Lightning Damage to Wind Turbine Blades from Wind Farms in U.S.

Abstract--This paper presents statistical data about lightning damage on wind turbine blades reported at different wind farms in the U.S. The analysis is based on 304 cases of damage due to direct lightning attachment on the blade surface. This study includes a large variety of blades with different lengths, laminate structure and lightning protection systems. The statistics comprises the distribution of the lightning damage along the blade and classifies the damage by severity. In addition, the frequency of lightning damage to more than one blade of a wind turbine after a thunderstorm is assessed. The results of the analysis show that the majority of the lightning damages are concentrated at the tip of the blade. Furthermore, all the blades involved in the study show a great similarity in the distribution of damages along the blade and the characteristics of the damages, even concerning the significant differences in the blades geometry and materials.

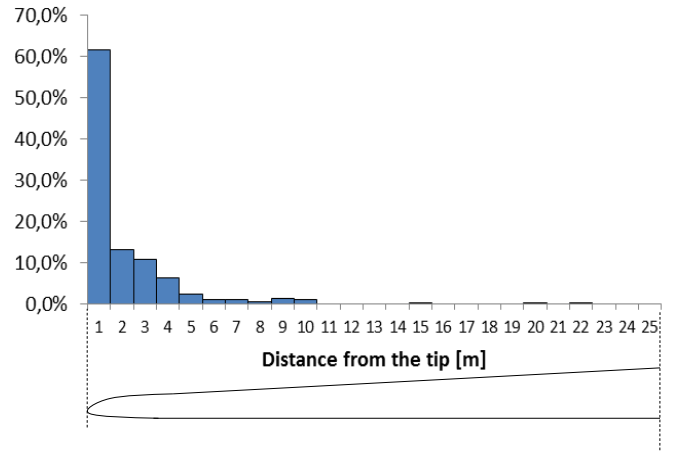
Fig. 1. Location of the lightning damage (in percentage) for the total population of damaged blades

It is observed in Figure 1 that more than the 60% of the total damage occurred at the last meter of the blade, and 90% of all damages are located at the last 4 m. The remaining 10% of damages are found mainly at 5 to 10 m from the blade tip.

There are only three lightning incidences further inboard, at 15, 20 and 22m from the tip.

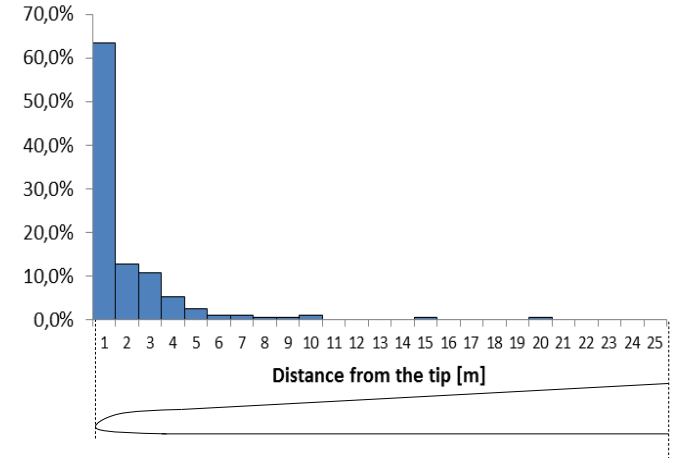
Fig. 2. Location of the lightning damage (in percentage) in damaged blades with fiberglass structure

Interestingly, both types of blade with and without carbon fiber experience very similar lightning distribution along the blade, with the largest percentage at the tip of the blade. The number of damages at 1 to 4 m from the blade tip is slightly higher in blades with carbon fiber in the structure.

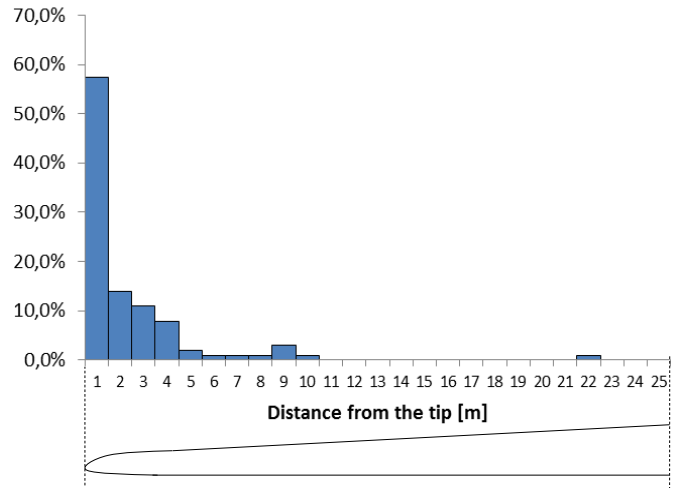
Fig. 3. Location of the lightning damage (in percentage) in damaged blades with mixed fiberglass and carbon fiber structure

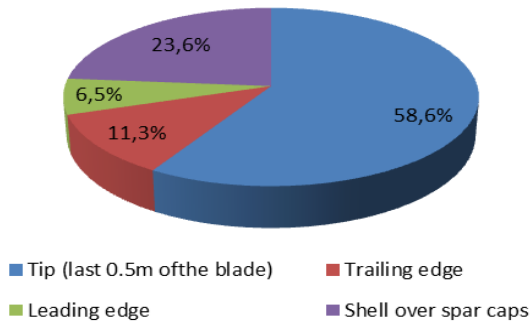
The lightning damage on the blades has also been classified according to whether the lightning attached the blade surface adjacent to the spar caps, the trailing edge, the leading edge or the area covering the last 0.5 m of the blade tip. Figure 4 reveals that 58.6% of the damage occurred at the very tip of the blade, followed by 23.6% of the damage on the shells over the spar caps (attachment to carbon fibre structures or the down conductor for pure fibreglass blades) and 17.8 % on the trailing and leading edges.

Fig. 4 Distribution of the lightning damage (in percentage) in the tip, shell over the spar caps, trailing and leading edges

It is noted that many of the incidences included in the ‘tip location’ (last 0.5 m of the blade) are likely due to direct strike to the edges, but the small area of the tip made it difficult to determine the exact location of the lightning attachment.

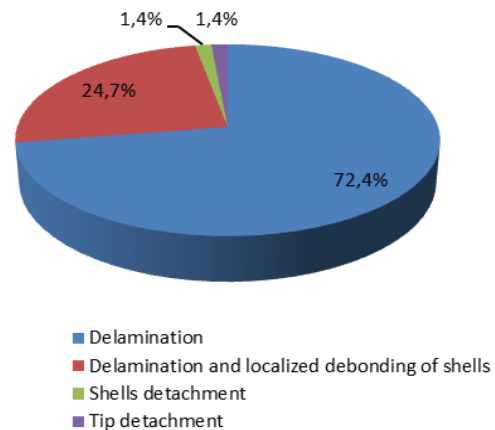
Figure 10 shows the distribution of the lightning damages according to the damage types described above. It is observed that the most common type of lightning damage is delamination, followed by debonding of the shells. The shells and tip detachment occurred only in 2.8% of the cases.

Fig. 10. Distribution of the damage according to the type, including delamination, debonding, shell detachment and tip detachment

It is important to point out that the costs associated with the damage vary significantly with the type of damage and type of blade. Considering the amount of time needed to repair a blade, with the consequent down time and lost revenue, the less severe type of delamination may take a couple of hours to repair, while most severe damage may involve 2 to 5 days to repair. Therefore, taking into account only the lost revenue, the total cost due to shells and tip detachment (2.8% of occurrence) may be comparable to the total cost due to delamination (72.4% of occurrence).

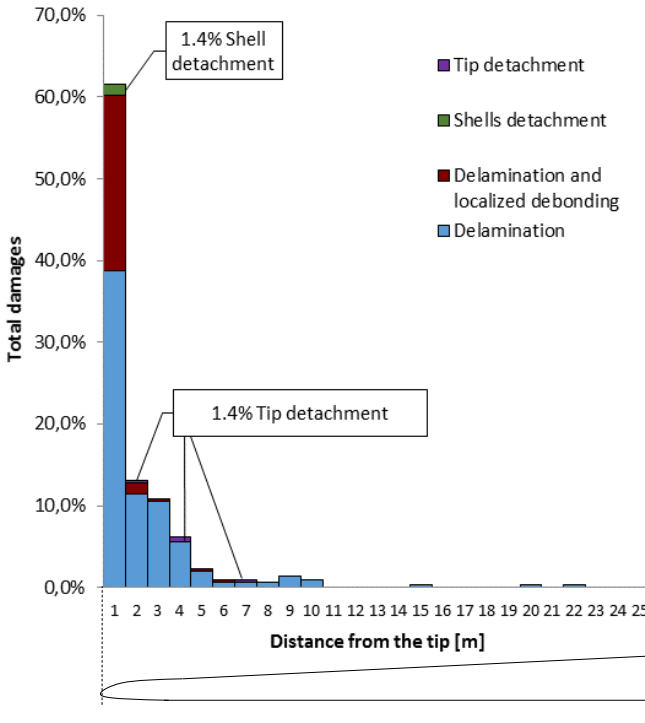
Figure 11 shows the distribution of the different types of damage along the blade length. It is observed that delamination occurs in all radius from the blade tip to 11 m inboard, and punctual cases further inboard up to 22 m from the tip. The localized debonding of the shells is mainly located at the tip of the blade, there are only few cases between 2 and

6 m from the tip and none further inboard. The distribution of the debonding can be explained by the fact that the blade is more robust in inboard radius, and therefore the expansion of the air due to direct strike on the blade surface does not cause the separation of the shells. Regarding the shell detachment, it is observed that in all the reported events the lightning strike was located at the last meter of the blade, even if eventually a shell section of several meters was detached from the load carrying structure. This would support the assumption that the shell detachment is initiated by a localized shell debonding and aggravated by the rotation of the blades and strong wind conditions. Finally, the tip detachment is located within 2 and 7 m from the blade tip, where a direct lightning strike can be critical for the integrity of the relatively thin laminate of the load carrying structure.

Fig. 11. Distribution of the different types of damages along the blade length.

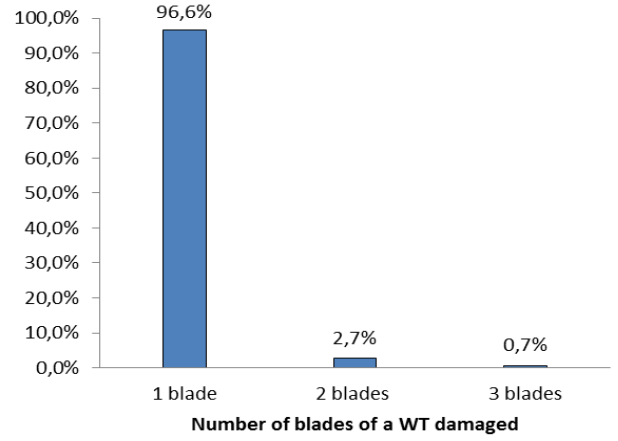
The analysis of the damaged blades revealed few cases where a wind turbine suffered damages in more than one blade. Figure 12 shows the percentage of lightning incidences including one, two or all three blades of a wind turbine.

Since the inspections at the wind farms were carried out after thunderstorms, it is not possible to determine with certainty the cause of every damaged blade. There are several likely scenarios, including a single lightning stroke sweeping from one blade to another due to the blade rotation, different branches of a single lightning stroke attaching the blades, lightning subsequent strokes attaching to the blades, or different lightning events during the thunderstorm. In any case, the statistics here show that damage to more than one blade of a single wind turbine is a rare event.

Fig. 12. Number of damaged blades of a WT reported after a thunderstorm
