# Flanders Loft

## FY 2025 RESERVE STUDY AND MAINTENANCE SCHEDULE

**Flanders Loft Community  
Association**

**February 20, 2025**

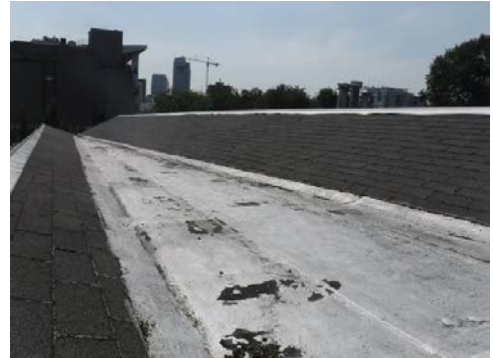
### Roof - 3 Tab Composition - Replacement

This component funds for the replacement of the 3 tab asphalt composition roofing. Replaced in 2023.

Replaced in FY2023 with Owens Corning 50 Year Shingles for \$7,800

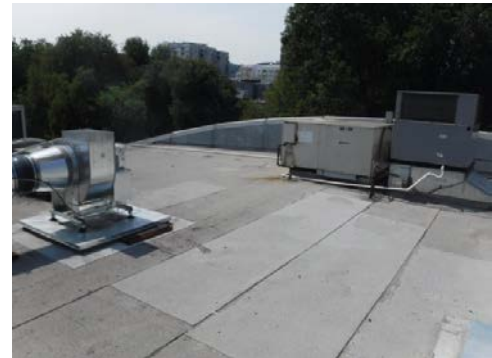
### Roof - Built-up With Mineral Cap - Replacement

It was noted in the prior study that the roof was damaged at HVAC pads when new equipment was installed (with possible water penetration issues). Also noted was that the roof was repaired by Snyder Roofing, including selected field repair, perimeter flashing, and gutters and downspouts.

Forensic BECA in 2021 noted this item is failing at penetrations and transitions.

This component funds for the replacement of the existing roofing to the decking, repairs to decking and correction of pooling as needed, and installation of three ply built-up with mineral cap, together with perimeter and penetration flashing.

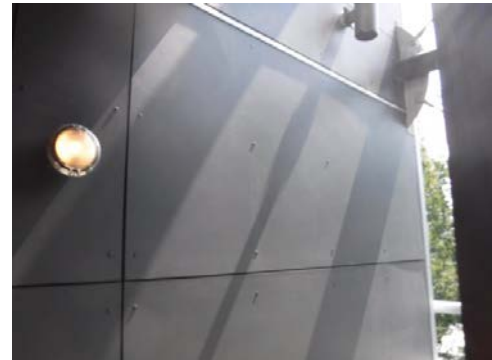
### Siding - Composite Panels - Replacement

This item was observed by Forensic to be in good condition overall, with minor damage noted in the BECA report.

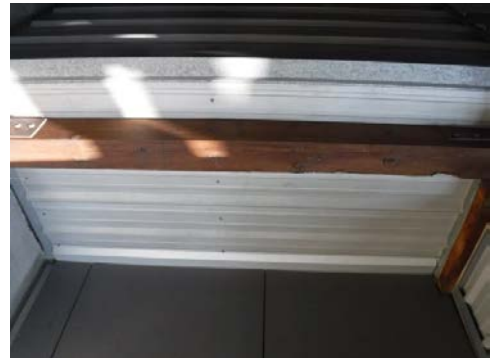
### Siding - Metal Standing-Seam - Replacement

This item was observed to be in good condition by Forensic.

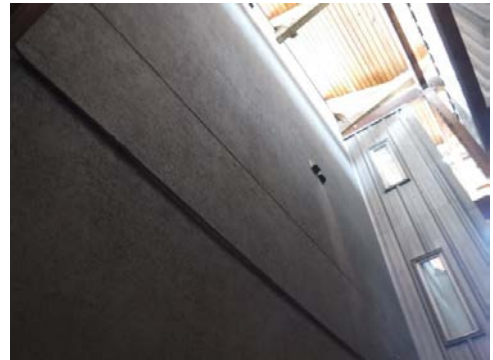
### Siding - Stucco/EIFS - Replacement

This item was observed to be in good condition by Forensic.
