Arlo Pro 3 Floodlight Camera

Troubleshooting

FB1001 – Arlo Pro 3 Floodlight

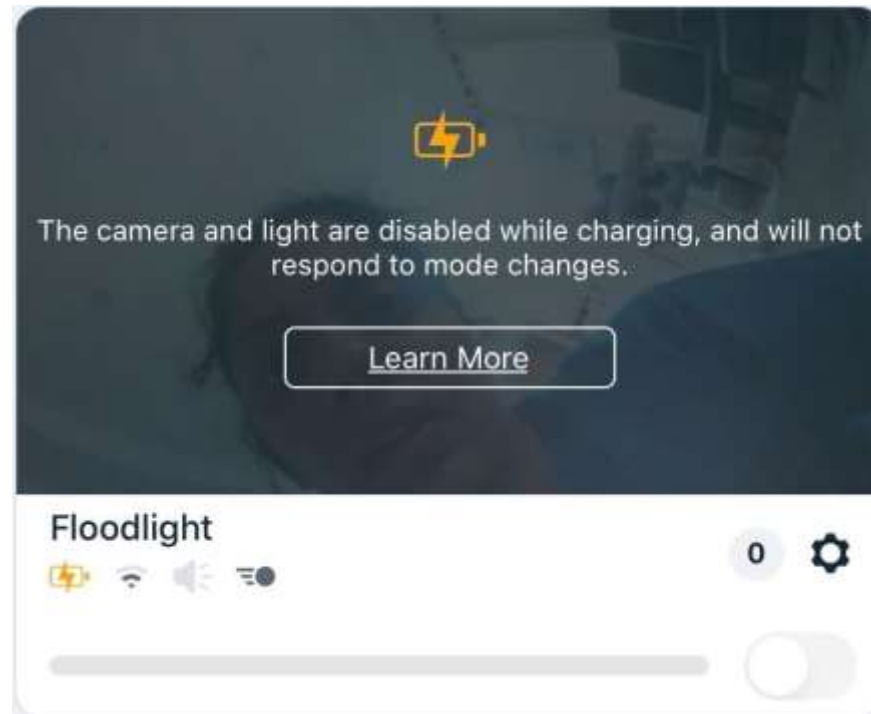
Arlo Pro 3 Floodlight – Charging Operation

The Arlo 3 Floodlight operates in a limited capacity when the floodlight is being charged using either the included **MicroUSB cable**, or the **Arlo Indoor Magnetic Charging cable**. **The floodlight's camera and spotlight capabilities will be disabled during charging.**

Users will receive an in-app error message indicating that the floodlight is charging and the functionality is limited.
