# Detection of inefficiencies in a solar plant

Daniel Sánchez Gómez

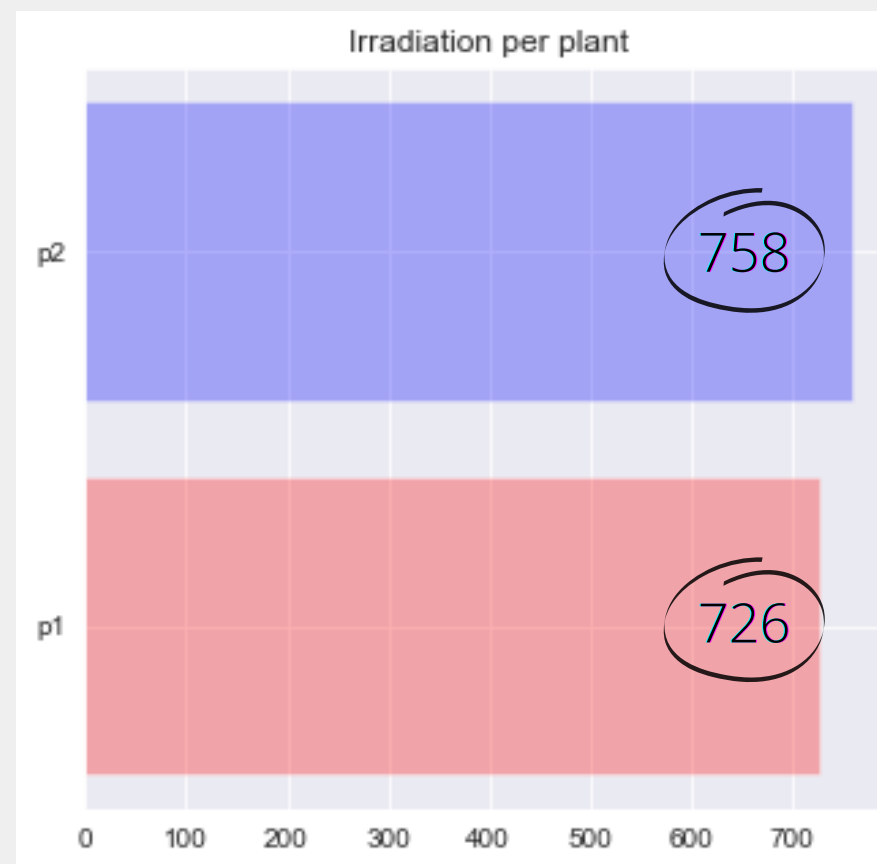
**Irradiation per plant  
(Kw/m2)**

# The two solar plants receive high and similar amounts of irradiation, with no evidence of a problem at this point.

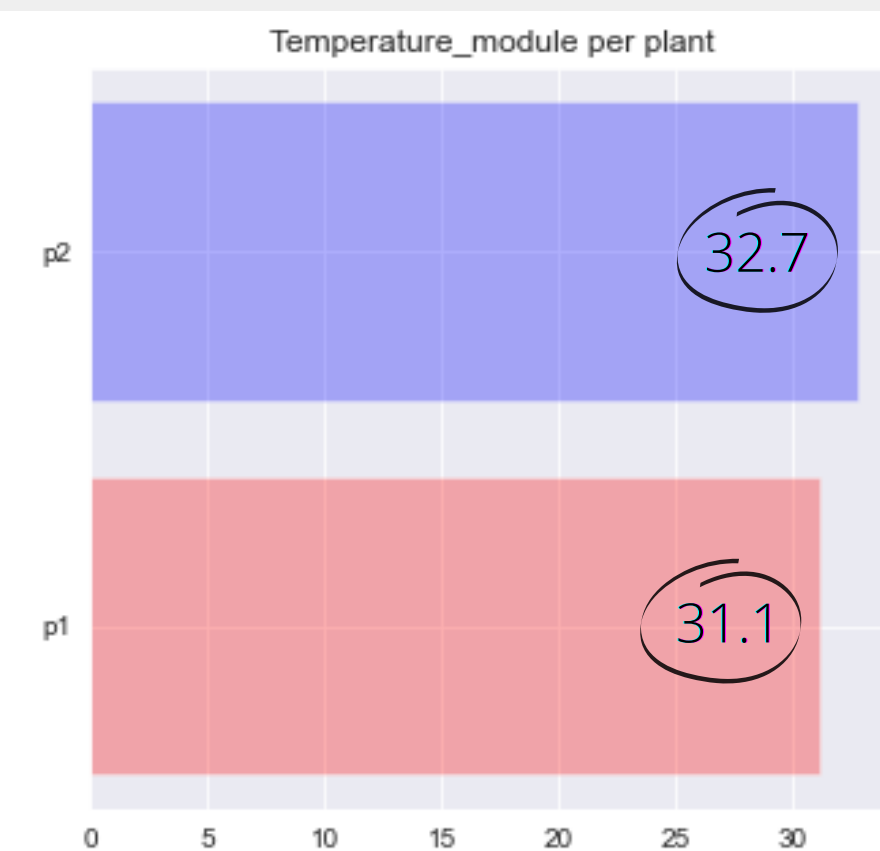
**Module temperature  
(°C)**

The average differences found between the plants do not suggest that there are major differences in the capacity to generate direct current.
