December 20, 2022

Insured:	Harry Silverglide
Address:	15771 Waite Island Drive Fort Myers, Florida 33908
D/O/L:	9/28/2022
Your File No.:	80134492
FCNA File No.:	105783

The purpose of the site investigation and this report was to provide an opinion on: (a) the cause, origin, duration, and extent of the reported damage to the exterior, interior, and roof, (b) whether this damage was a result of wind or flood associated with Hurricane Ian, and (c) the repairability of the roof.

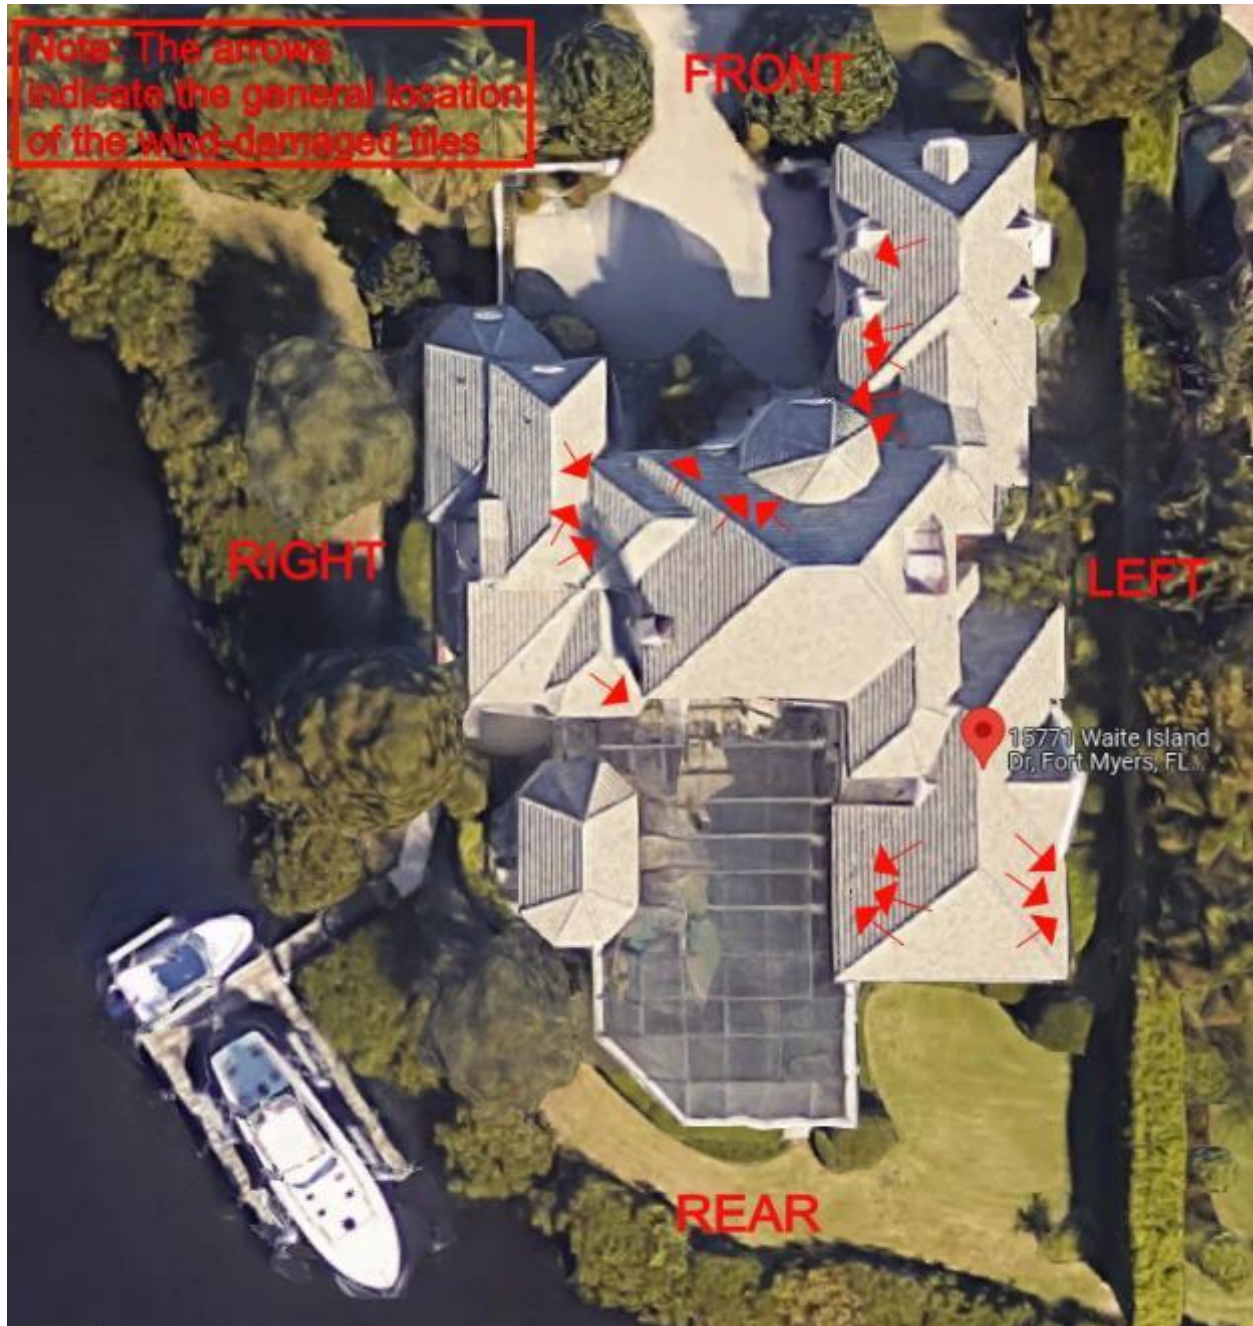
***ATTACHMENT B: ROOF DIAGRAM***

- Overviews of the roof facets are shown in Photographs 17 through 28. Attachment B of this report shows a roof diagram with the general location of the wind-damaged tiles.

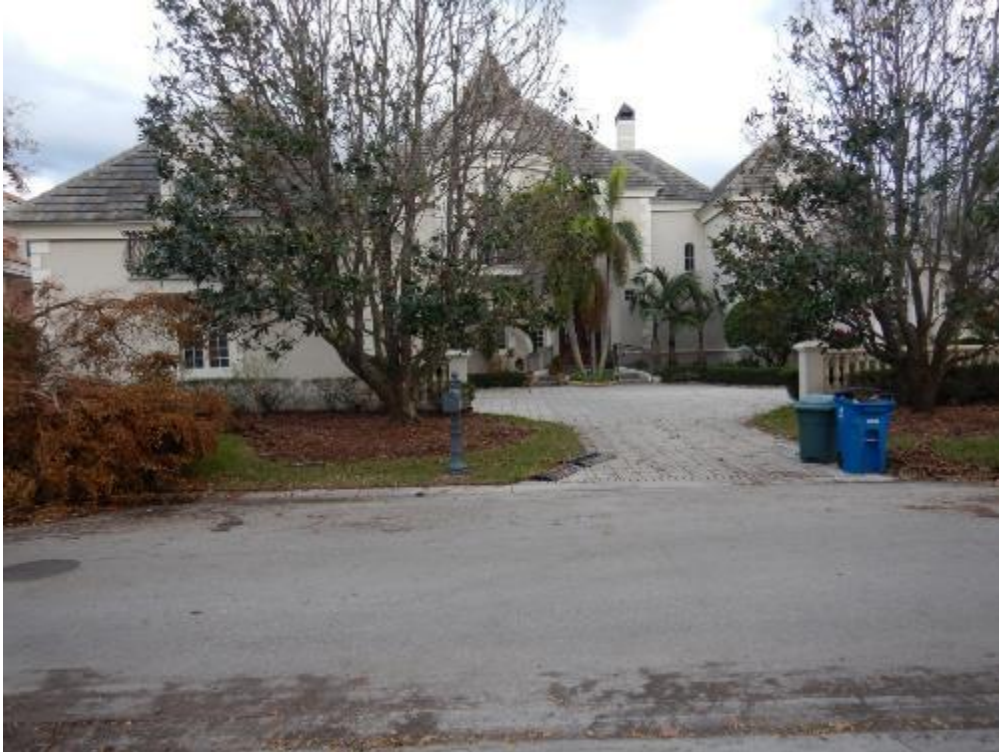
The subject structure was a two-story, single-family, concrete masonry unit (CMU) residence (Photographs 1 through 4). The exterior of the residence was clad with painted CMU and stucco. The roof was hip and gable in configuration and covered with concrete roof tiles.

Photograph #1 – North (front) elevation.

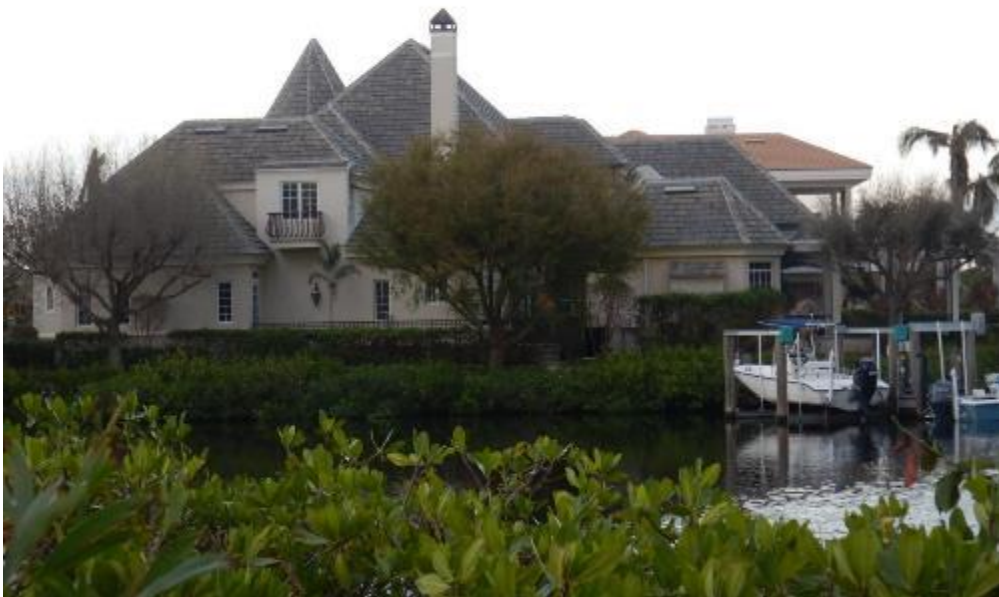
Photograph #2 – West (right) elevation.

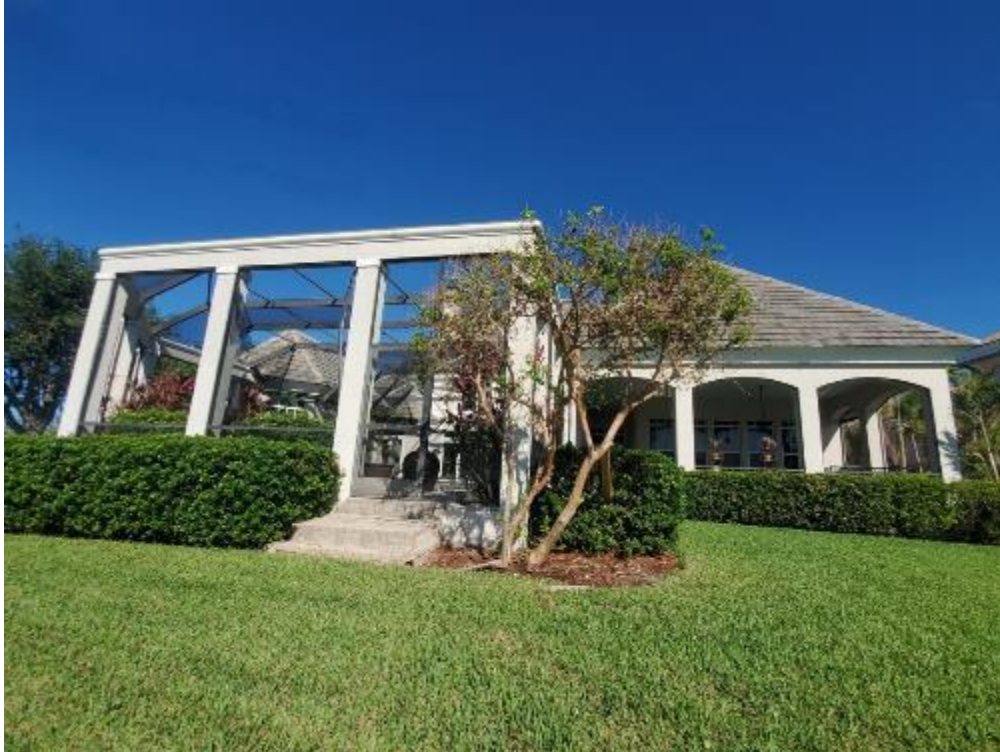
Photograph #3 – South (rear) elevation.

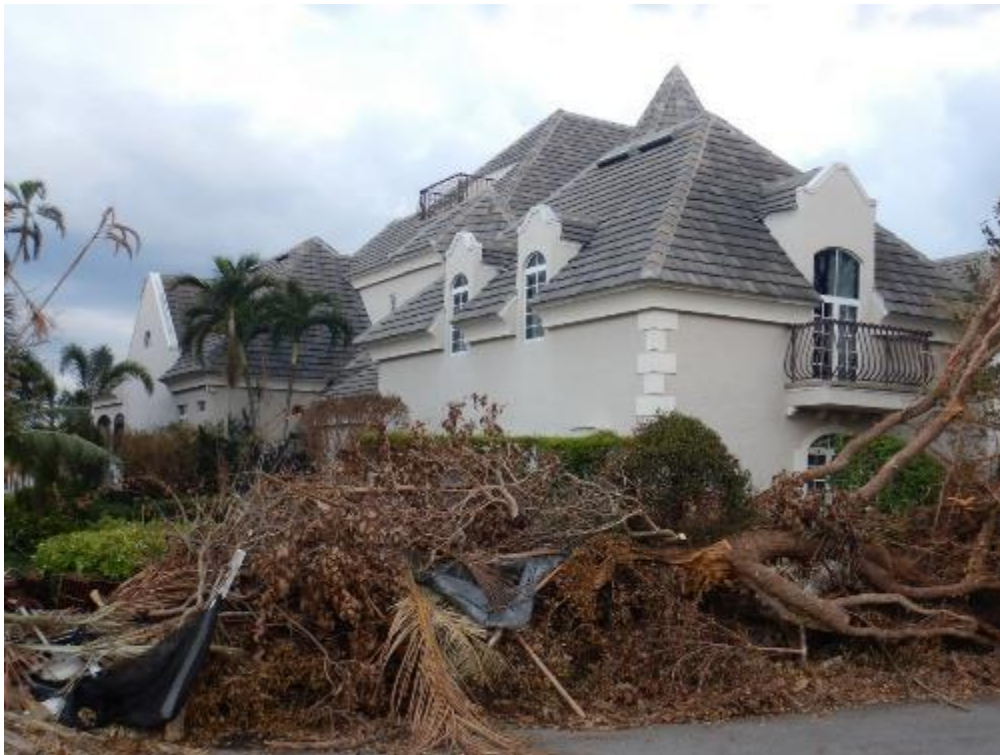
Photograph #4 – East (left) elevation.

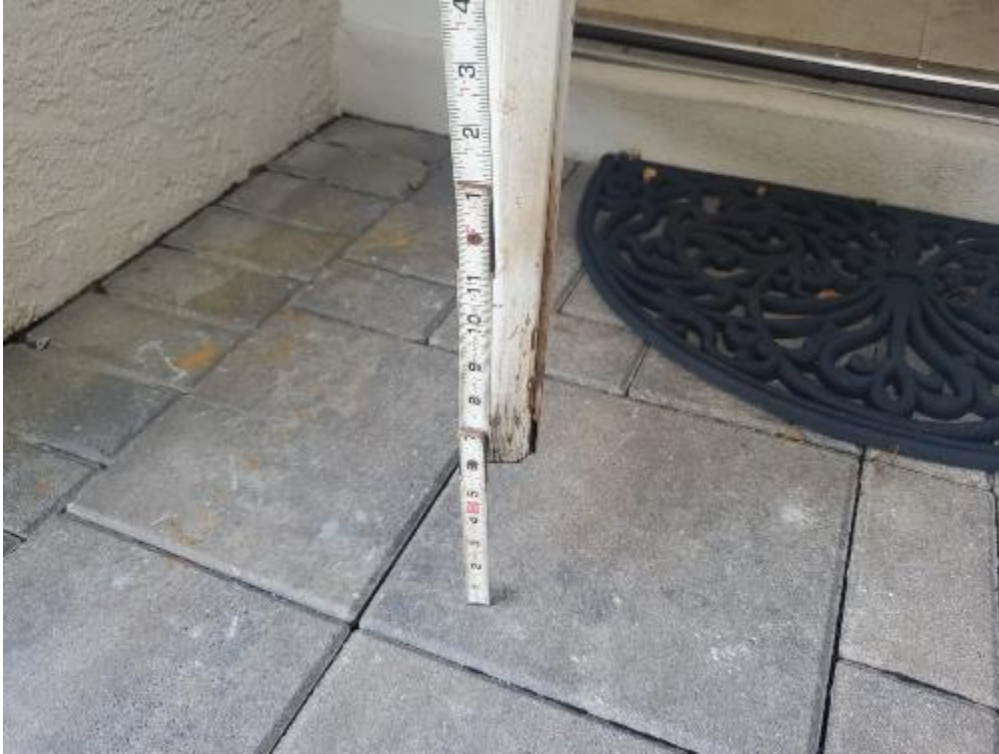
- The exterior high-water marks along the front side of the residence were approximately 12 inches above the adjacent exterior grade (Photograph 5).
- No abrasion (impact) marks, fractures, or separations were on the piles, boat dock, or boat lift. The floorboards of the dock were not loose, fractured, separated, warped, or missing (Photograph 6).

Based on the available evidence, the building materials within 12 inches above the exterior grade were affected by the flood event. Therefore, the building materials in the garage were submerged and/or damaged by the flood event and were not damaged by wind associated with Hurricane Ian consisted of the following:

Photograph #5 – The exterior high-water marks along the front side of the residence were approximately 12-inches above the adjacent exterior grade.

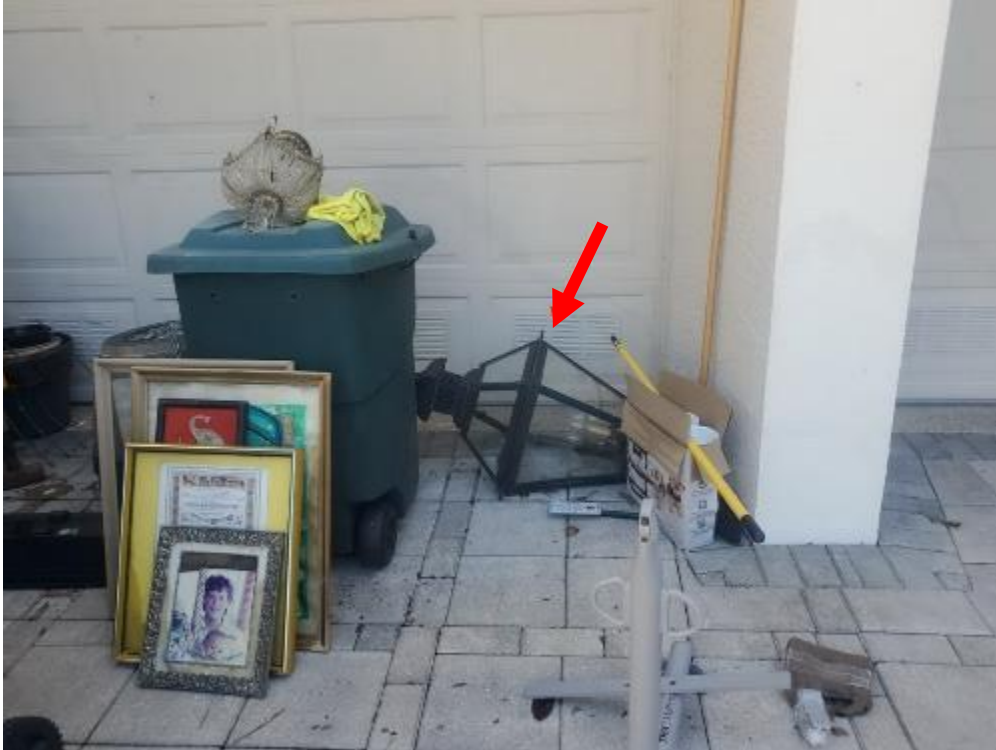
- One (1) exterior electrical light fixture was fallen along the front side of the residence (Photograph 7).
- Approximately three (3) fascia boards along the left side of the residence were loose, fractured, separated, and missing (Photographs 8 and 9).
- Separations up to ½-inch wide and abrasion marks were on the roof deck railing along the left side of the residence (Photographs 10, 11, and 12).
- Approximately fifty-five (55) pool and patio enclosure screens along the rear side of the residence were loose, torn, separated, and/or missing. Nine (9) pool enclosure framing members were bent, twisted, warped, fractured, or separated (Photographs 13 through 16).

Photograph #7 – This exterior electrical light fixture was fallen along the front side of the residence.

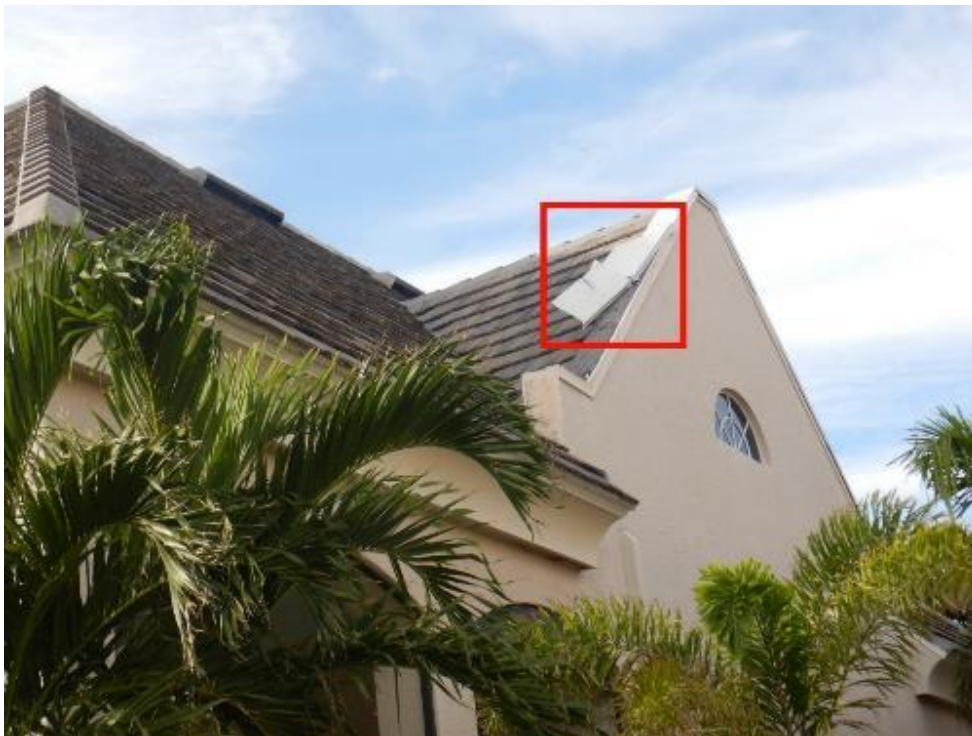
Photograph #8 – Approximately three (3) fascia boards along the left side of the residence were loose, fractured, separated, and missing.

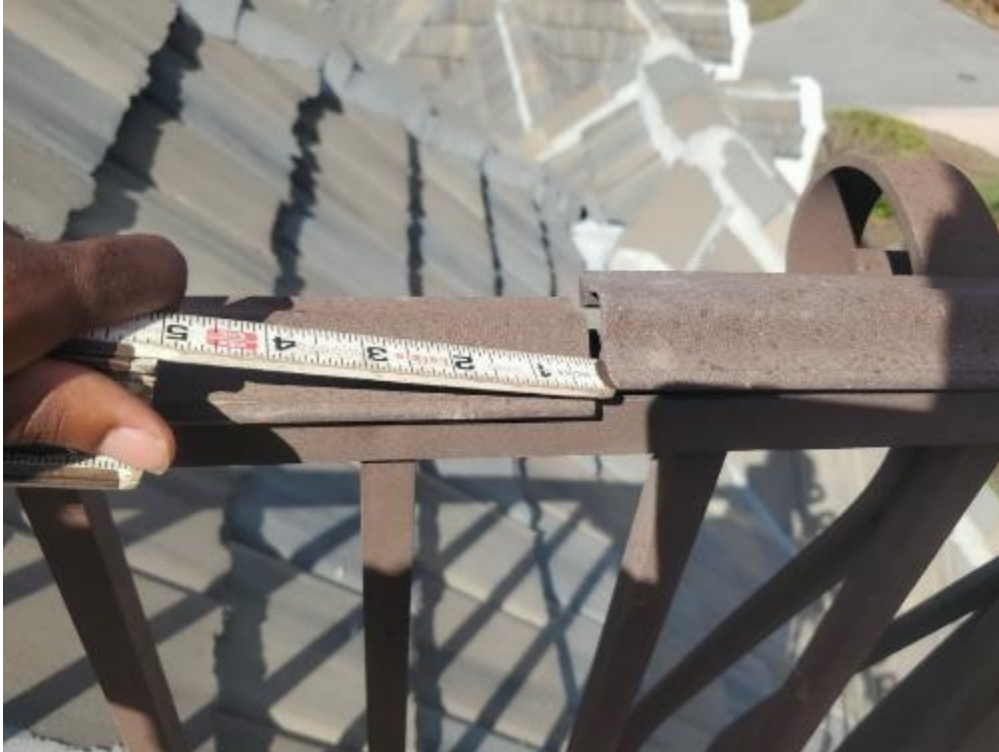
Photograph #11 – Separations up to ½-inch wide were on this section of the roof deck railing along the left side of the residence.

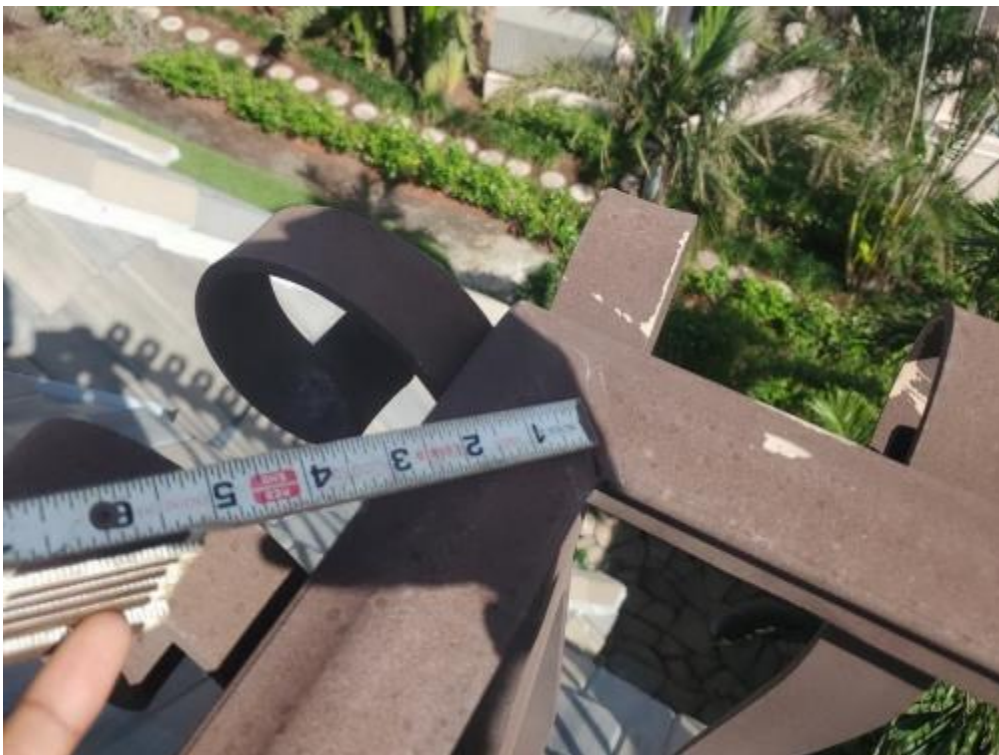
Photograph #12 – Abrasion marks were on the roof deck railing along the left side of the residence.

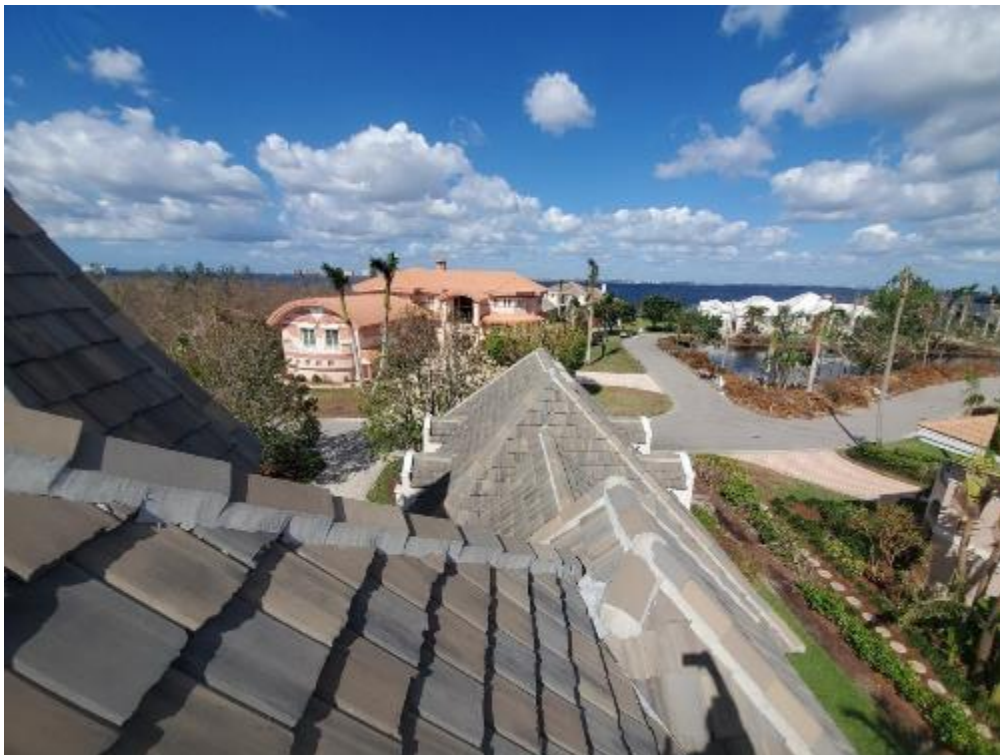
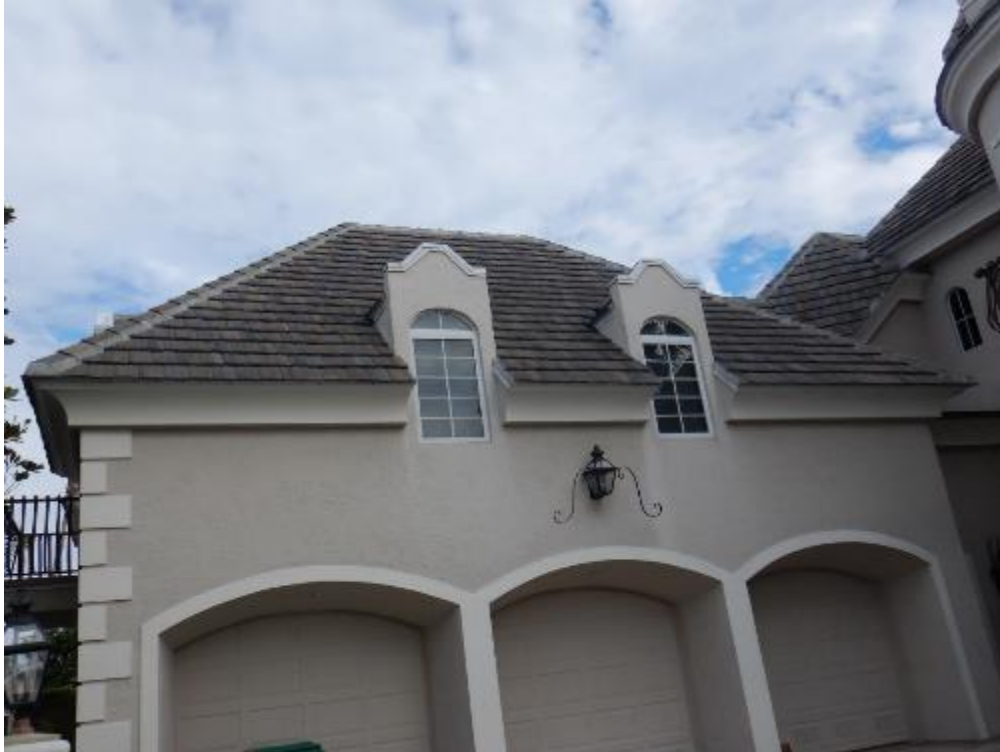
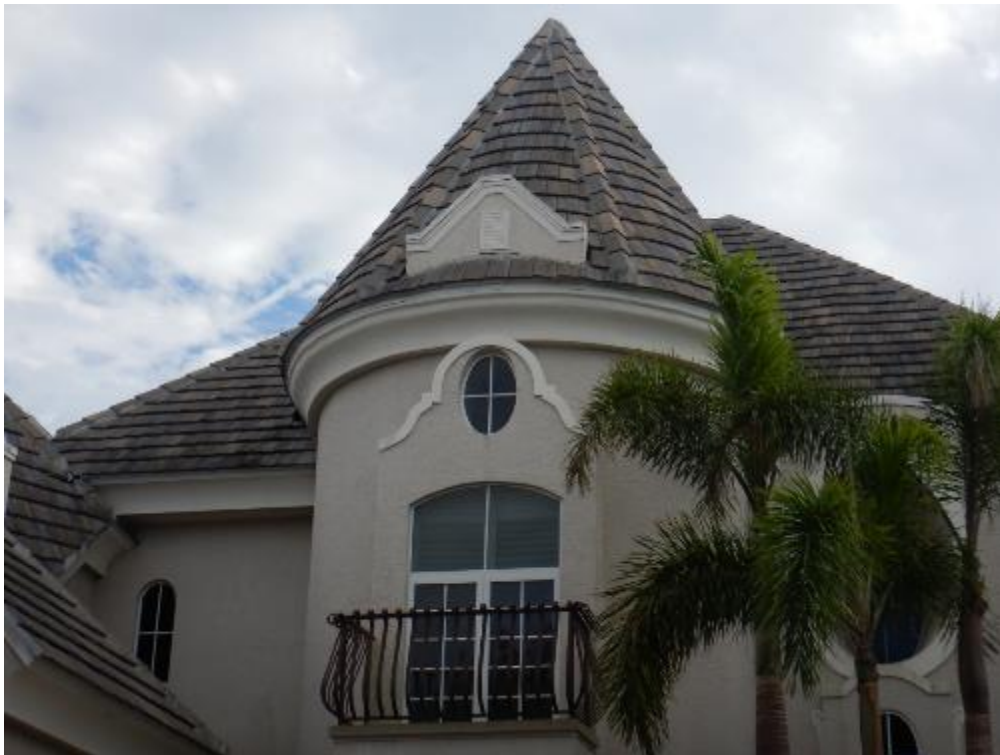
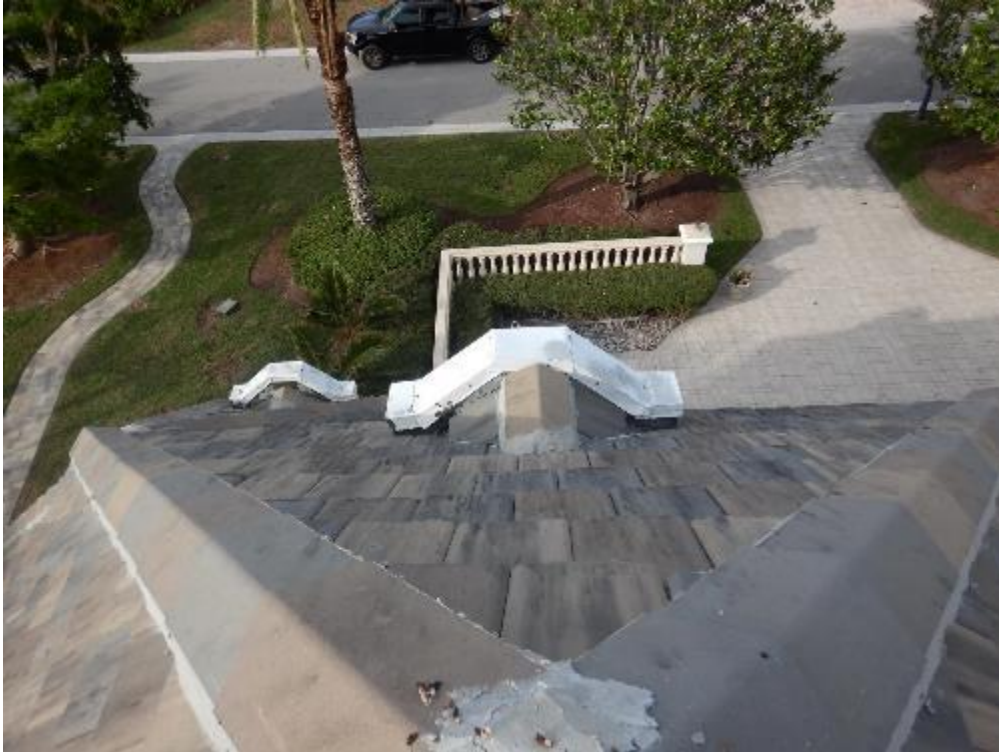
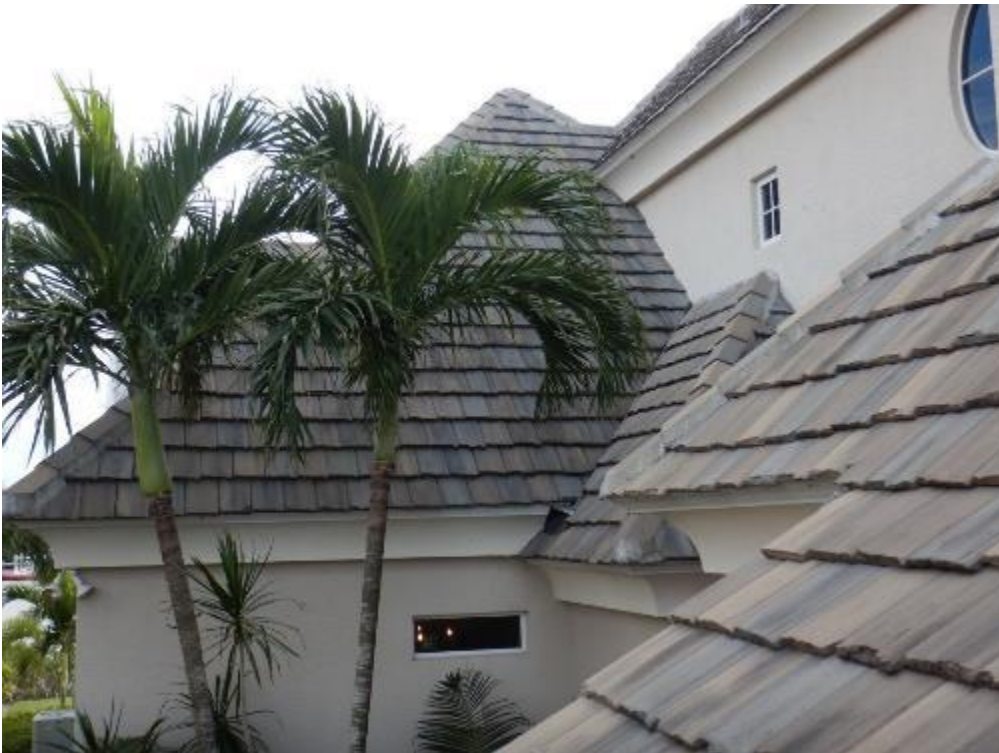
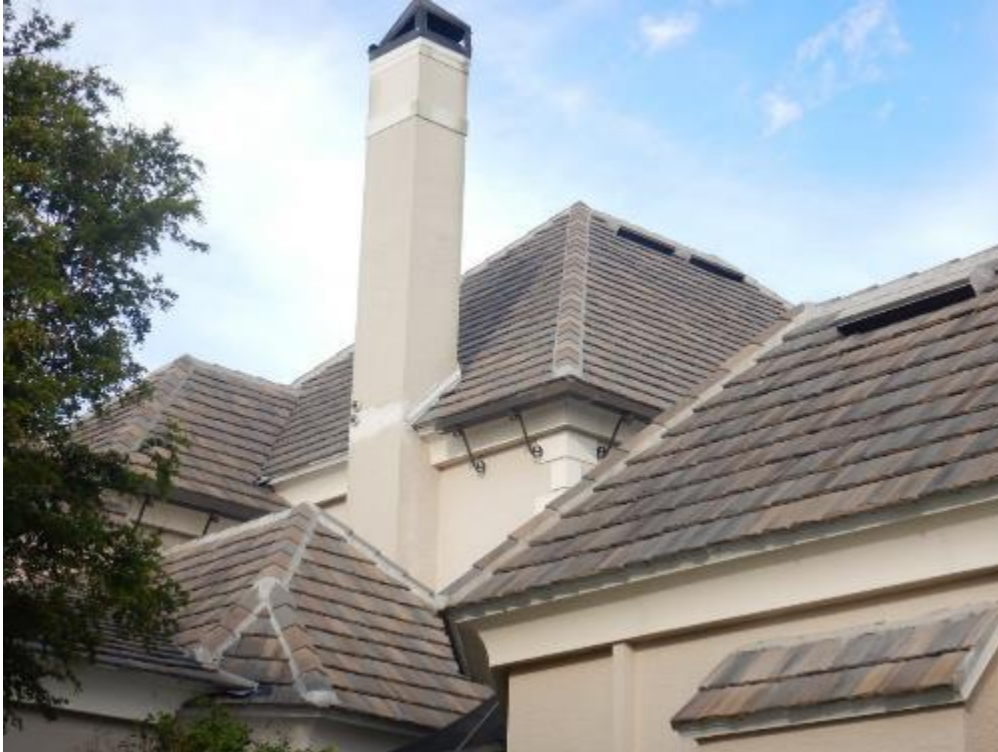
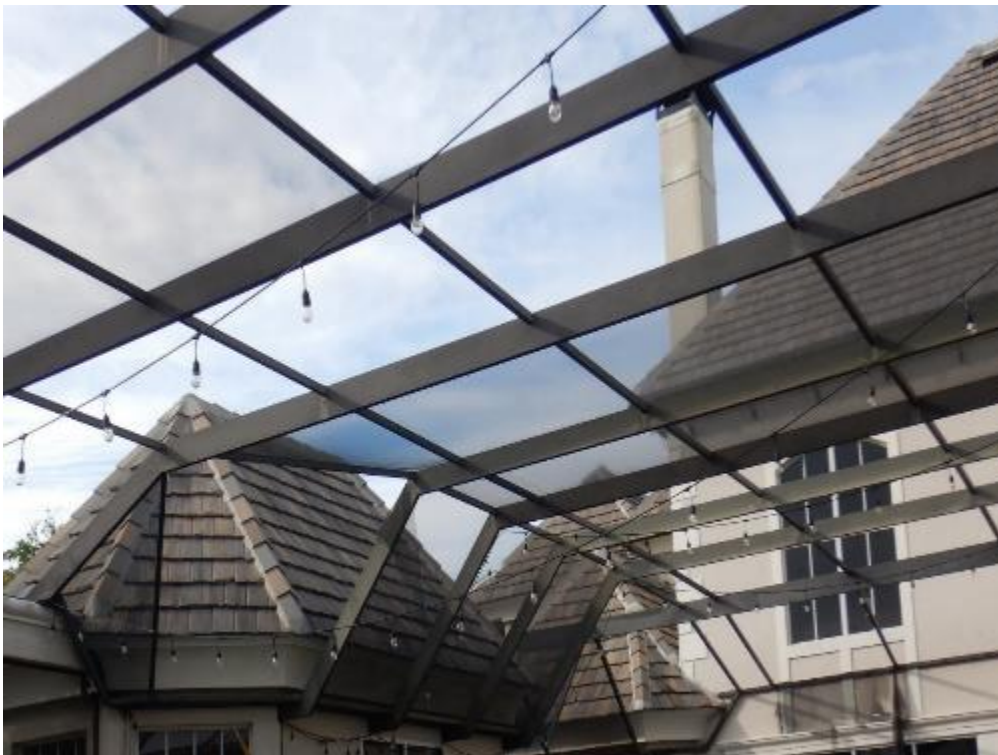
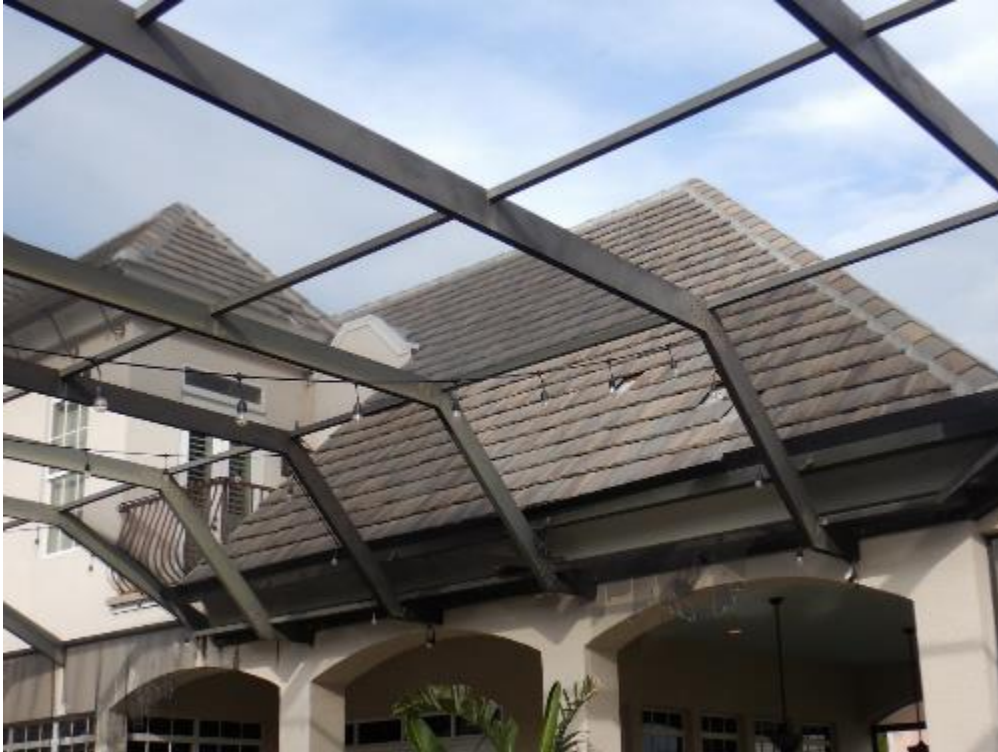
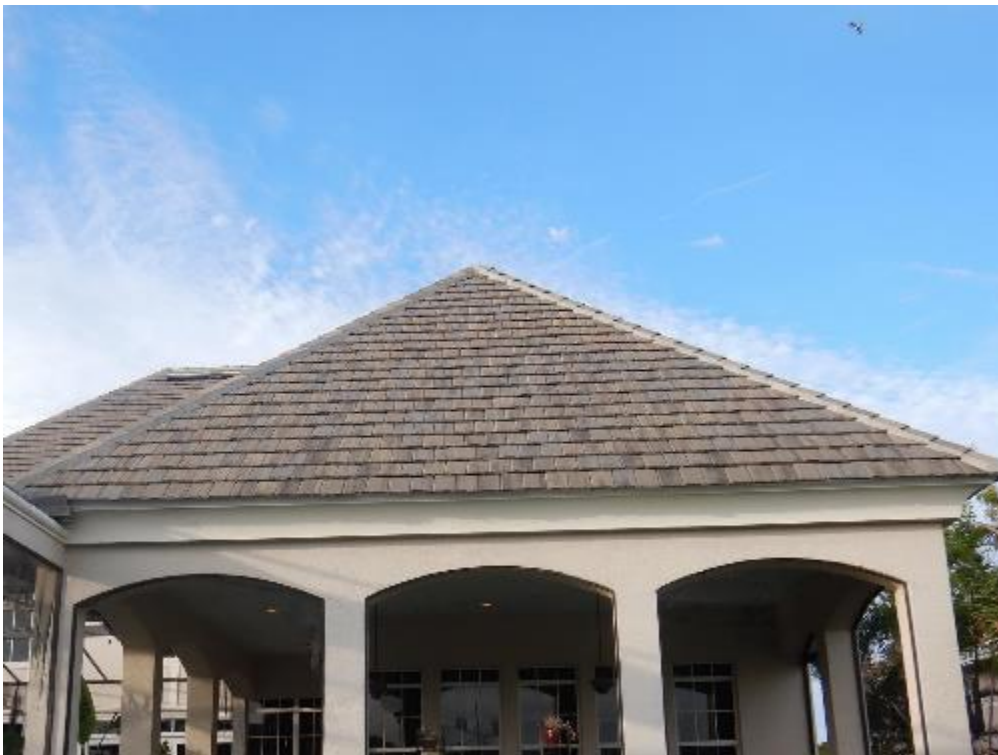
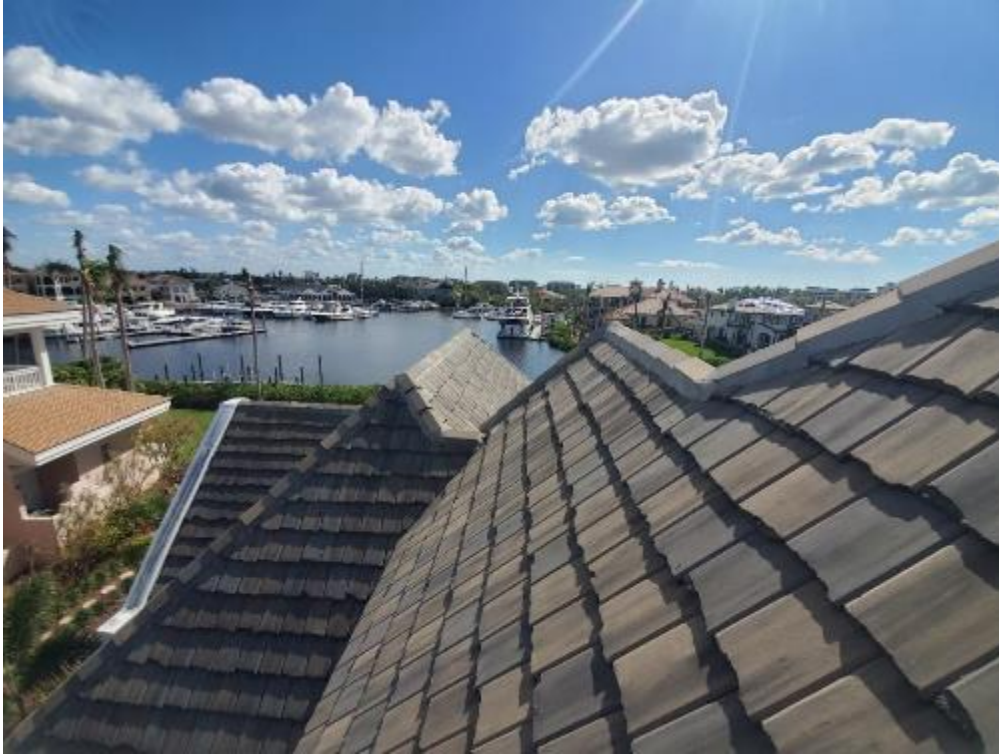
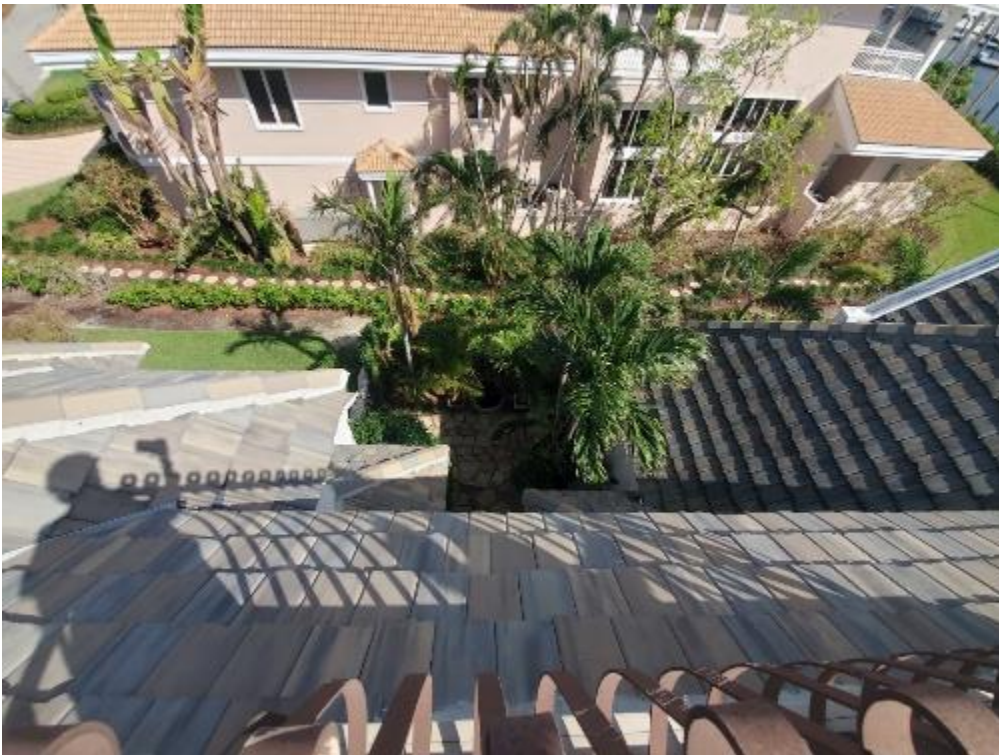
Photograph #18 – Overview of the roof facets.

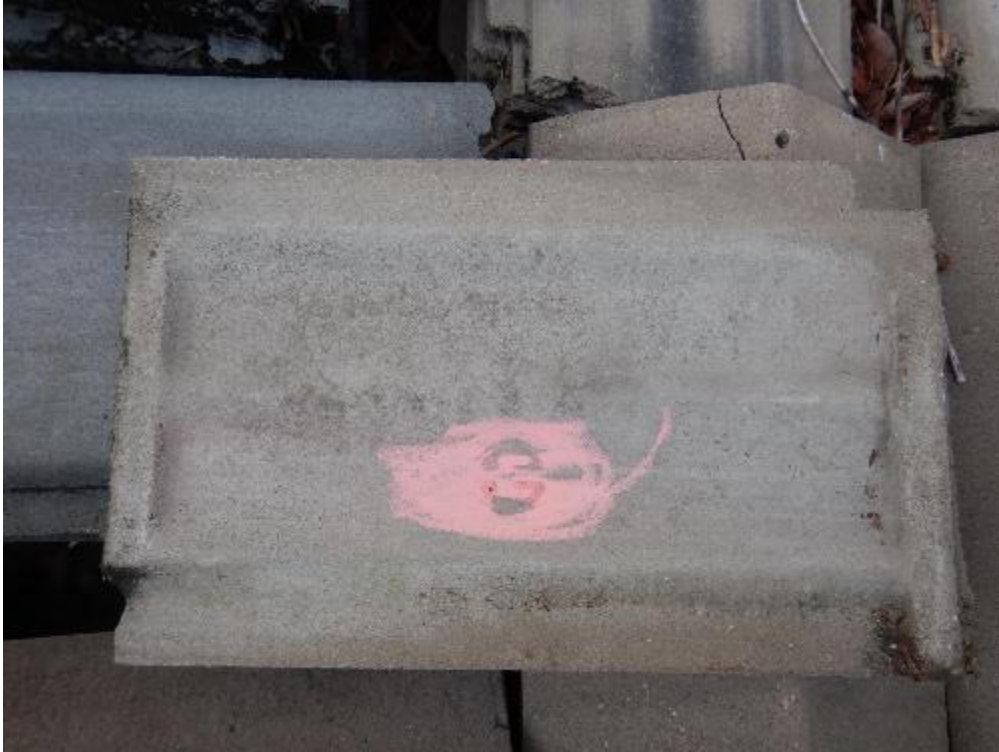
- The concrete roof tiles on the residence were of the “Entegra” brand and were adhesive foam set. The approximately 10-inch-wide by 16½-inch-long by 1½-inch-thick field tiles were installed with an average 13-inch exposure. The approximately 10-inch-wide by 17-inch-long by 1-inch-thick hip/ridge cap tiles were installed with an average 14½-inch exposure. The ridge-cap and hip-cap tiles were mortar set (Photographs 29 through 35).

Photograph #29 – The concrete roof tiles were of the “Entegra” brand and were adhesive foam set.

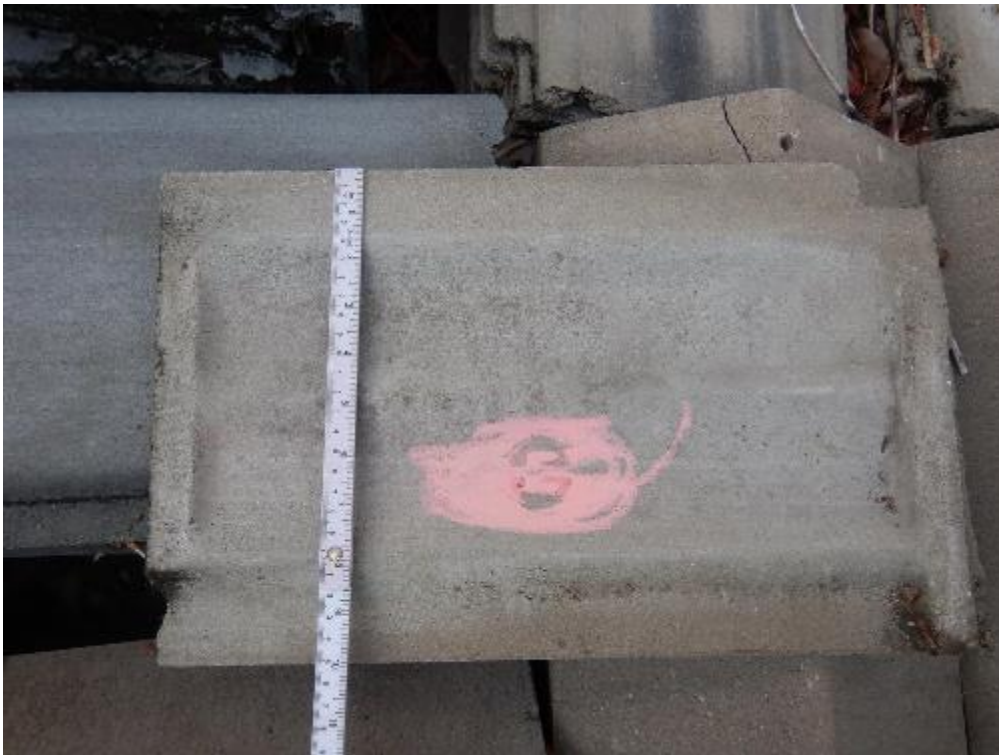
Photograph #30 – The concrete roof tiles were of the “Entegra” brand and were approximately 10 inches wide.

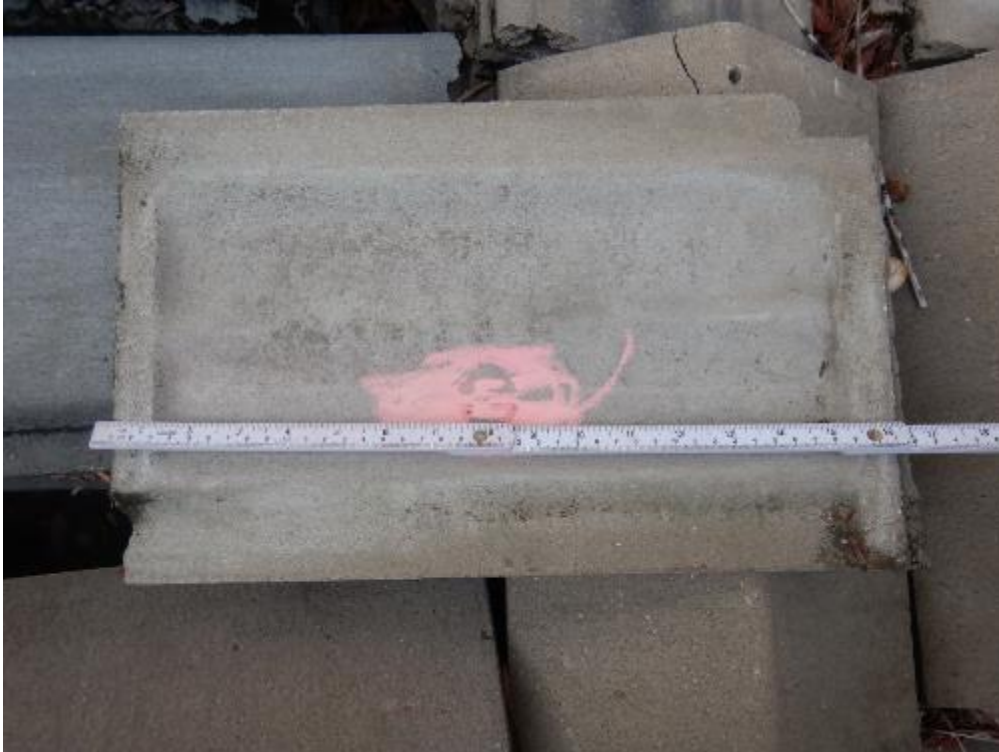
Photograph #31 – The approximately 16½-inch-long field tiles were installed with an average 13-inch exposure.

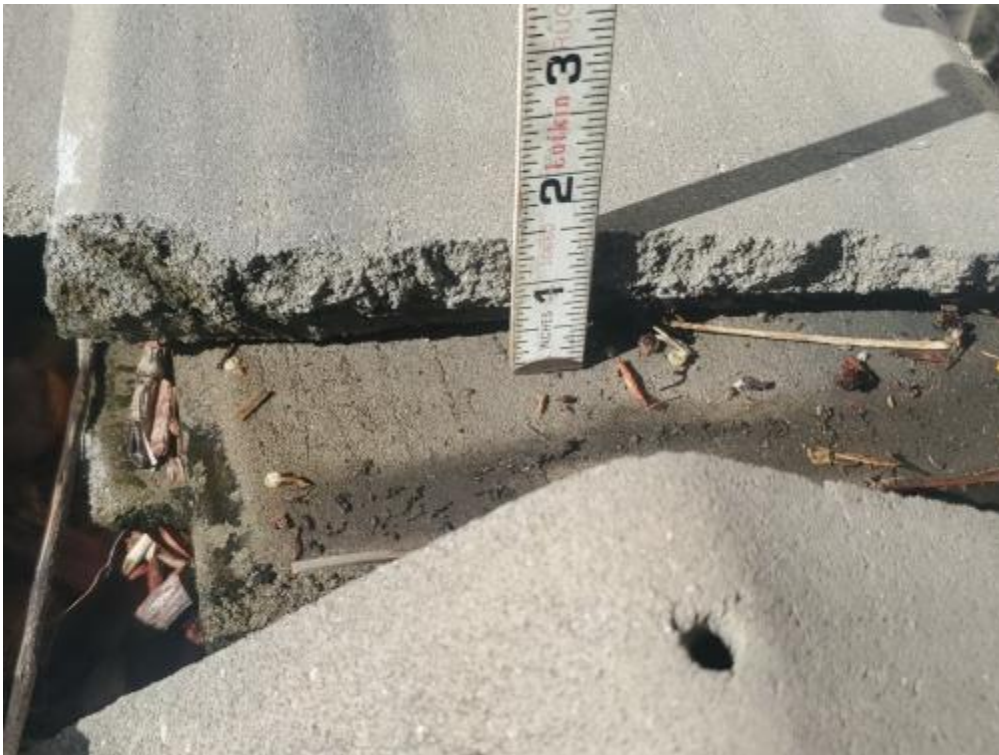
Photograph #32 – The field tiles were approximately 1½ inches thick.

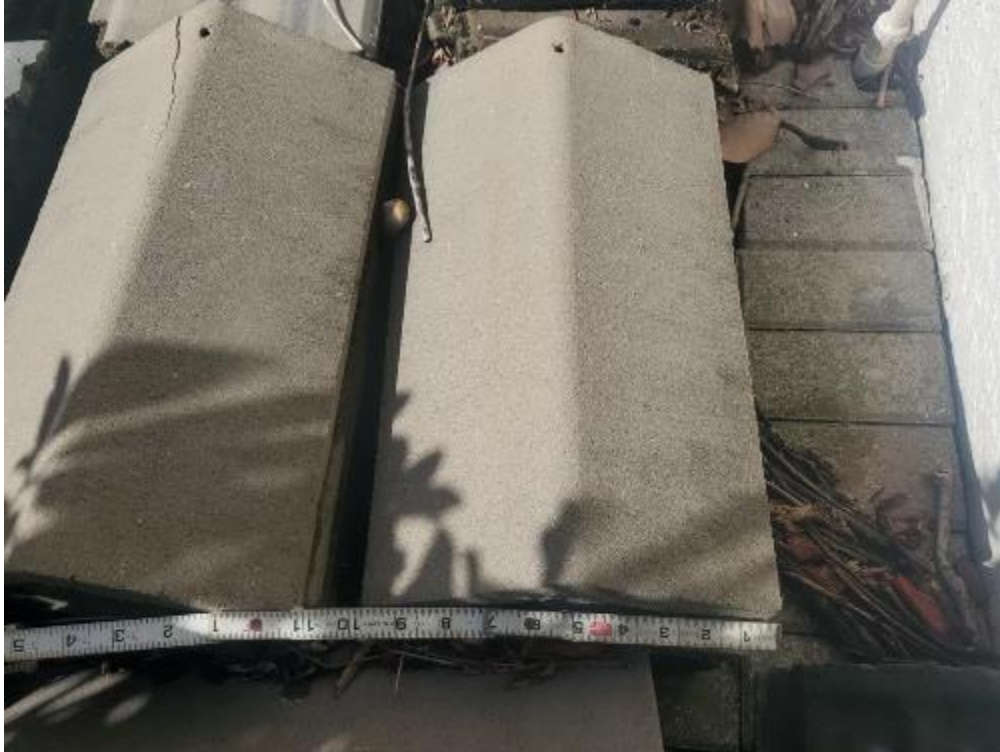
Photograph #33 – The hip/ridge cap tiles were 10-inch-wide.

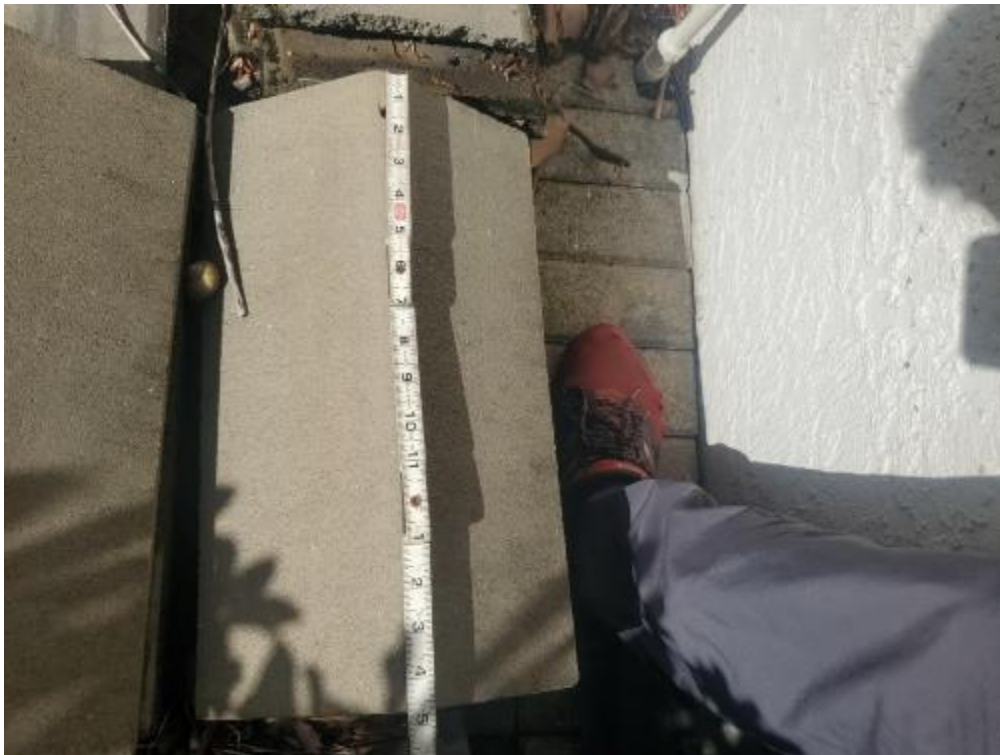
Photograph #34 – The approximately 17-inch-long hip/ridge-cap tiles were installed with an average 14½-inch exposure.

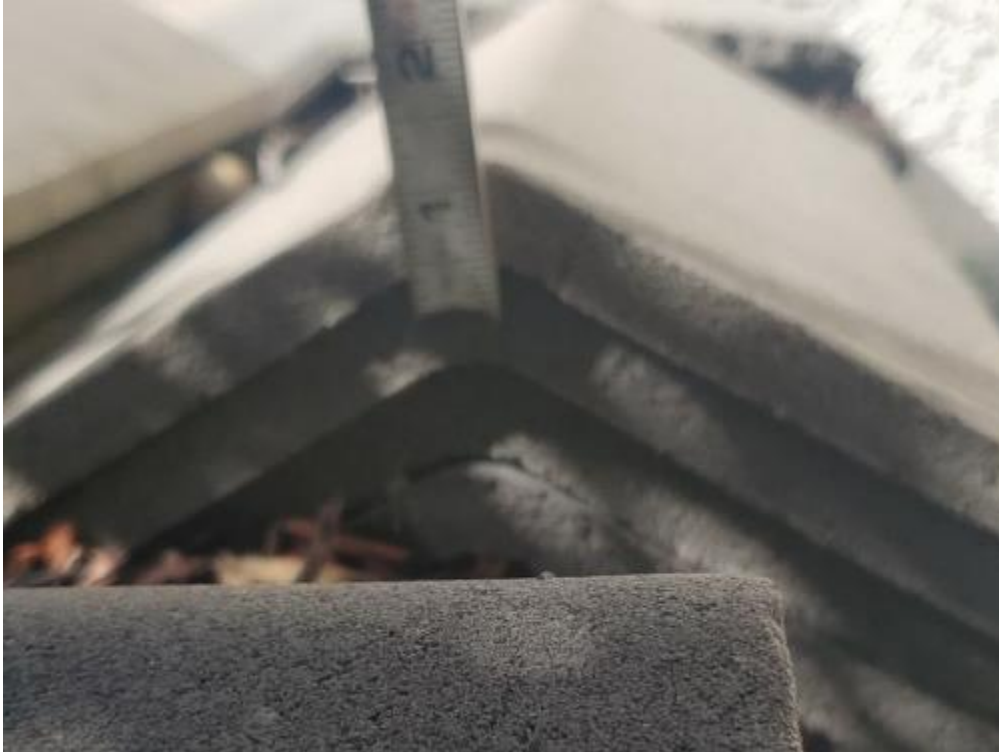
Photograph #35 – The hip/ridge cap tiles were approximately 1 inch thick.
