December 20, 2022

Insured:	Harry Silverglide
Address:	15771 Waite Island Drive Fort Myers, Florida 33908
D/O/L:	9/28/2022
Your File No.:	80134492
FCNA File No.:	105783

The purpose of the site investigation and this report was to provide an opinion on: (a) the cause, origin, duration, and extent of the reported damage to the exterior, interior, and roof, (b) whether this damage was a result of wind or flood associated with Hurricane Ian, and (c) the repairability of the roof.

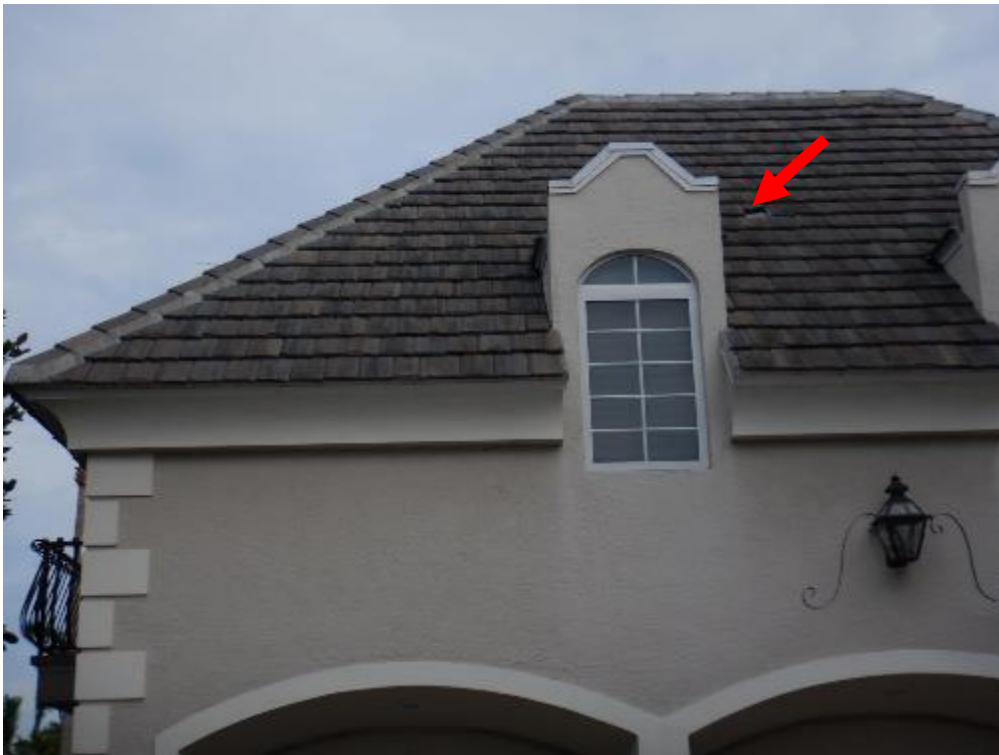
- Several randomly fractured, scattered, and/or missing field tiles were on the roof, as follows: (facet-quantity of shingles) front-facing-8, right-facing-3, rear-facing-4, and left-facing-3. These included 18 field tiles (Photographs 36 through 44).

Photograph #36 – One (1) randomly fractured, scattered, and/or missing tile was on the front-facing facet.

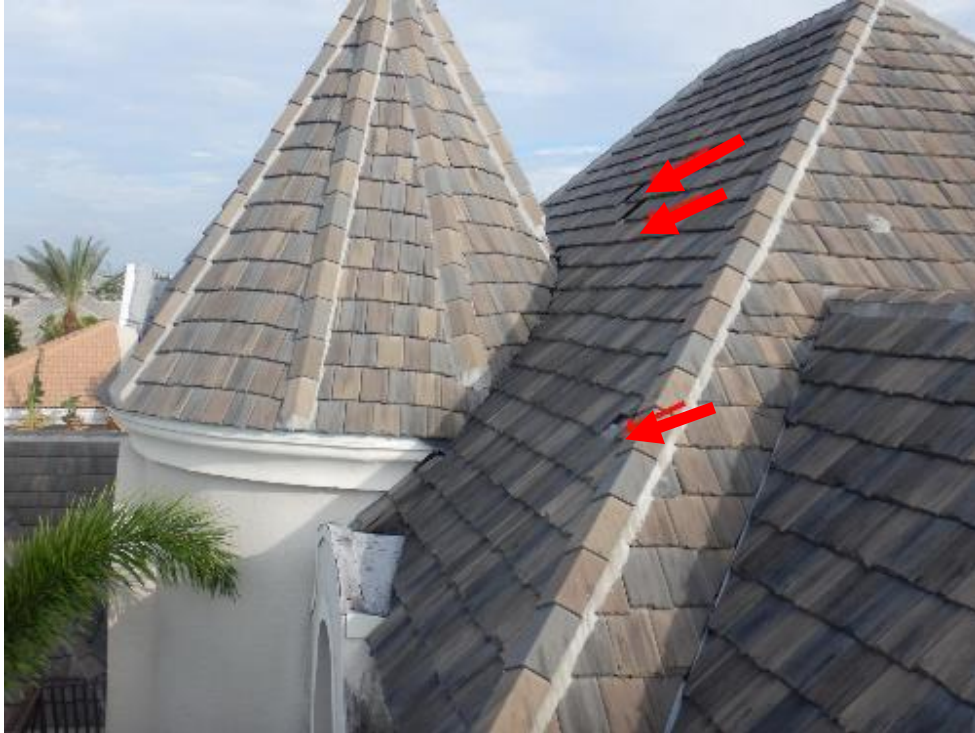
Photograph #39 – Three (3) randomly fractured, scattered, and/or missing tiles were on the front-facing facet.

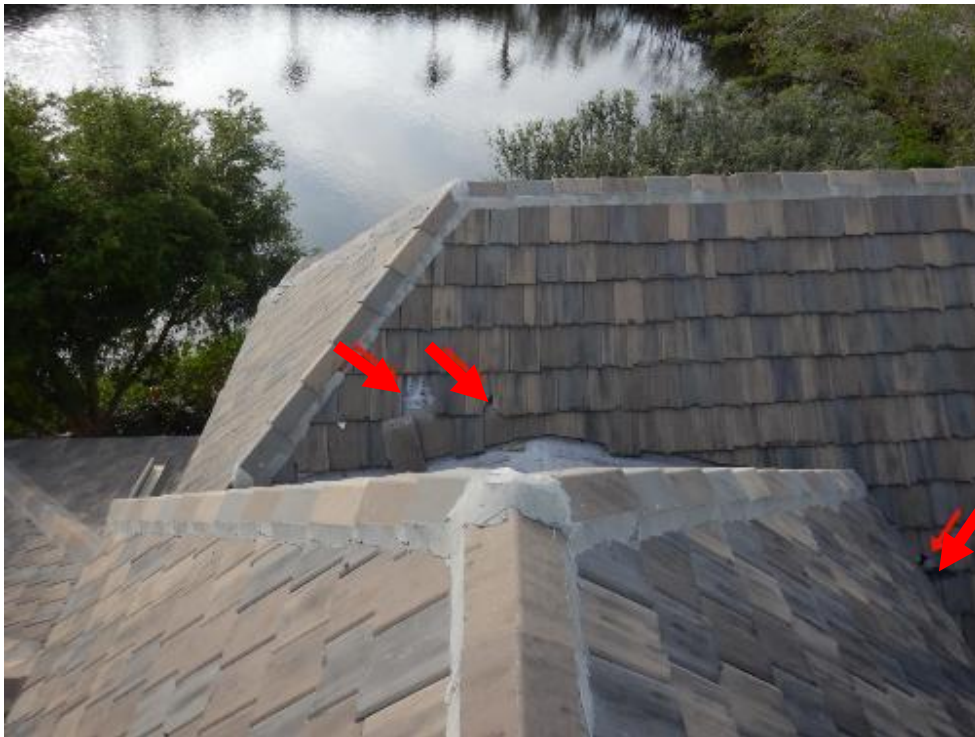
Photograph #40 – Three (3) randomly fractured, scattered, and/or missing tiles were on the right-facing facet.

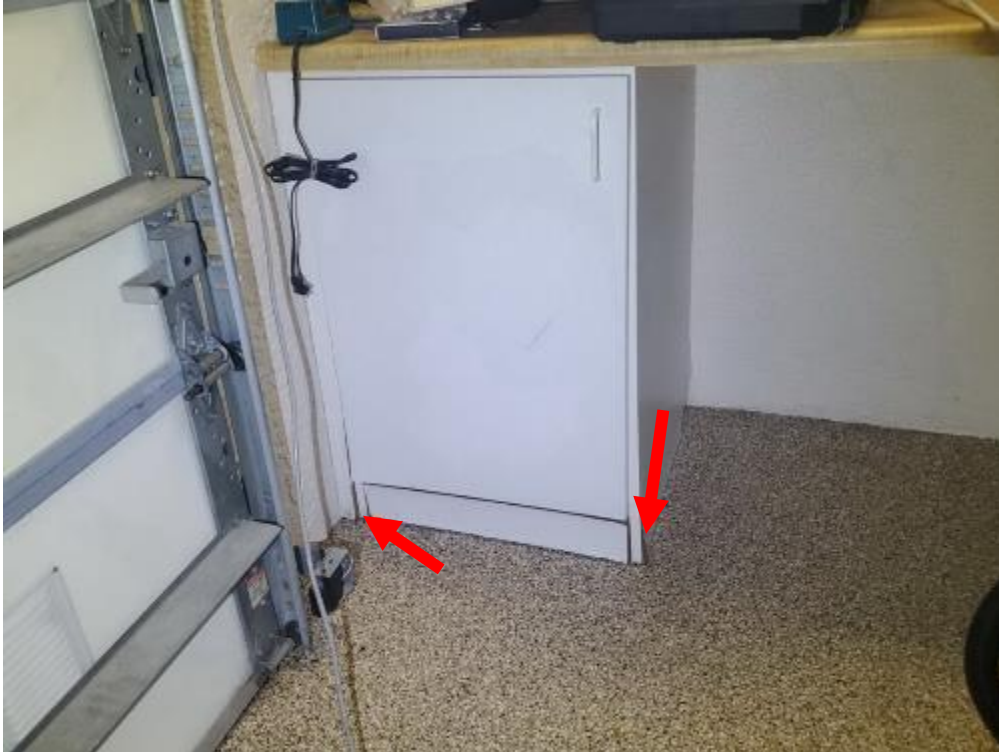
- Delamination, bulges, and separations were on the bottom of the cabinet inside the garage. Dark brown stains, cracks, and/or peeled texture were on the baseboard and the floor adjacent to the garage door and on the exterior surface of the garage door (Photographs 49 through 52).

Photograph #49 – Delamination, bulges, and separations were on the bottom of the cabinet inside the garage. A close-up view is shown in the next photograph.

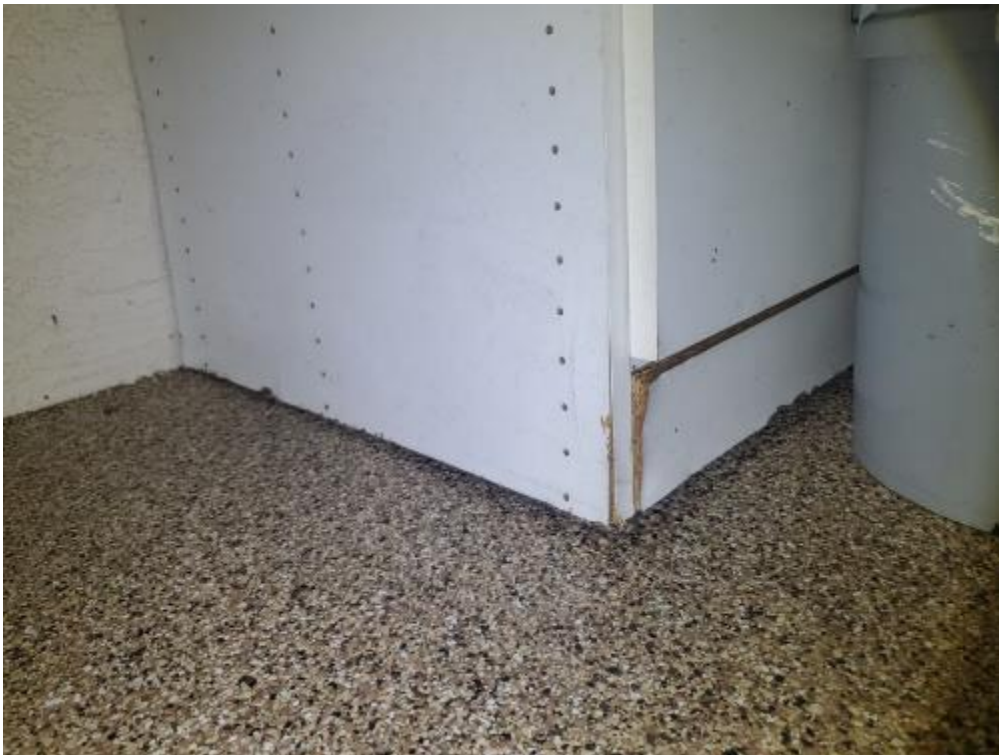
Photograph #50 – Delamination, bulges, and separations were on the bottom of the cabinet inside the garage.

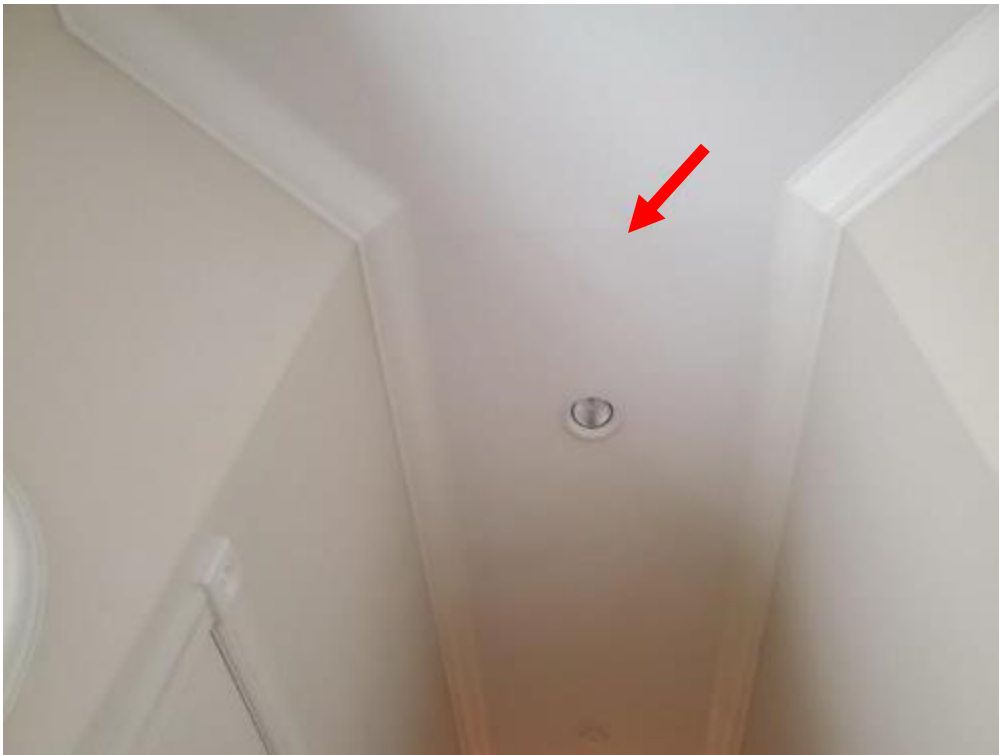
- Cracks up to 1/16-inch wide without discoloration and/or drywall separation were on the ceiling, wall, and/or crown molding of the rear-right closet, master bathroom, and master bedroom of the apartment, first story office, and second story of the front-left bedroom, theatre room, and left stairway to the roof decking area of the residence (Photographs 56, 57, and 58).

Photograph #56 – Cracks up to 1/16-inch wide without discoloration were on the first story hallway ceiling (representative condition shown here).

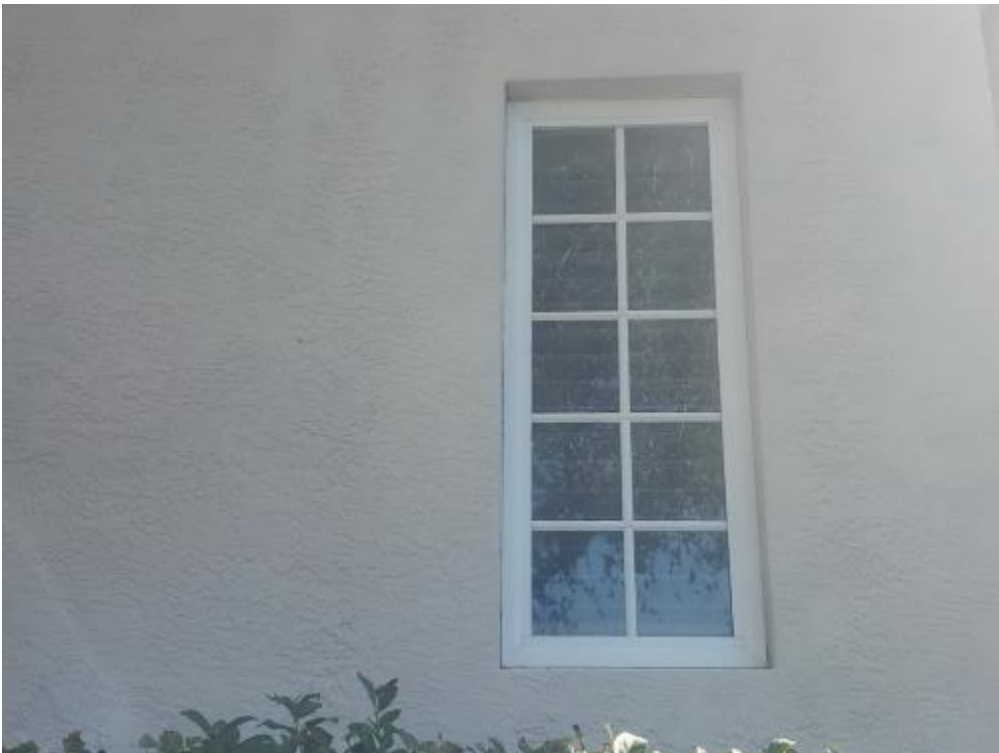
Photograph #62 – No cracks, fractures, warp, bows, or other forms of distortions were on the window glass panes, window frames, or stucco around the laundry room window (representative condition).

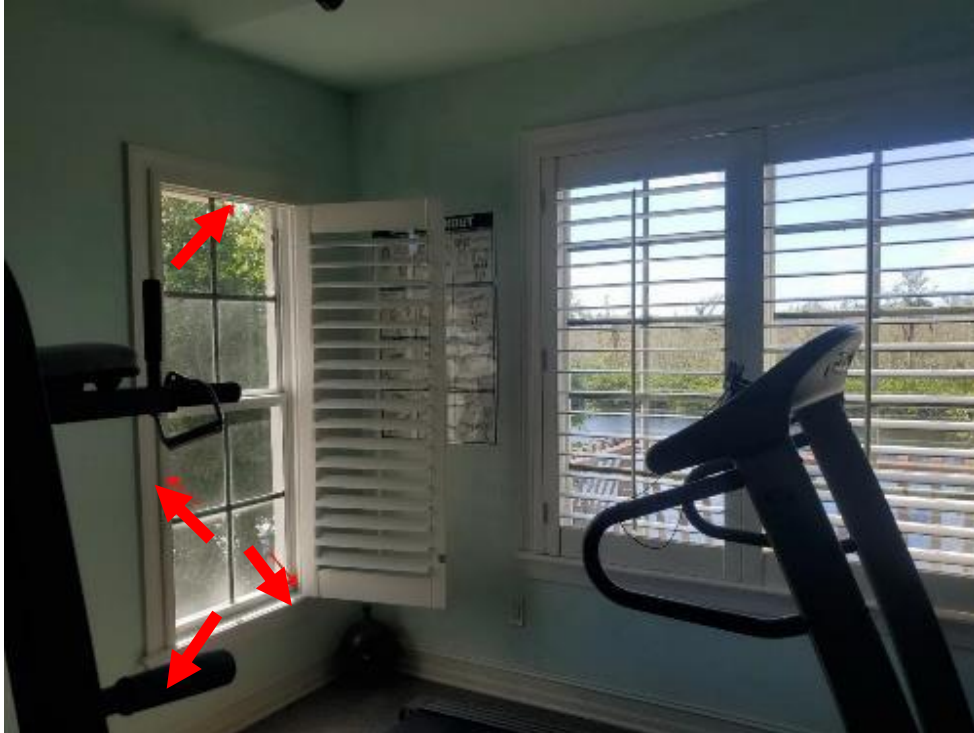
Photograph #63 – Light brown stains, cracks, and/or delamination were on the window stools and frames. Gaps, up to 2 inches long, were between the ends of the weather stripping seals and window frames of the second story gym window (representative condition shown here).

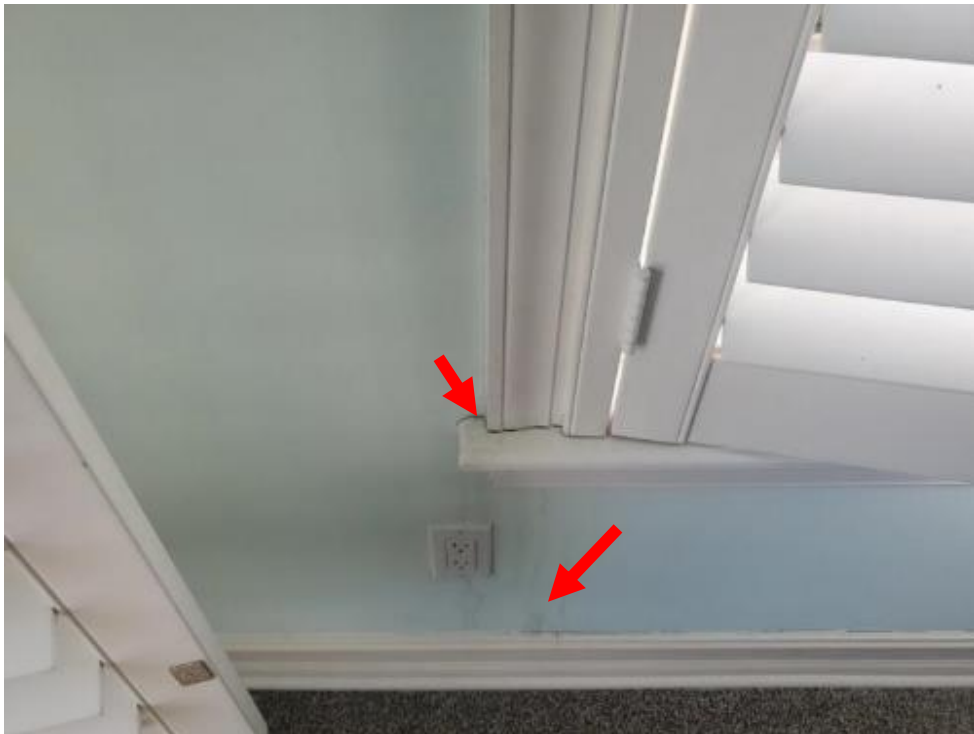
Photograph #64 – Light brown stains and cracks were around the second story gym window (representative condition shown here).

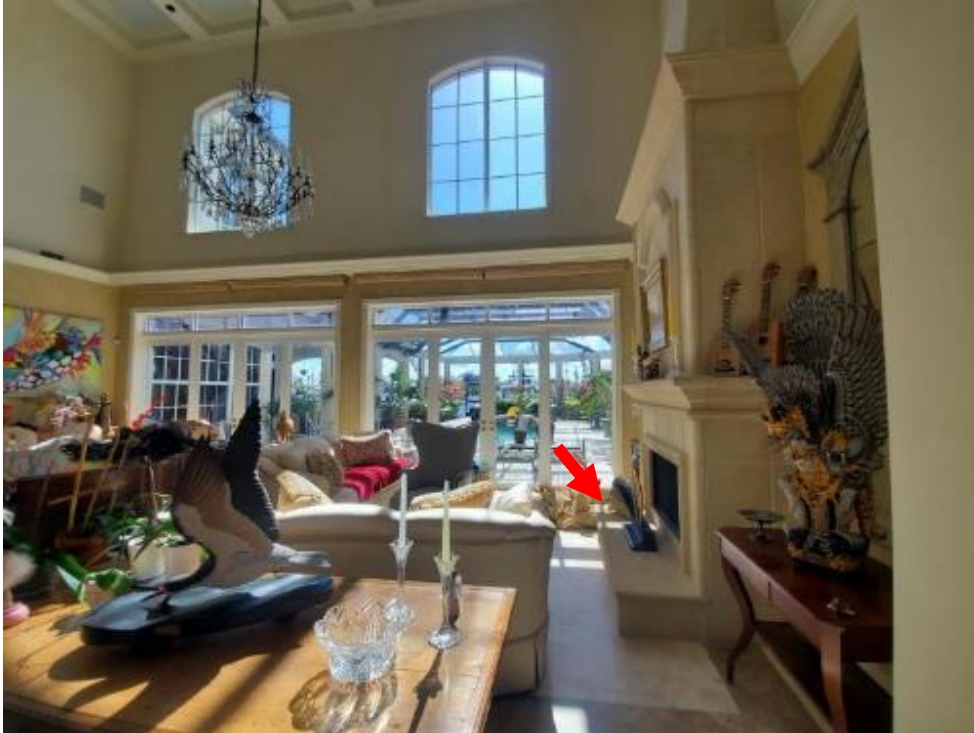
below the doors of the detached studio, the living room of the apartment, the first story of the rear left bedroom, entry/hallway, and living room, and second story of the rear-left bedroom of the residence. No discoloration was on the ceiling and wall above these doors (Photographs 67 through 75).

Photograph #67 – Light brown stains, peeled texture, and/or cracks were around the door and floor below the first story living room door. No discoloration was on the ceiling and wall above this door (representative condition shown here).

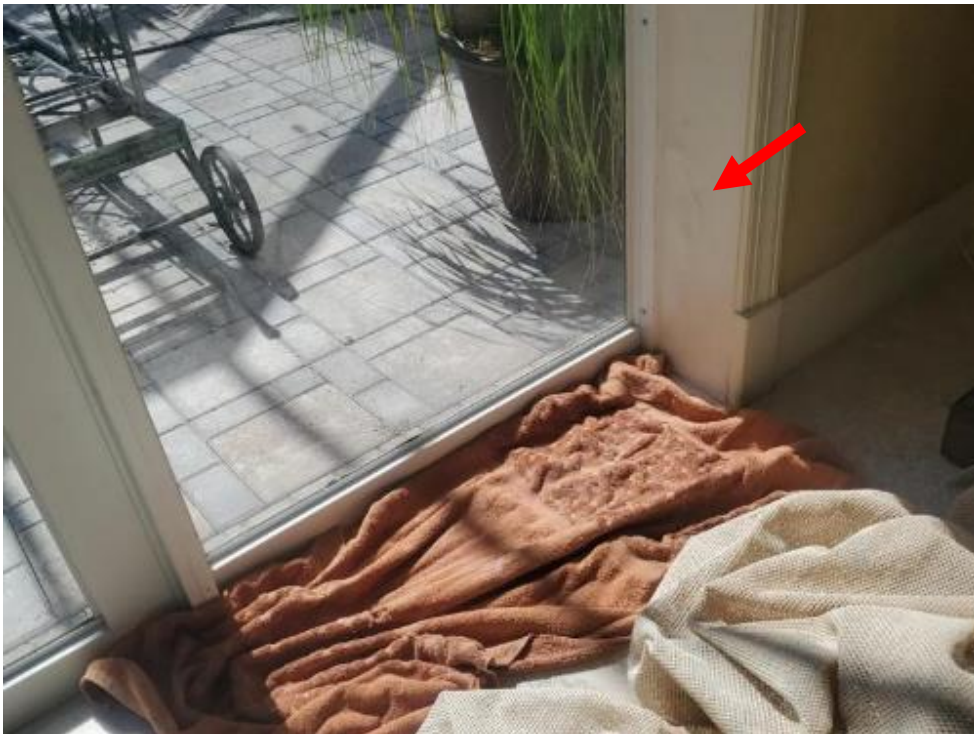
Photograph #68 – Light brown stains, peeled texture, and/or cracks were around the door and floor below the first story living room door (representative condition shown here).

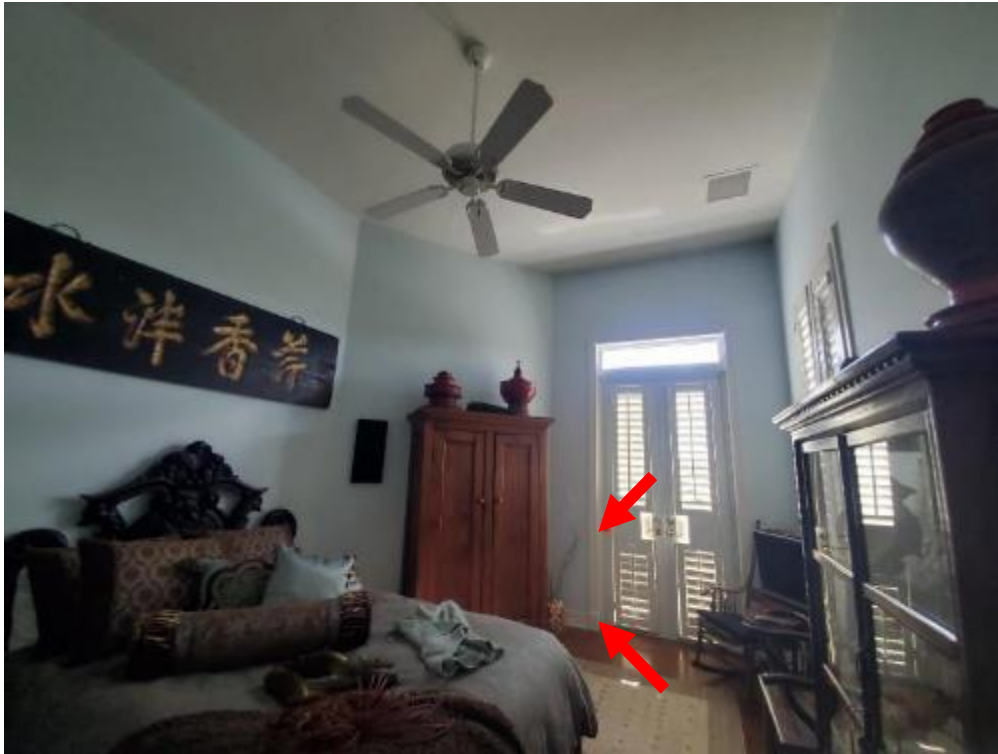
Photograph #71 – Light brown stains, peeled texture, and/or cracks were around the door and floor below the second story rear-left bedroom door (representative condition shown here).

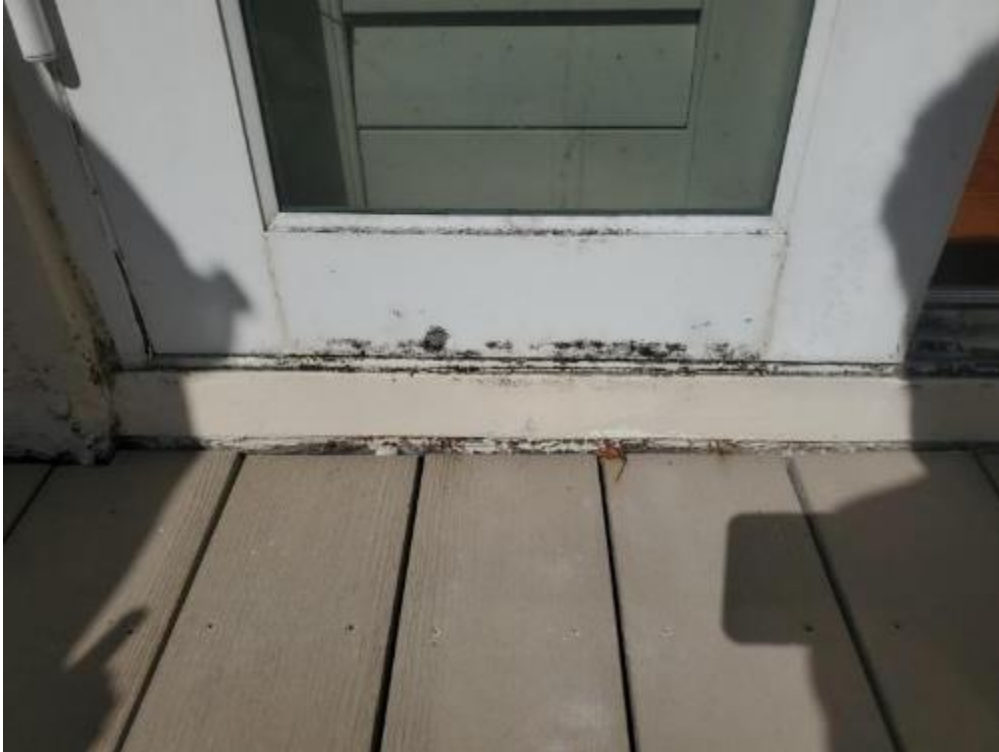
Photograph #75 – Black stains, delamination, and fungal decay were on the exterior surface of the second story rear-left bedroom door (representative condition shown here).

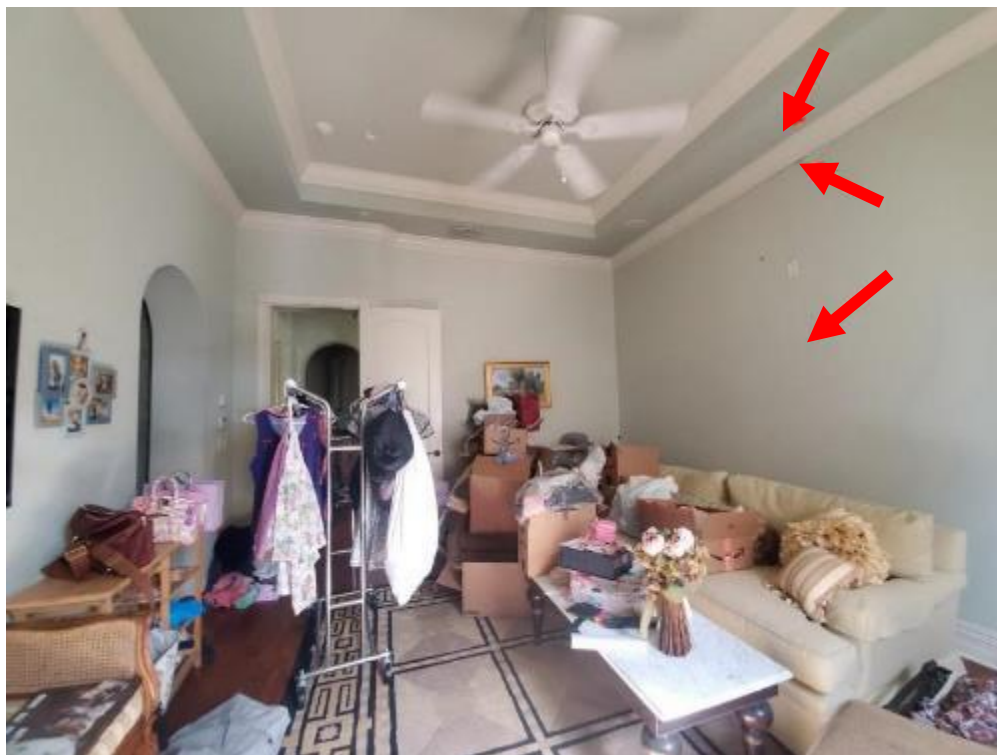
Photograph #79 – Light brown stains, vertical streaks, and/or cracks up to 1/8-inch wide were on the ceiling, ceiling-to-crown molding interface, and walls of the apartment living room.

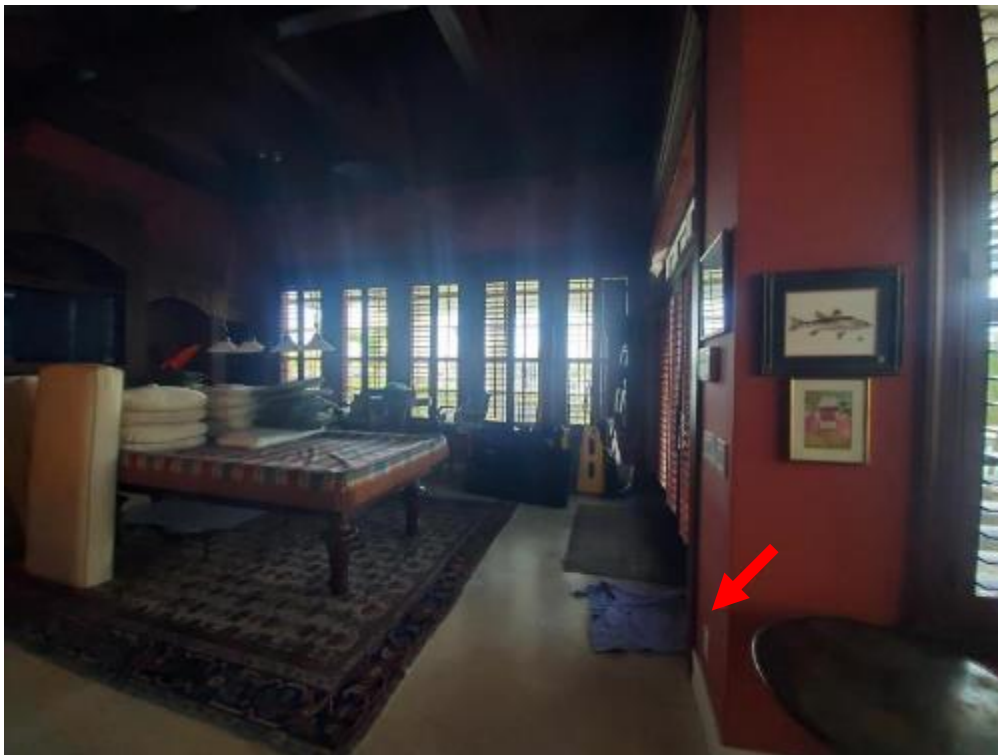
Photograph #82 – Light brown stains, vertical streaks, and/or cracks up to 1/8-inch wide were on the ceiling and wall of the first story game room.

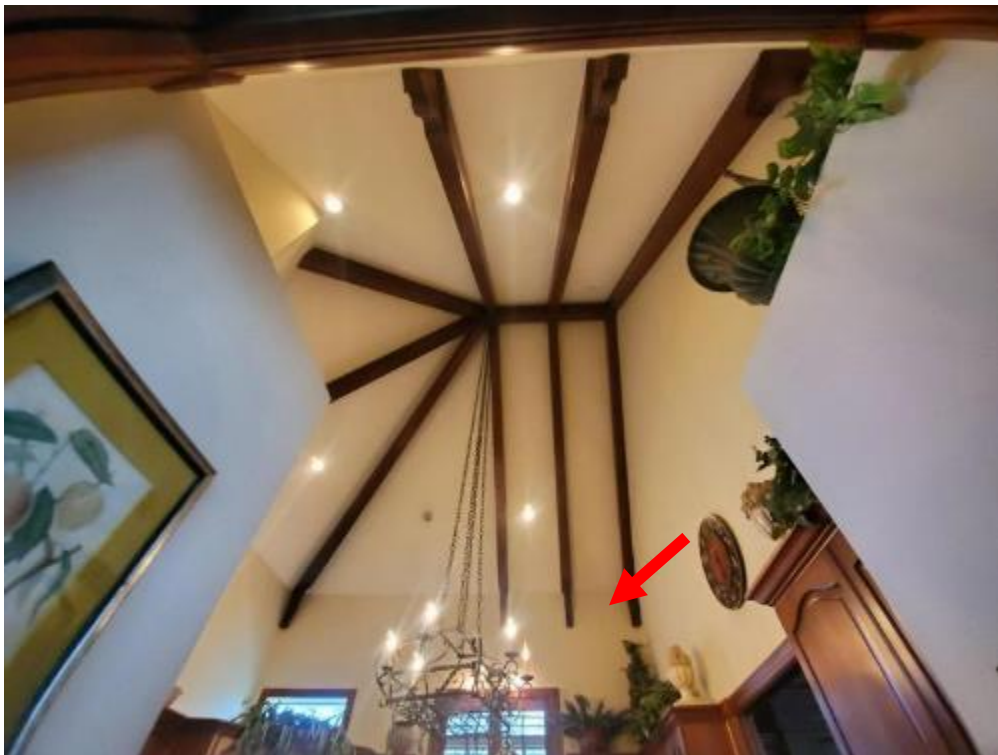
Photograph #86 – Light brown stains and peeled texture were on the first story kitchen ceiling.

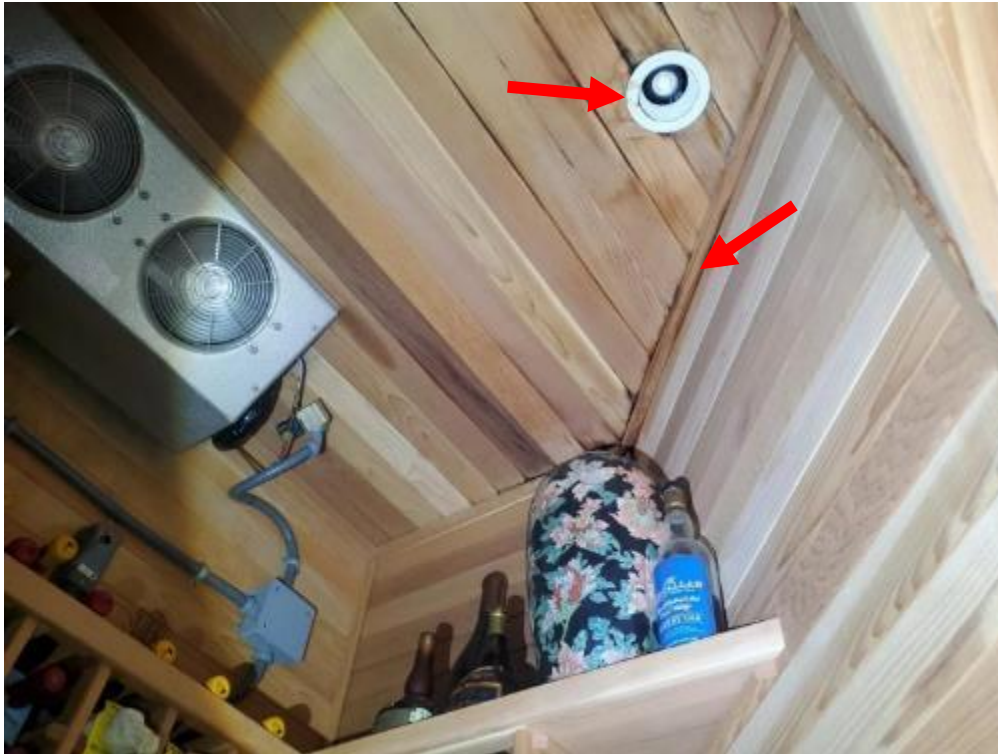
Photograph #89 – Dark brown stains were on the first story wine room ceiling.

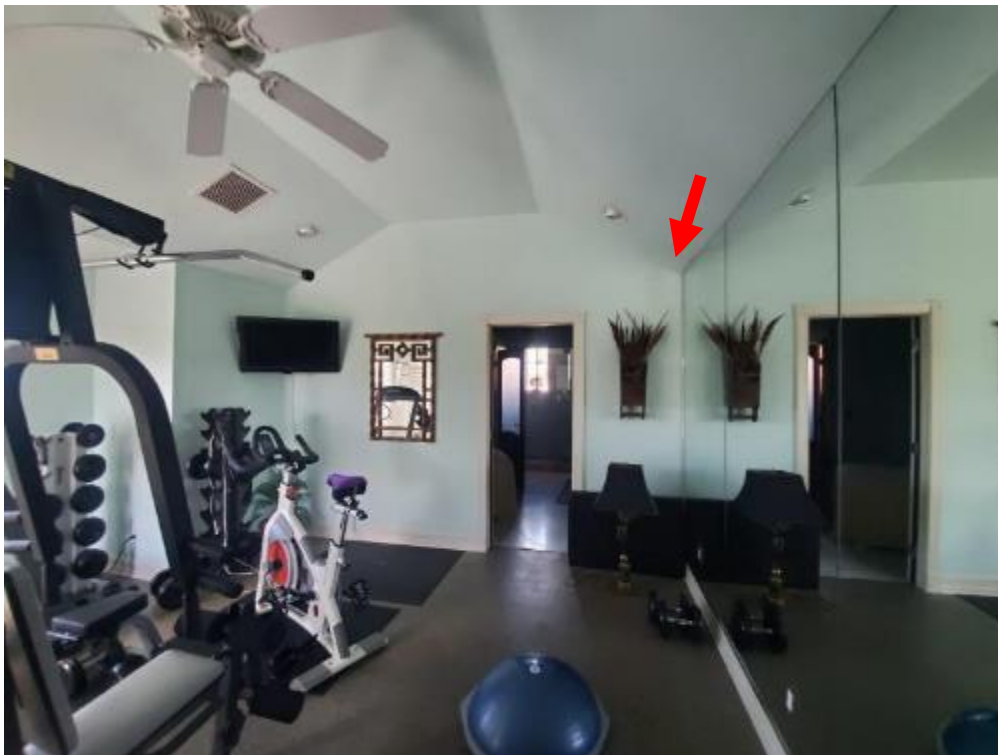
Photograph #94 – Dark brown stains were on the ceiling and wall of the second story gym.

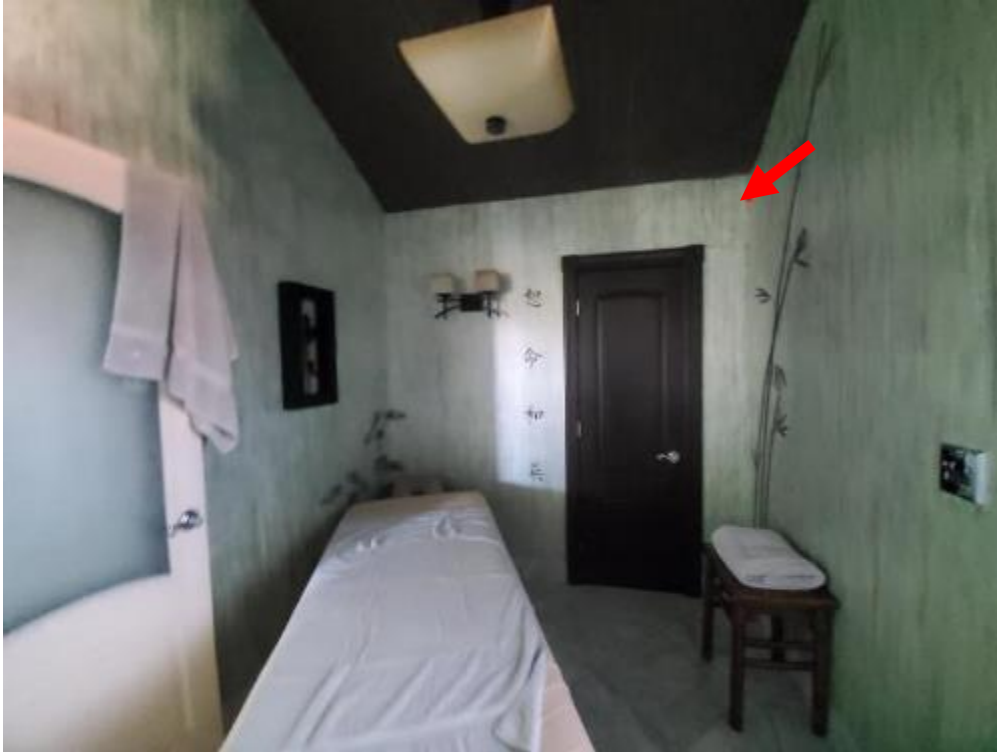
Photograph #97 – Light brown stains, peeled texture, and separations were on the ceiling and wall of the second story sauna.

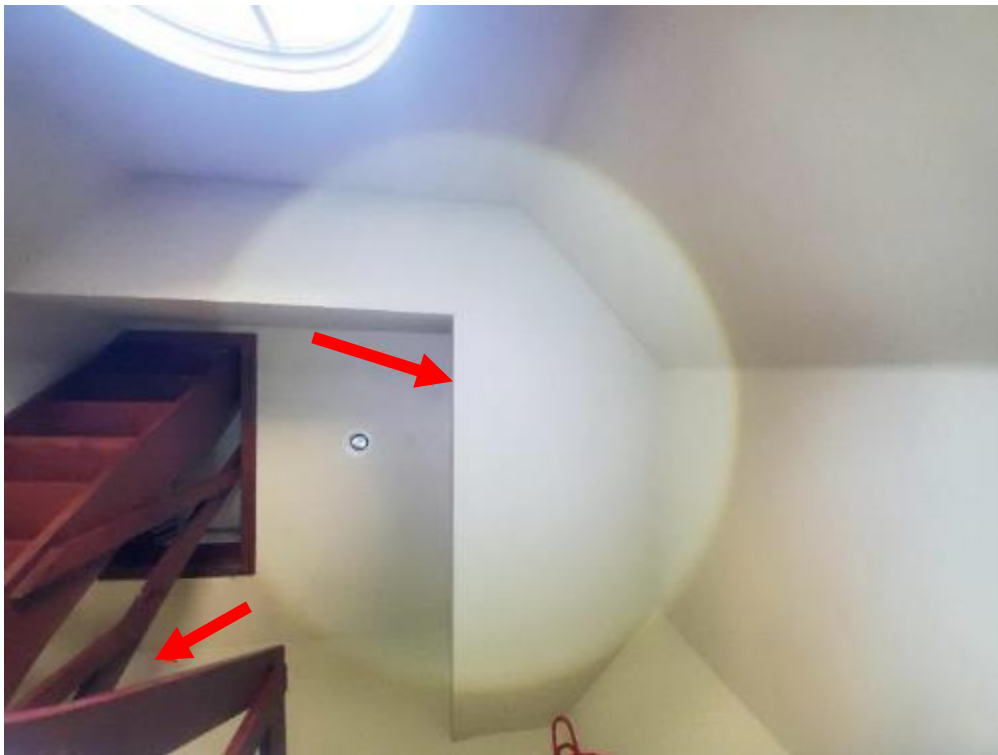
Photograph #100 – Dark brown stains and fungal decay were on the ceiling and wall of the second story left stairway to the roof decking area.

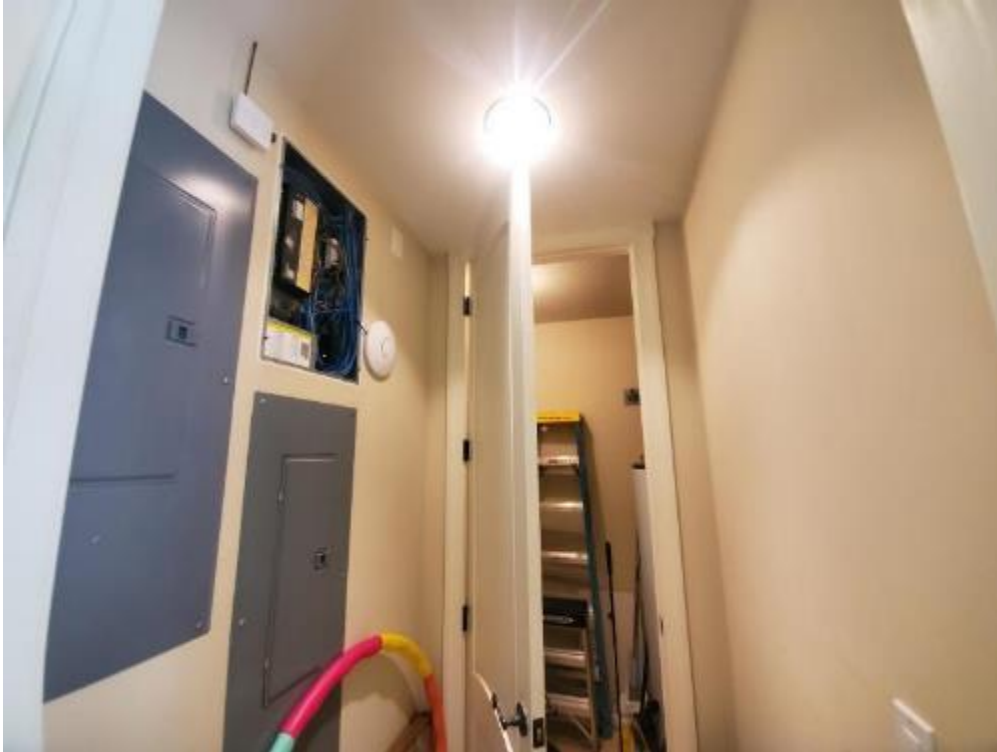
- No discernible stains or cracks were on the ceiling, walls, and/or around the windows of the first story of the utility closet and elevator room and the second story of the stairway to the theatre room and living room of the residence (Photographs 105 and 106).

Photograph #105 – No discernible stains or cracks were on the ceiling and walls of the first story utility closet (representative condition shown here).

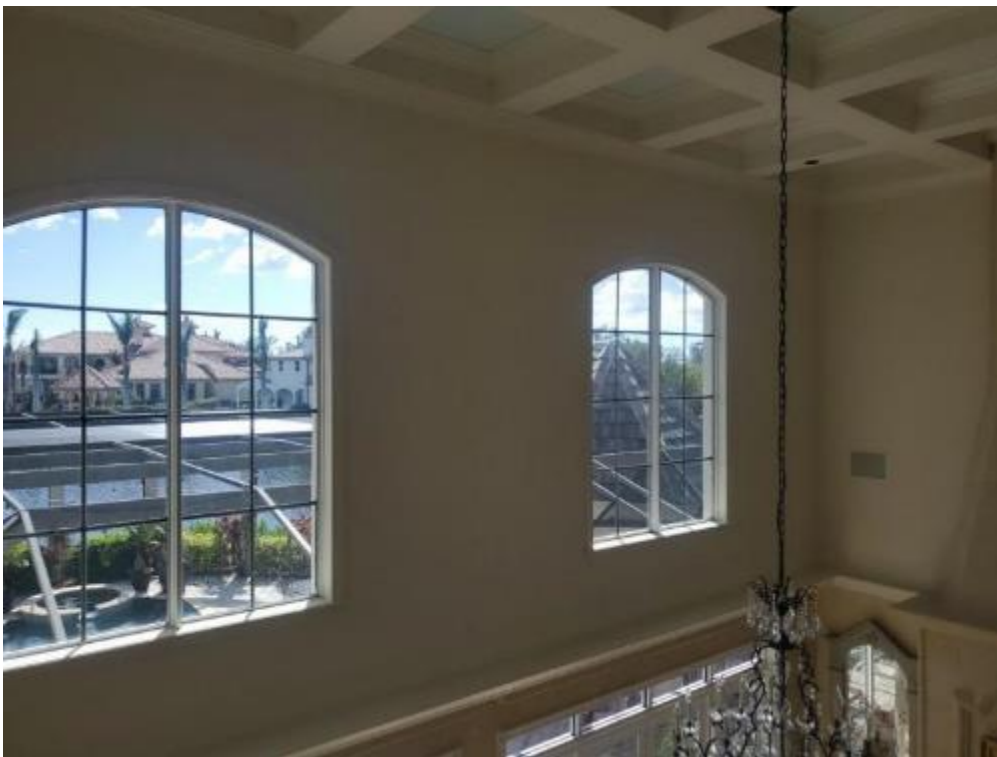
Photograph #106 – No discernible stains or cracks were on the ceiling, walls, and around the windows of the second story living room (representative condition shown here).
