## Technical Report

### MAN Lion's Explorer – Windscreen replacements

**Report Date:** 14 April 2011

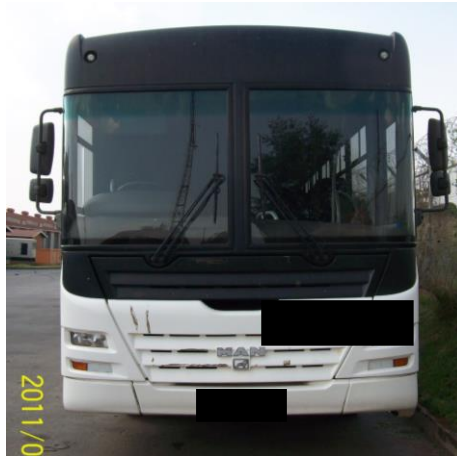
Multiple complaints from various depots within Autopax has highlighted a possible problem with the left hand windscreen of the MAN Lion's Explorer vehicles. MAN was notified of the problem but no apparent solution was forth coming. This report details all relevant information.
