Auger Roll Over

February 2018 – ver 1.0

Author - DA Brand

Tanker 15033 over turned onto Truck D915

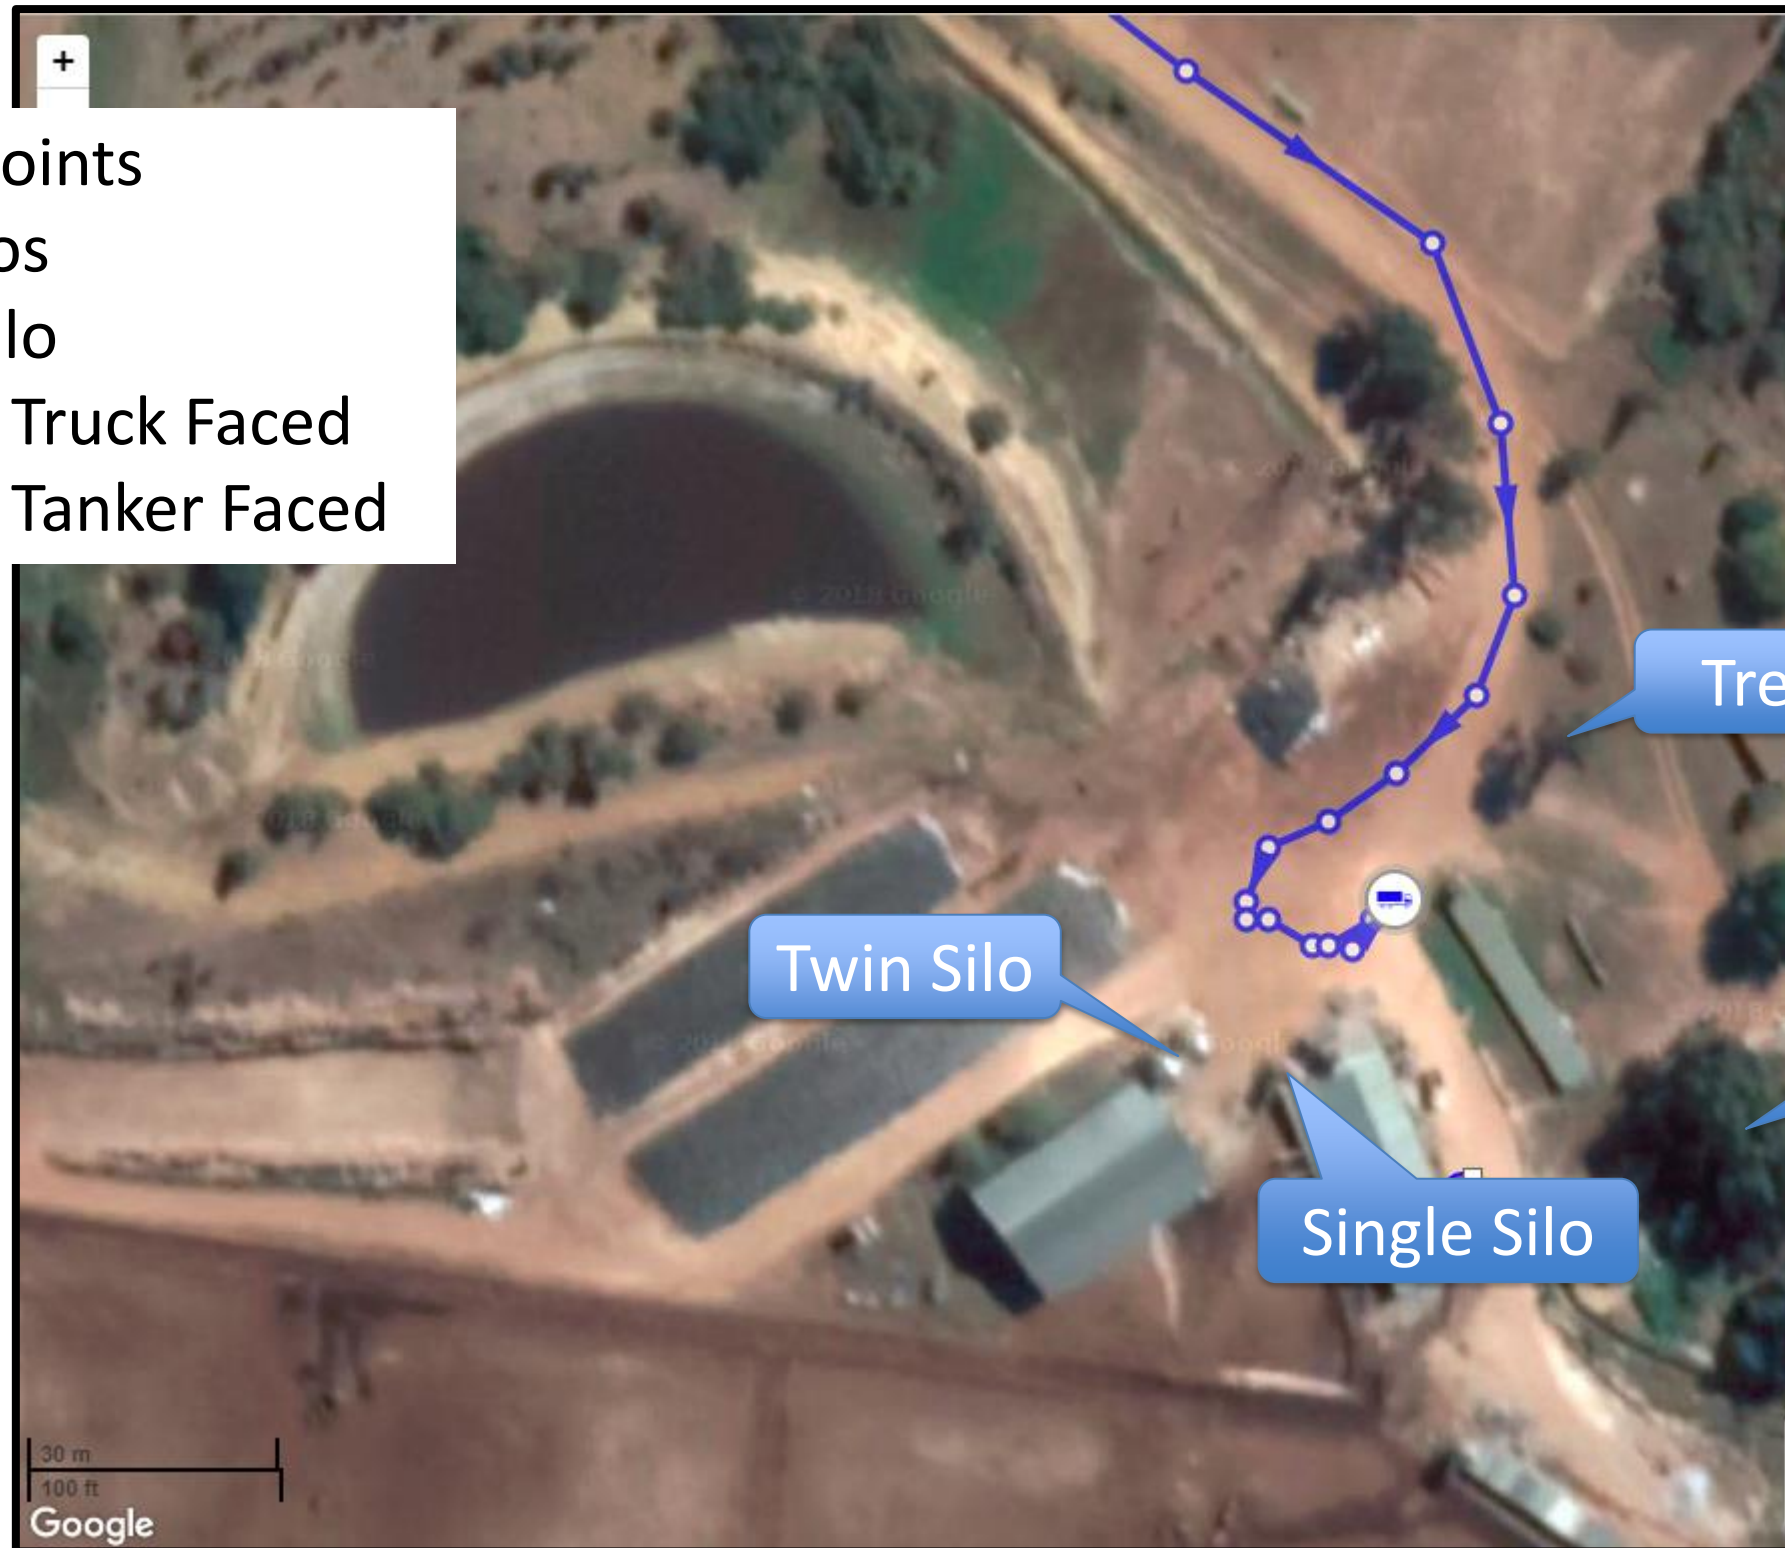
Reference Points

1. Twin Silos
2. Single Silo
3. Tree 1 – Truck Faced
4. Tree 2 – Tanker Faced

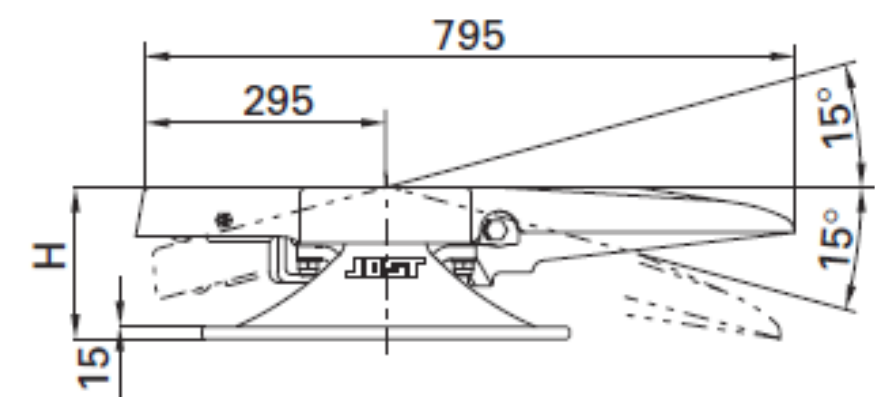
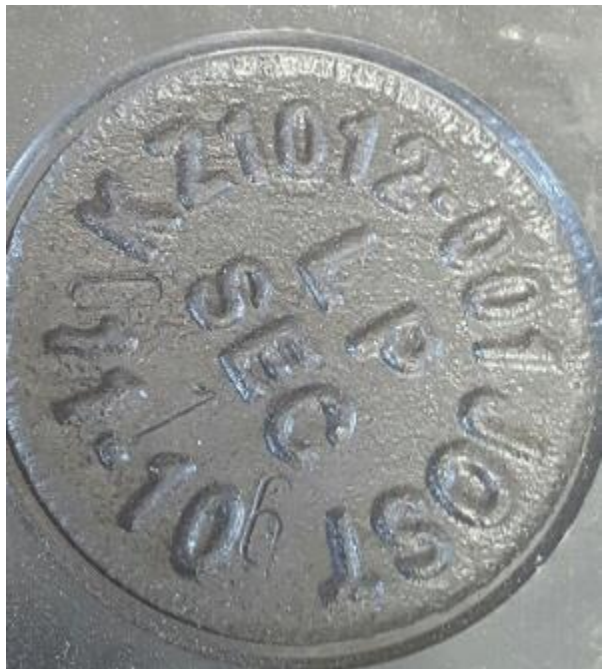
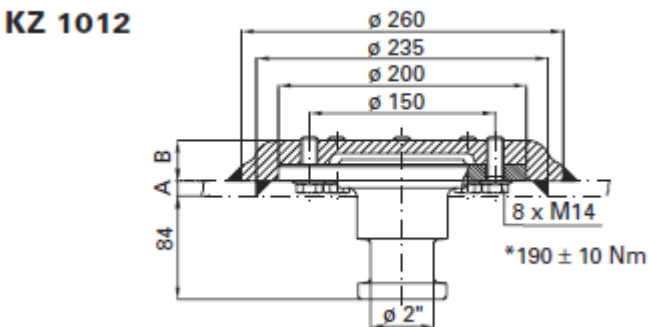
Maximum tilt allowed by Jost is 15°
The fifth wheel was execively over extended prior to failure

Fifth wheel and king pin were within specification and complies to regulations

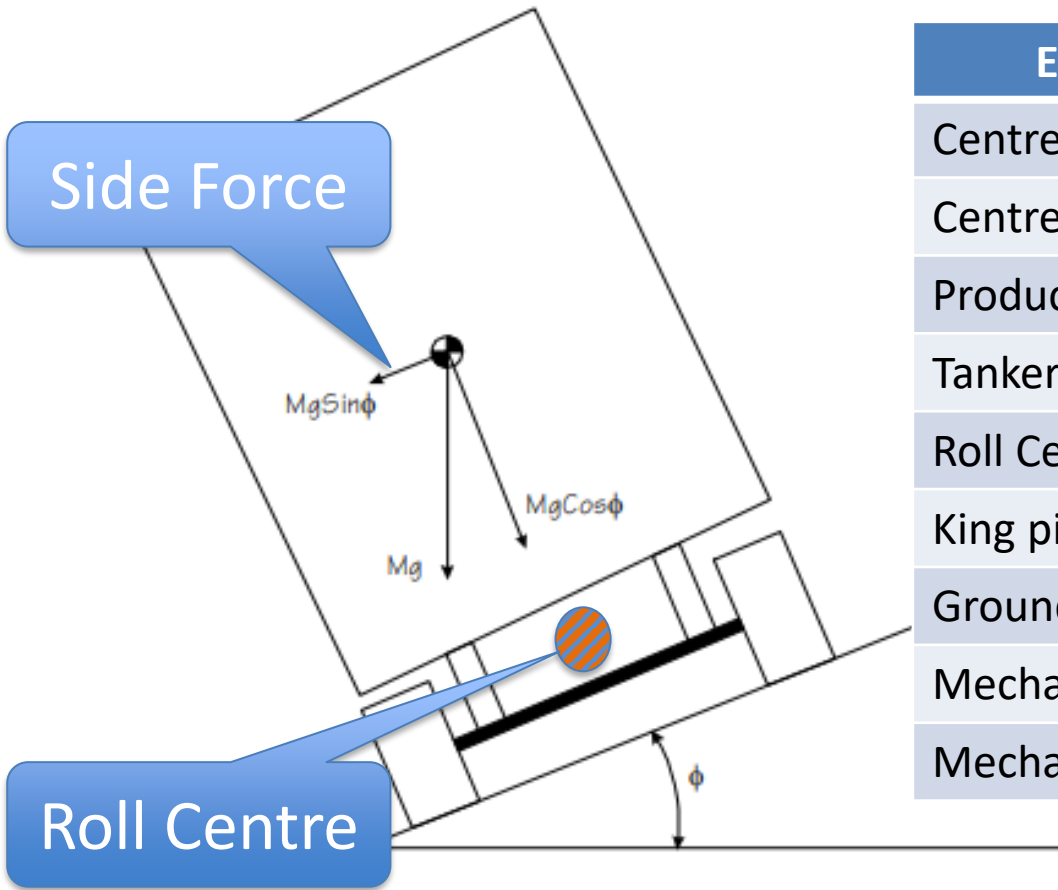
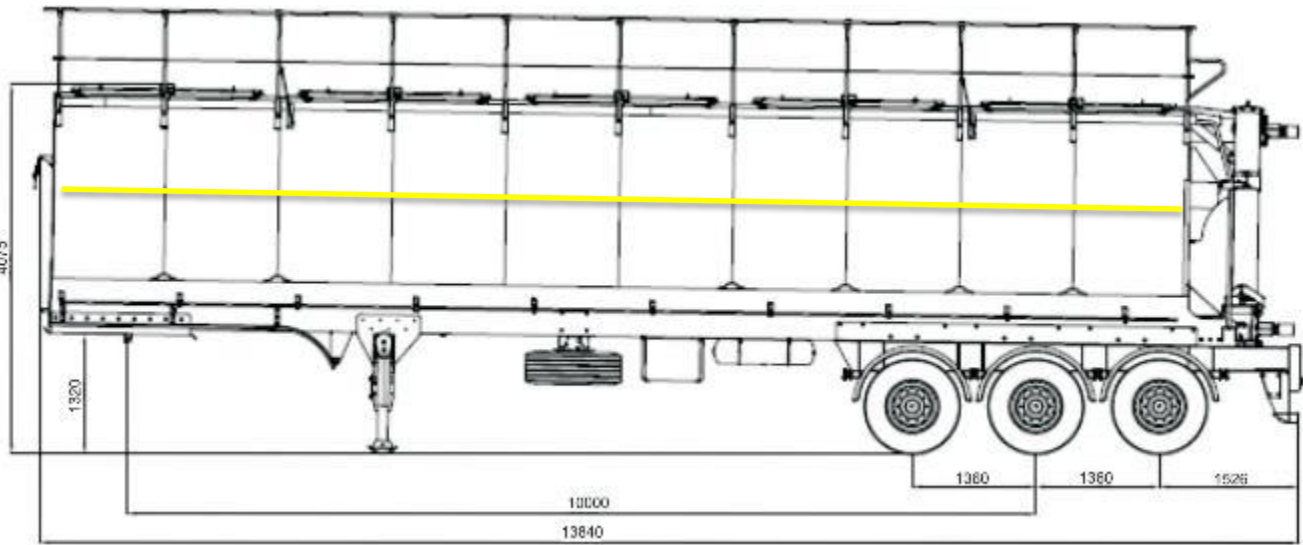
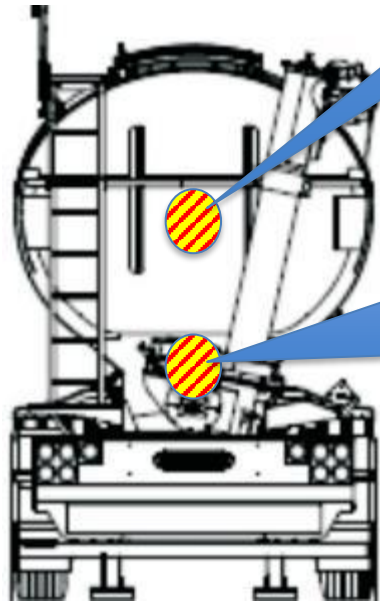
ESTIMATED VALUES AS USED IN CALCULATIONS	
Centre of Gravity – Unladen Tanker	1.6 m
Centre of Gravity – Product	3 m
Product mass	30,000 kg
Tanker Tare mass	9,000 kg
Roll Centre – Centred between road springs	0.837 m
King pin height	1.32 m
Ground to Roll Centre	0.837 m
Mechanical Leverage Ratio – Product	4.5
Mechanical Leverage Ration – Tanker	1.6
