for MITSUI—MAN B&W engines, Countermeasure for erosion of nozzle ring on TCA turbocharger		No. 199	
		APPROVED	N. Osako
		CHECKED	
		PREPARED	T. Matsubara
ENGINE TYPE	TCA turbocharger	DATE	2019.1.15

Erosion on TCA nozzle rings in two-stroke engines

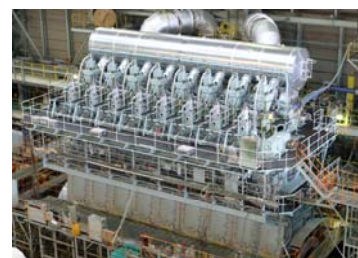
It is recommended that nozzle ring can be rotated once as shown in Figure 1 providing that the erosion condition is within acceptable range. In order to fit the nozzle ring in new rotated position, it is necessary to drill the additional screw holes in the gas admission casing, because those holes pitch is not equal interval. For more information about additional machining, please contact to our Techno service.
