Eight Discipline Report (8D Report)

To: 8D report No.: **CPCQ0421**
 From : **Chicony Power Technology** RMA claim No.: **N/A**
 CC : **N/A** Chicony P/N: **A045R00CH-HW01-0A**
 Customer P/N:
 Submit date: **2015/05/11** Product description: **45W adapter**
 Receive date: **2015/04/21** Defect D/C or Lot No.: **WEJZB0AGC7J0D2(Version 0A)**
 Subject : **45W adapter sample ISN failed**

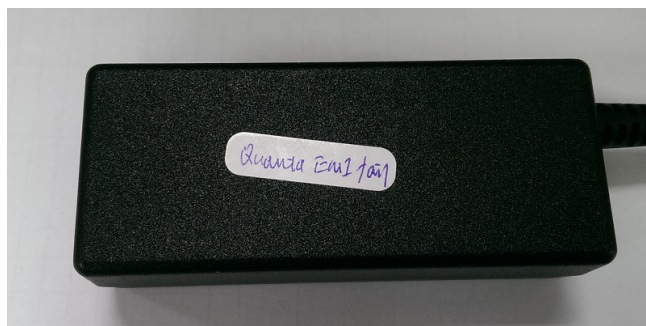
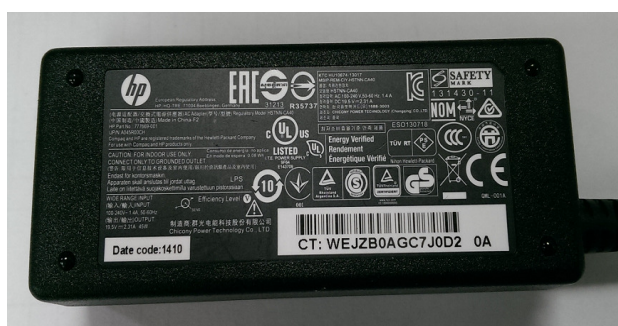
Defect S/N & Defect D/C: Fail sample: WEJZB0AGC7J0D2(Version 0A)

2015/4/21, 廣達反饋有 1pcs A045R00CH 於 ISN 測試 Fail

良機與不良機於客戶端之測試結果如下:

Fail sample: (Version 0A S/N: WEJZB0AGC7J0D2)
