## Eight Discipline Report (8D Report)

To: <b>Customer</b>	8D report No.:
From: : <b>Chicony Power Technology</b>	RMA claim No.: <b>N/A</b>
CC :	Chicony Power P/N: <b>A035R001H</b>
	Customer P/N:
Submit date: <b>2014/7/9</b>	Product description: <b>35W adapter</b>
Receive date: <b>2014/6/16</b>	
<b>Subject : No power*1pcs , ( 零件 / 磁件, 變壓器的線刺破 tape,導致感量下降)</b>	
<b>D1.) 問題解決成員:Use Team Approach</b>	
主持者 (Team Leader) : <b>Cf_Liu</b> 內部成員 (Internal Team Members): <div style="text-align: center; margin-top: 10px;"> <b>CQS: Jack Wang</b>  <b>QE: Kitty Zhang</b>  <b>MFG: Xiaohui Du</b>  <b>PE: Yong Liu</b>  <b>Sales: Justin Yu</b>  <b>RD: Jay Huang</b> </div> 外部成員 (External Team Member):	
<b>D2.)問題說明:Problem Description:</b>	
(Note: Use <b>who, what, when, where, why, how, how many</b> to specify the Customer's problem.)	
<b>2014/6/16 CPT has received 1pc won't power on from customer product team.</b> <b>SN: 140312003CC7</b>	
<b>D3.)內部或客戶的暫時解決辦法及實施日期:Implement and Verify Containment Action:</b>

To:	8D report No.:
From: : <b>Chicony Power Technology</b>	RMA claim No.:
CC : <b>N/A</b>	Chicony P/N:
	Customer P/N:
Submit date: <b>2014/6/18</b>	Product description: <b>35W printer adapter</b

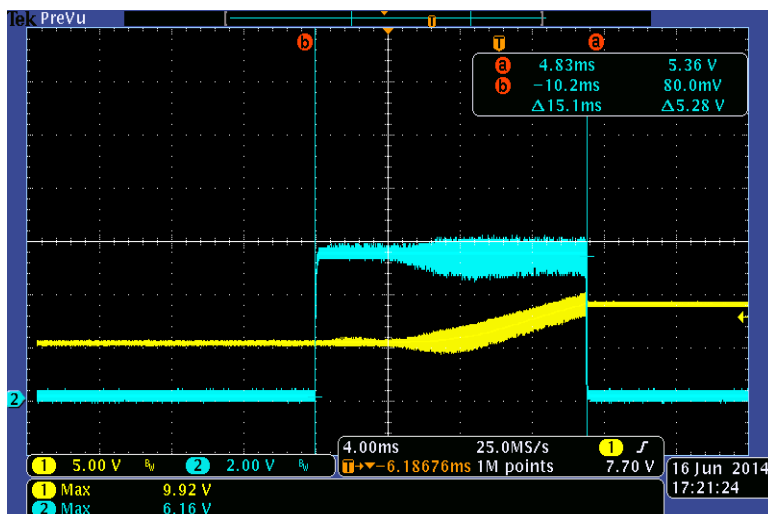
### Transformer SPEC.

- We found the inductance of transformer no meet spec. 450uH. We measured the inductance of transformer 35.68uH ( Fig.3) which is causing the PWM IC trigger the SCP as Fig.4.

Item	contain	winding	Pin out	spec	unit	tol	remark
2.1.	Inductance	N1 + N6	5 – 3	450	μH	±5%	@ 100KHz / 1V

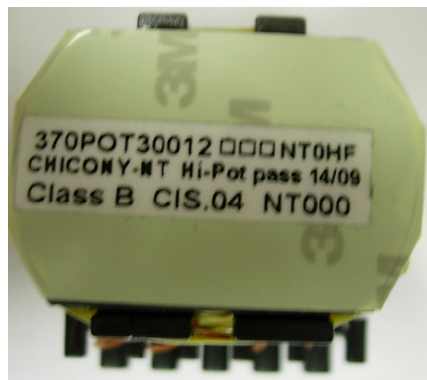
- **Provided failed sample Transformer to supplier to analysis.**

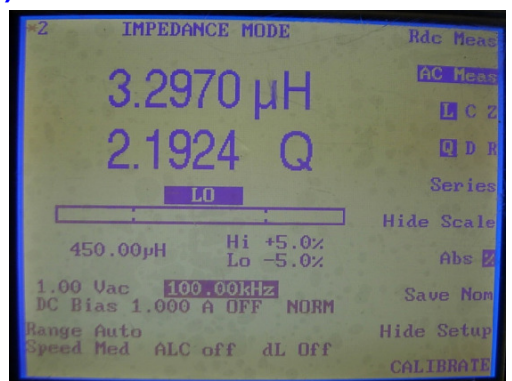
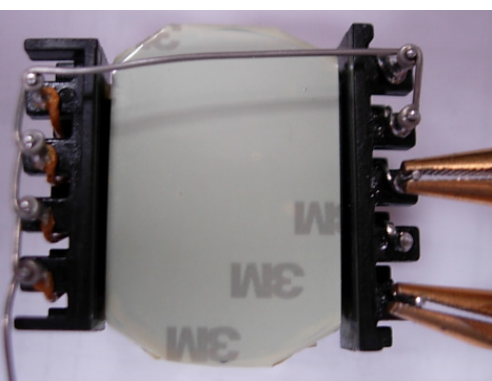
**b.) L.K. Inductance test :**

Item	Pin out	Spec	Sample test	Test condition
L	5-3	450uH±5%	35.775uH	100KHz/1V
L.k	5-3	7.2uH Max	3.2970uH	100KHz/1V
Q	5-3	50 Min	1.8864	100KHz/1V
D.C	5-3	345mΩ Max	301.0mΩ	
	2-1	52mΩ Max	41.5mΩ	
	8-6	77mΩ Max	65.5mΩ	
	9-7	84mΩ Max	71.5mΩ	
Hi-Pot	Pri-Sec	3200Vac	PASS	0.75mA 60SEC(AC)
	Pri-Core	1000Vac	FAIL	0.75mA 60SEC(AC)
	Sec-Core	3200Vac	PASS	0.75mA 60SEC(AC)

**\*Test Result : Inductance, Q Factor and Hi-pot Pri.- Core Fail**

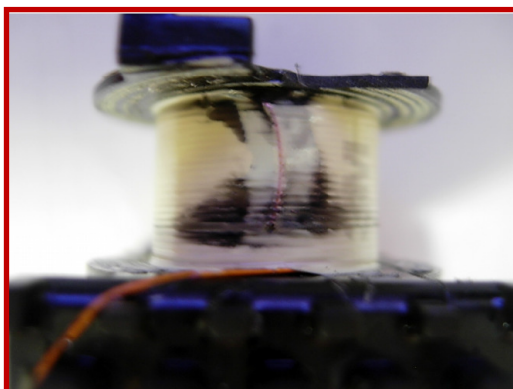
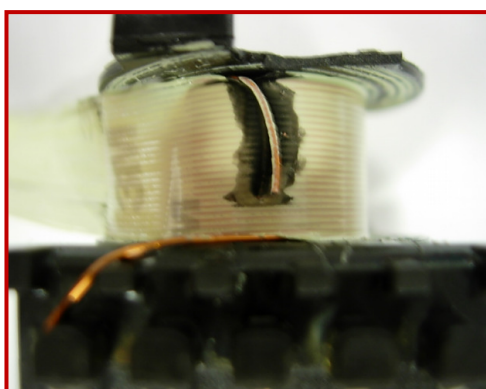
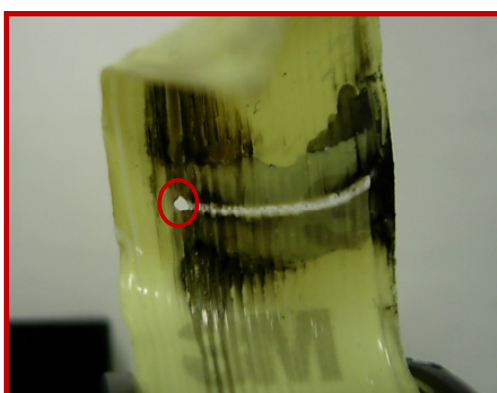
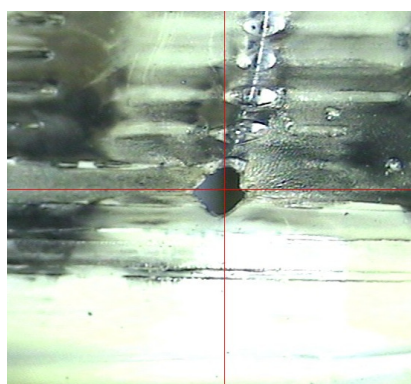
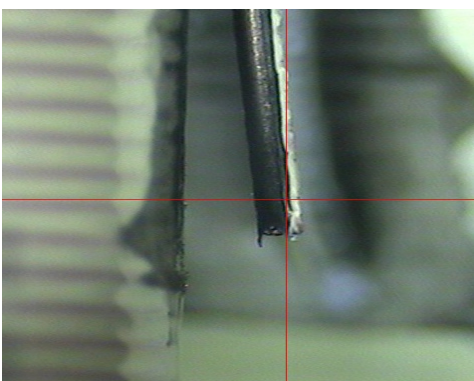
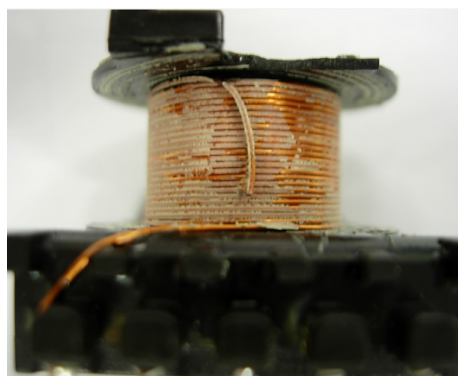
According to the disassemble pictures listed above. The tail of S1 winding wire just ends in the middle of winding area. And in this case, the sharp edge of the ending wire punctured the insulation tape as N1 and other upper windings cover and compress S1. Therefore the tape was damaged and leading to undesirable characteristics.

**Change the tail ending of S1 winding to let it parallel to N1 winding, to prevent the tape damaged.**
