Eight Discipline Report (8D Report)

To:	8D report No.:																								
From: Chicony Power Technology	RMA claim No.: N/A																								
CC :	Chicony Power P/N:																								
	Customer P/N:																								
Submit date: 2023/7/14	Product description: 65W PD																								
Receive date: 2023/7/24	Defect D/C or Lot No.:																								
Subject : 客戶 7/14 反應 sample 樣機測試殼溫 fail																									
D1.) 問題解決成員: Use Team Approach																									
主持者 (Team Leader) : Edward Ho 內部成員 (Internal Team Members): <div style="text-align: center;">RD: Will Wu</div> 外部成員 (External Team Member):																									
D2.) 問題說明: Problem Description:																									
(Note: Use who, what, when, where, why, how, how many to specify the Customer's problem.)																									
2023/7/14 客戶告知: 下面為 WM 機種殼溫測試數值，發現 Top 面 ΔT>40 度， Fail 請確認量測的熱點是否不是最 worst ， fail 的部分盡快釐清

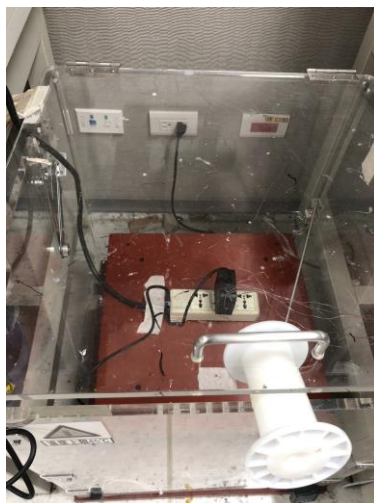
2. 殼溫測試

- (1) Input Voltage : 100Vac
- (2) Input Frequency : 50Hz
- (3) Load Condition : 95% Load
- (4) Temperature : 25°C.

3.6 CASE TEMPERATURE RISE:
At input voltage 100Vac/240Vac 50Hz,
case temperature rises $\leq 40^{\circ}\text{C}$ at 95% loading.

3. 殼溫測試結果，與客戶反應的狀況一致。

CPT 測試 fail 面 : SMD

客戶測試 fail 面 : Top

- 1.CPT 將樣機重新測試，殼溫一樣 Fail.
- 2.驗證升溫線不同架設方式，殼溫測試結果差異約 3.7 度。
- 3.增加 Shielding 和 Case 之間的點膠面積，並重新驗證殼溫，測試結果均符合客戶規格。
