Eight Discipline Report (8D Report)

To: Wistron	8D report No.: 20240301
From: : Chicony Power Technology	RMA claim No.: N/A
CC :	Chicony Power P/N: A090AP06P-DL01
	Customer P/N: H2FR2
Submit date: 2024/5/17	Product description: 90W Adapter
Receive date: 2024/3/19

Subject : noise issue * 2pcs

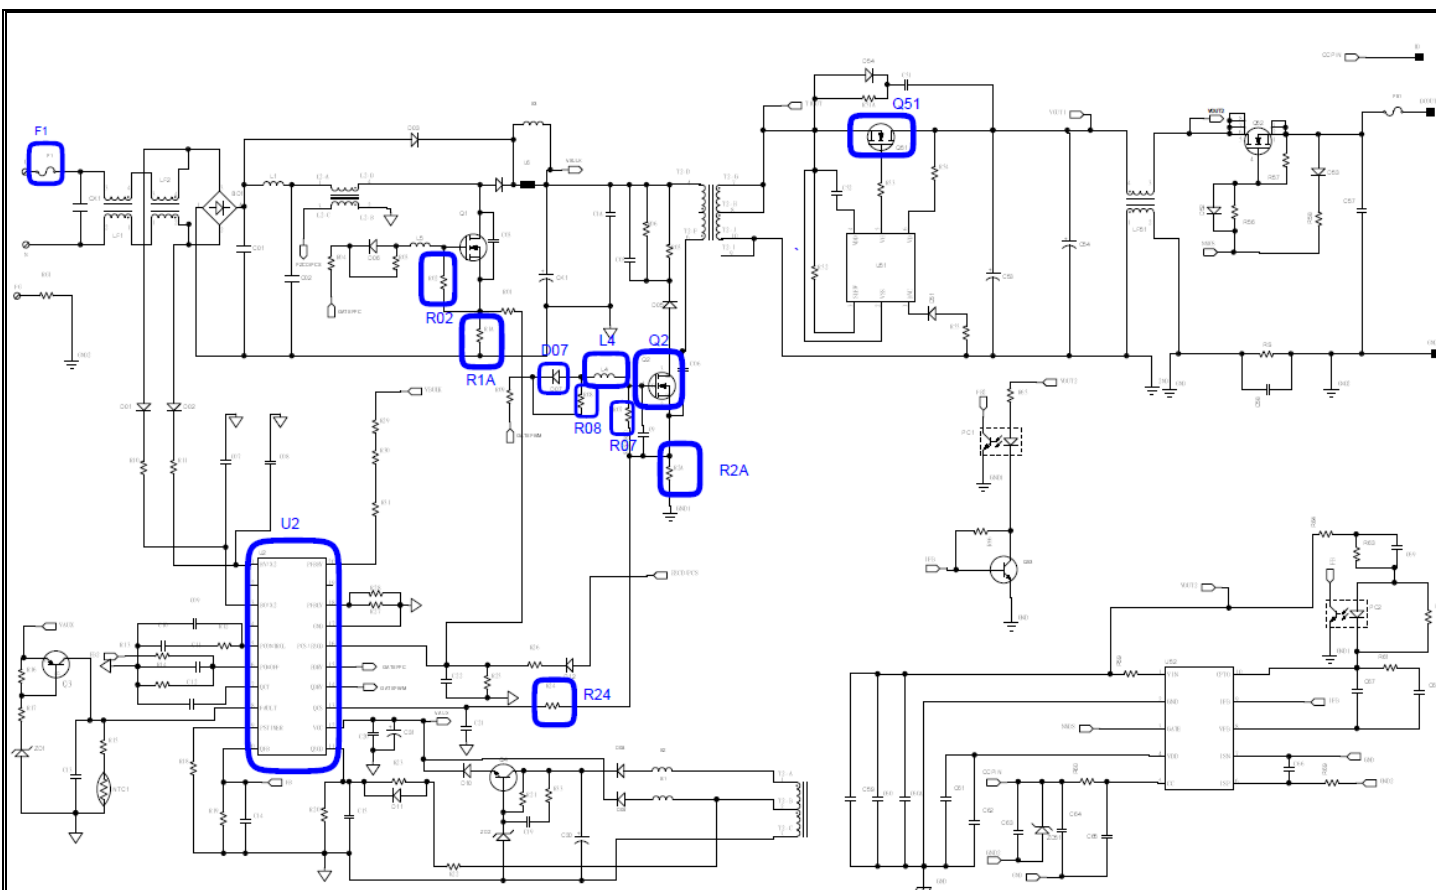
8. Schematic:

6. Measure the circuit of the key components , the result as below(note: red font =fail , green font=Good

7. Repair the product by replacing good components then turn on the adapters , they can be power on normally.
 Burn in the samples for 24hours, they are still normal.

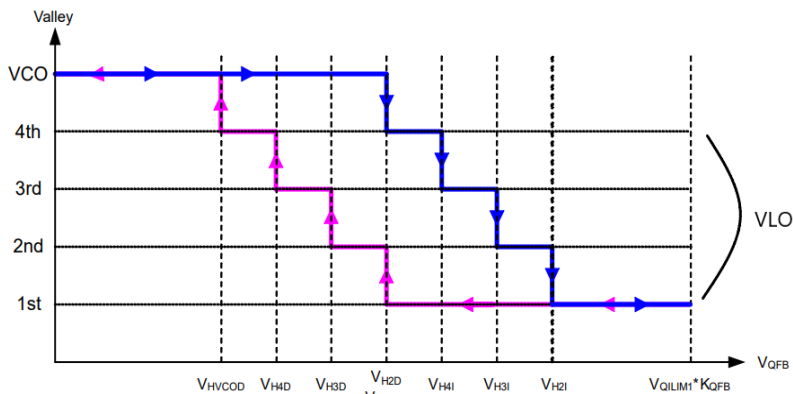
Figure 14. Selected Operating Valley vs. V_{QFB}

2.2 QCS glitch noise is in range from 20 to 30ns, which sums up with QR flyback's real current signal to be > FB/4 to turn off QDRV, i.e. 350-mV when FB is 1.4 V.

If the noise is shorter than 20 ns, it will NOT turn off the QDRV.

If the noise is longer than 30 ns, it will reset both QDRV and valley counter.

3. Compared fail waveform of Chicony, they all met above 4 criteria. (1. In VCO mode at 1st pulse. 2. Qcs had a noise (20ns-30ns) to turn off QDRV. 3. The counted number is 10. 4. The FB is 1.4-1.5V)
