## Eight Discipline Report (8D Report)

To: <b>Customer</b>	8D report No.:
From: : <b>Chicony Power Technology</b>	RMA claim No.:
CC :	Chicony Power P/N: <b>A035R004L</b>
	Customer P/N:
Submit date: <b>2014/09/04</b>	Product description: <b>Adapter 35W</b>
Receive date: <b>2014/09/01</b>	Defect D/C or Lot No.: <b>140628</b>
<b>Subject : Drop test fail 3pcs units(5 , 6, 7) , 由於 PCB &amp; T1 及 CASE 未固定好, 造成有元件損毀, 因此 Drop test 後發生有異音、failed hipot、輸出無法正常切換的問題。</b>

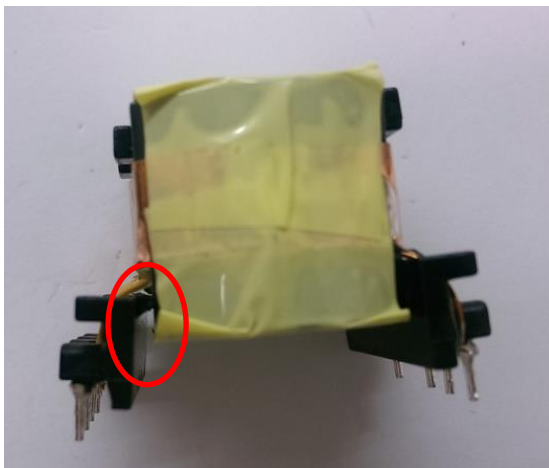
after re-welded

After open the case, we observed the transformer bobbin was broken and the R58 may has cold soldering after drop test. The output voltage was normal 32V after we re-welded the R58.
