Durability of rammed earth walls exposed for 20 years to natural weathering

Q.B. Bui^{a,b}, J.C. Morel^{a,b,*}, B.V. Venkatarama Reddy^c, W. Ghayad^{a,b}

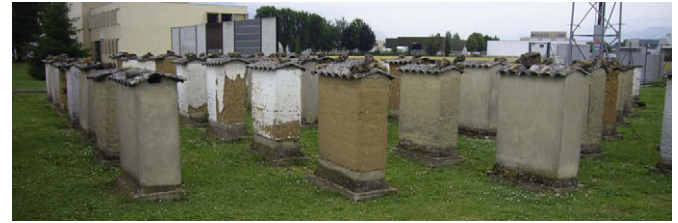
Fig. 3. General view from the south of the walls on the site.

A total of 104 earthen wall specimens were built (Fig. 3) using rammed earth, straw-earth, compressed earth block (CEB) masonry, and vibrated-compressed block masonry. Different types of soils were used for each of these construction techniques. Different types of surface protection methods were tested. This paper focuses on the durability issues of only the rammed earth walls. Fig. 4 shows a map of the rammed earth specimens indicating their positions at the experimentation site. More information on the construction of these wall specimens is given in Rubaub and Chevalier [12].

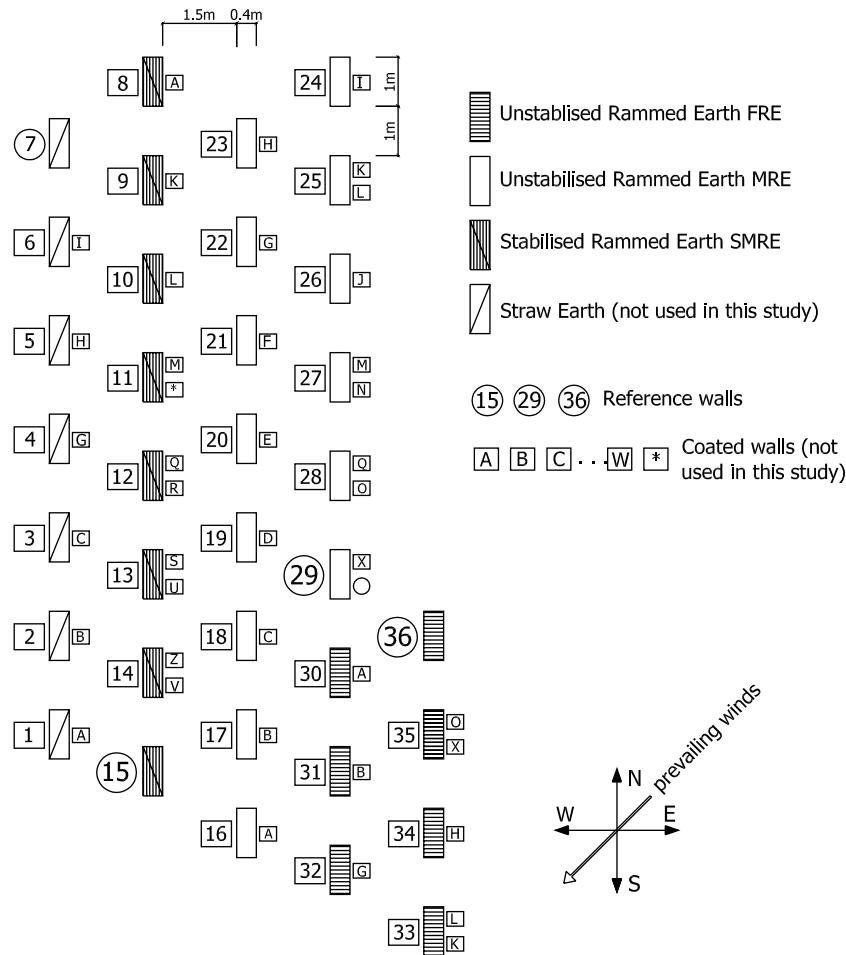
Fig. 4. Plan showing the location of various rammed earth specimens with protective coating details. Several walls were protected by 2 different coating types on each half. The numbers are the wall numbers.

The location of these walls along with the surface protection methods adopted is shown in Fig. 4. Initially, 7 FRE walls were constructed, in which the soil contained too much clay and a high natural water content. Considerable shrinkage was observed in the

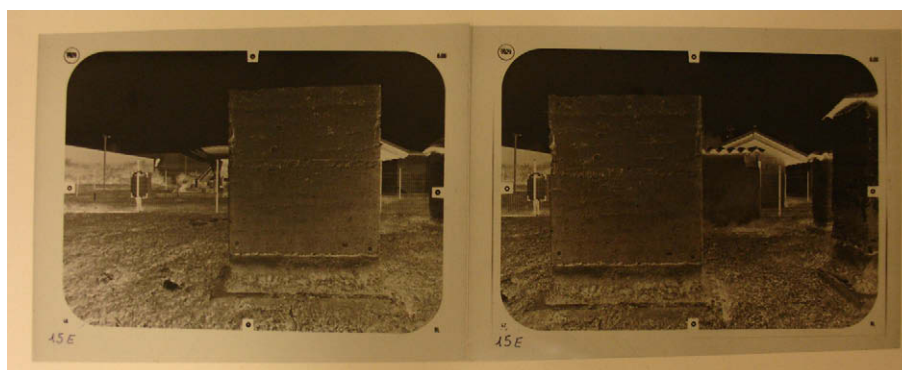
Fig. 9. Two photos taken from two different viewpoints on the same facing East of the wall no. 15. Left: photo taken from a point at left of the wall. Right: photo taken from a point at right of the wall.

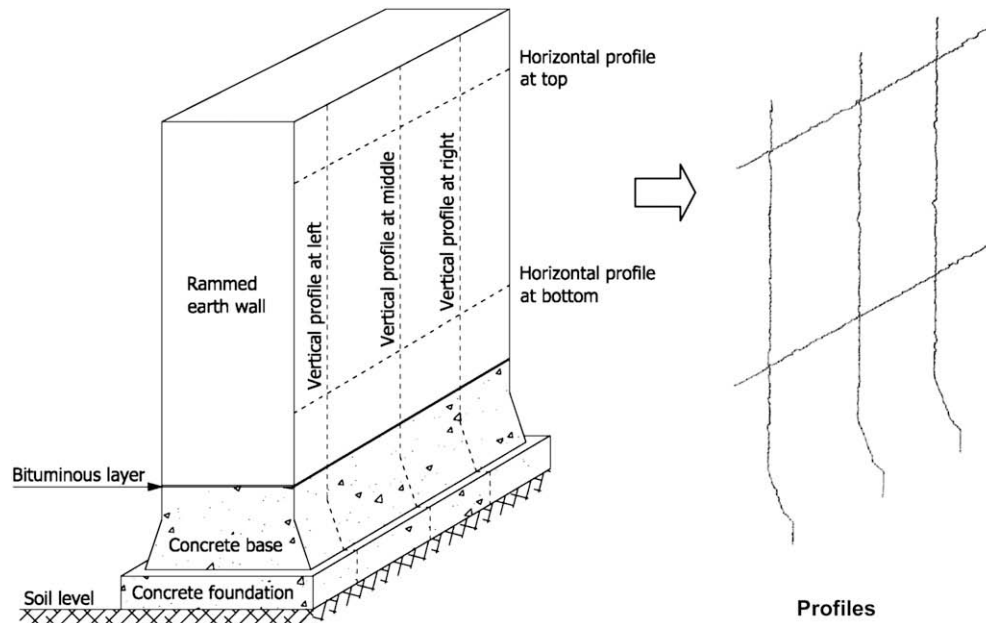
The vertical and horizontal profiles of the walls are plotted from the 3D image of the relief (Fig. 10). To obtain the erosion during the 20 years of exposure, it is necessary to compare the difference between the current relief and the initial relief after the wall manufacturing process. The initial relief soon after construction in 1985 is not available because no record was made at that time. However, it is possible to propose hypotheses on the initial state of the surfaces.

Fig. 10. Vertical and horizontal profiles of a wall.

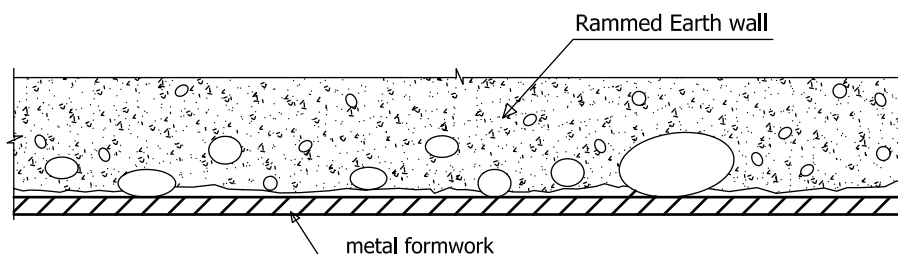
The formwork used for the installation consisted of steel plates, causing us to believe that the original wall surface was flat. It can be assumed that the “reference line” corresponding to the initial position of the wall surface is a line that touches the “summits” of the profile, Figs. 11 and 13. It should be noted that during the examination of the walls condition, pebbles could still be found on the surface of the walls, whereas the “fleur de pisé” had been watched. In practice, the presence of pebbles on the surface of the rammed earth is common due to the use of earth containing coarse gravel during construction. The mason only controls the concentration of big pebbles on the surface where fine particles of earth cannot fill the spaces between the pebbles, creating holes on the surface. With a length long enough for each profile (around 1 m), a number of non-eroded parts of the wall surface can be observed. By observing the profiles and tracking them, it is possible to determine the non-eroded positions of the wall surface, since the footprints of the formwork on which the reference line passes are still visible.

Fig. 11. Hypothesis of the reference line determination.

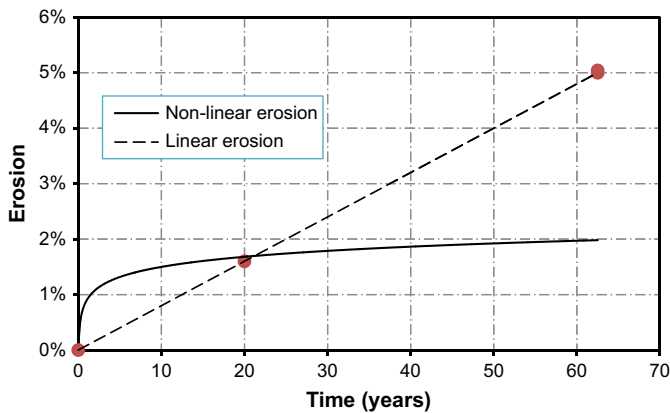
Fig. 14. Difference between linear and non-linear erosions with time.

However, there have not been studies researching this non-linear function. In this study, we have only data at the initial time (time = 0; erosion = 0) and at the time of this study (time = 20 years; erosion = 1.6%, case of unstabilised rammed earth). So, it is impossible to estimate exactly the lifetime of these walls by a non-linear function. Therefore we must try with the linear function. If we use the linear function of time for the erosion of the unstabilised rammed earth walls, 62.5 years should be required before these walls are eroded to 5% thickness (Fig. 14). The non-linear erosion curve in Fig. 14 is only an example of the non-linear possible behaviour of erosion that is often observed empirically in reality [17], but there is still no scientific researches giving an exact function. However, with this non-linearity aspect of erosion depending on the time, we can see that lifetime of these unstabilised rammed earth walls may be much longer than 62.5 years.
