Railway Accident Investigation Unit

INVESTIGATION REPORT

**Rock fall at Plunkett Station, Waterford,
31st December 2013**

RAIU Report No: R2014 – 006

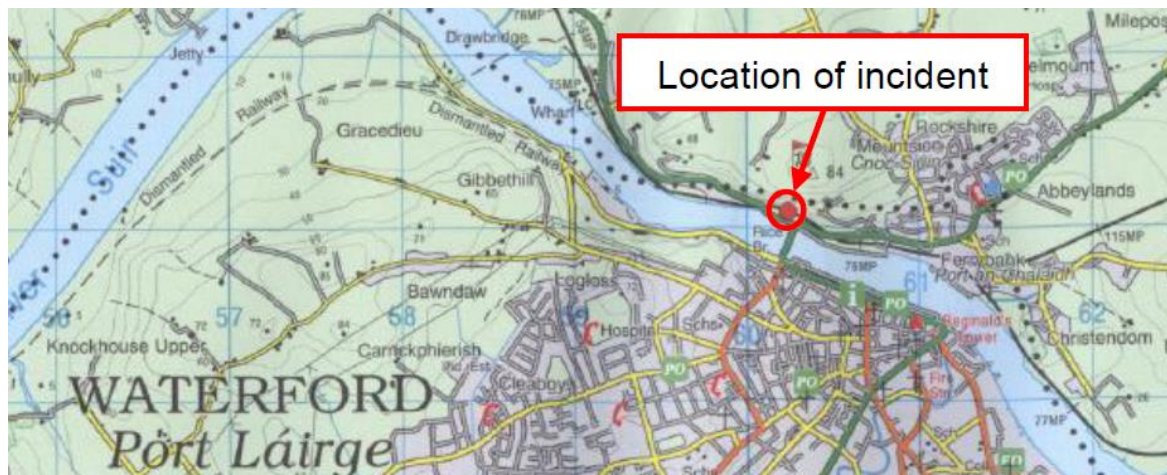
Figure 1 – Location of incident

- 1 At approximately 18:45 hrs on Tuesday 31st December 2013 the Signaller at Signal Cabin, at Plunkett Station (Waterford) heard a loud rumble from outside, see Figure 1 for the location of the incident.

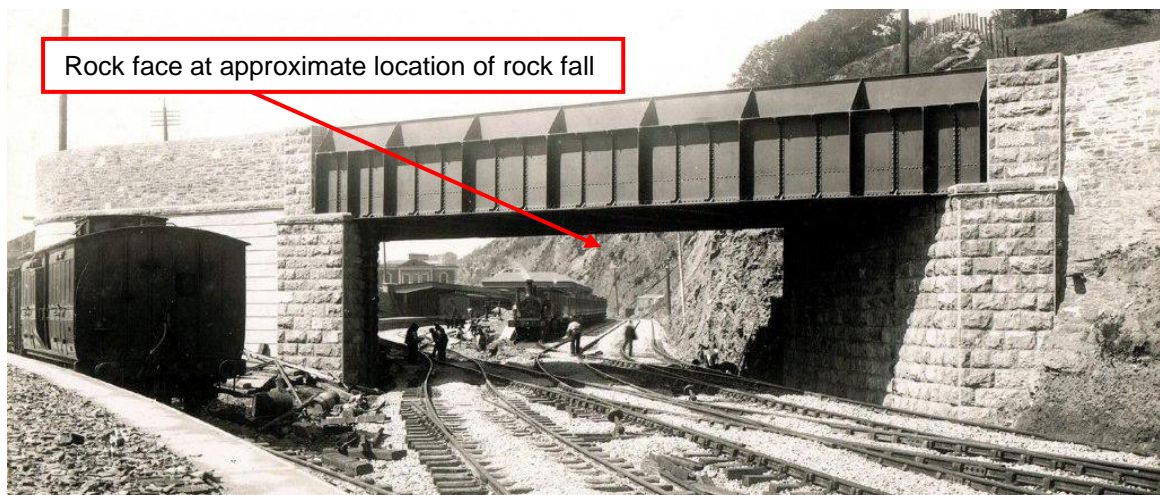
Figure 3 – 1905 photograph of Plunkett Station, including Mount Misery

- 7 Plunkett Station, Waterford, is located at the 75 $\frac{3}{4}$ milepost (MP), measured from Mallow via Fermoy, on the Mallow to Rosslare Line on the banks of the River Suir. The station consists of four tracks running through the station and four platforms (3,4,5 & 6), with the Signal Cabin situated at the Dublin end of Platform 4.
- 8 In 1864, to facilitate the building of Plunkett Station, rock from the Mount Misery rockface was excavated. In 1905 further excavation was carried out to facilitate the Plunkett Station extension works and additional Fishguard & Rosslare Railways and Harbours Line, see Figure 3.
