STATE COMMISSION ON RAILWAY ACCIDENT INVESTIGATION
Ministry of the Interior and Administration

REPORT No. PKBWK 4/2024

on the investigation of a railway incident
which occurred on 8 May 2023 at 07:26 hrs on the Góra Włodowska – Zawiercie route,
track no. 1, km 212.400 of railway line no. 4 Grodzisk Mazowiecki – Zawiercie,
the area of the infrastructure manager PKP PLK S.A. Railway Line Plant
in Częstochowa

Warsaw, 18 March 2024

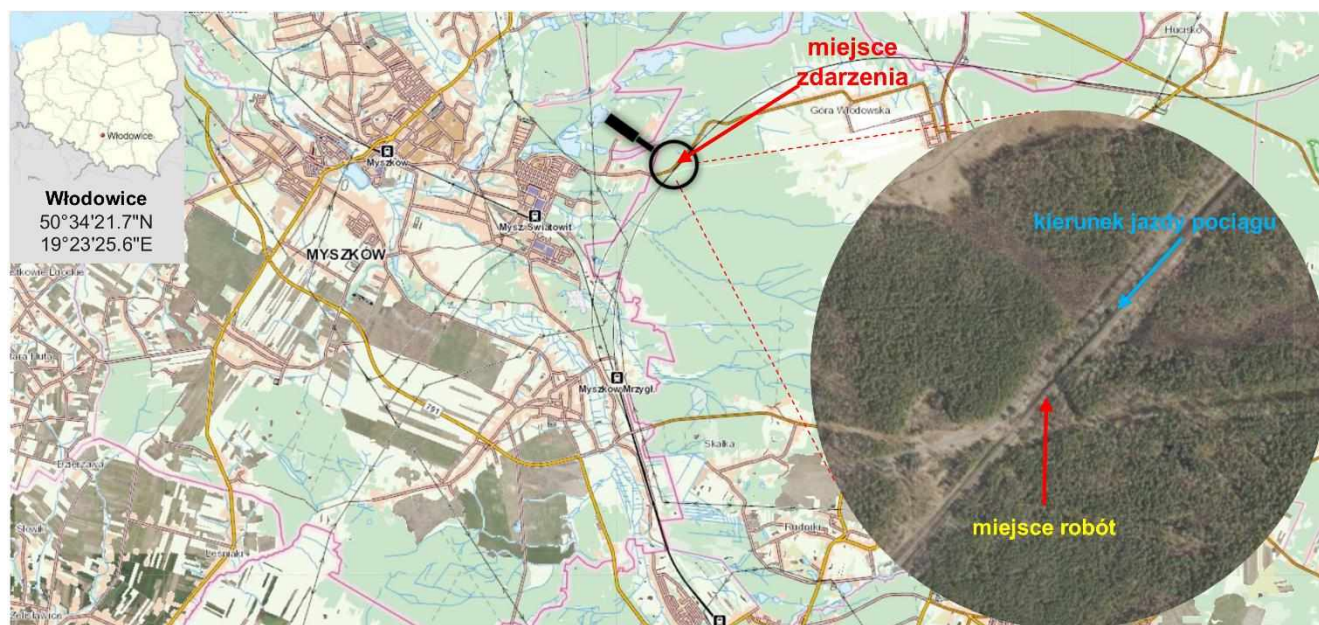
Figure 1 - A general view of the occurrence site (source: Geoportal)

Track no. 1 of the Góra Włodowska – Zawiercie route: contactless, at the place of the occurrence - situated on a straight embankment in a forested area, 5.79 ‰ inclination in the direction of travel. Weather conditions: time of day - morning, moderate cloud cover, no precipitations, temperature +8 °C, good visibility, good audibility, no other weather phenomena. The investment works carried out on that route are related to the modernisation of line no. 4. On the day of the occurrence, preparatory works were in progress involving dismantling the rail attachments.

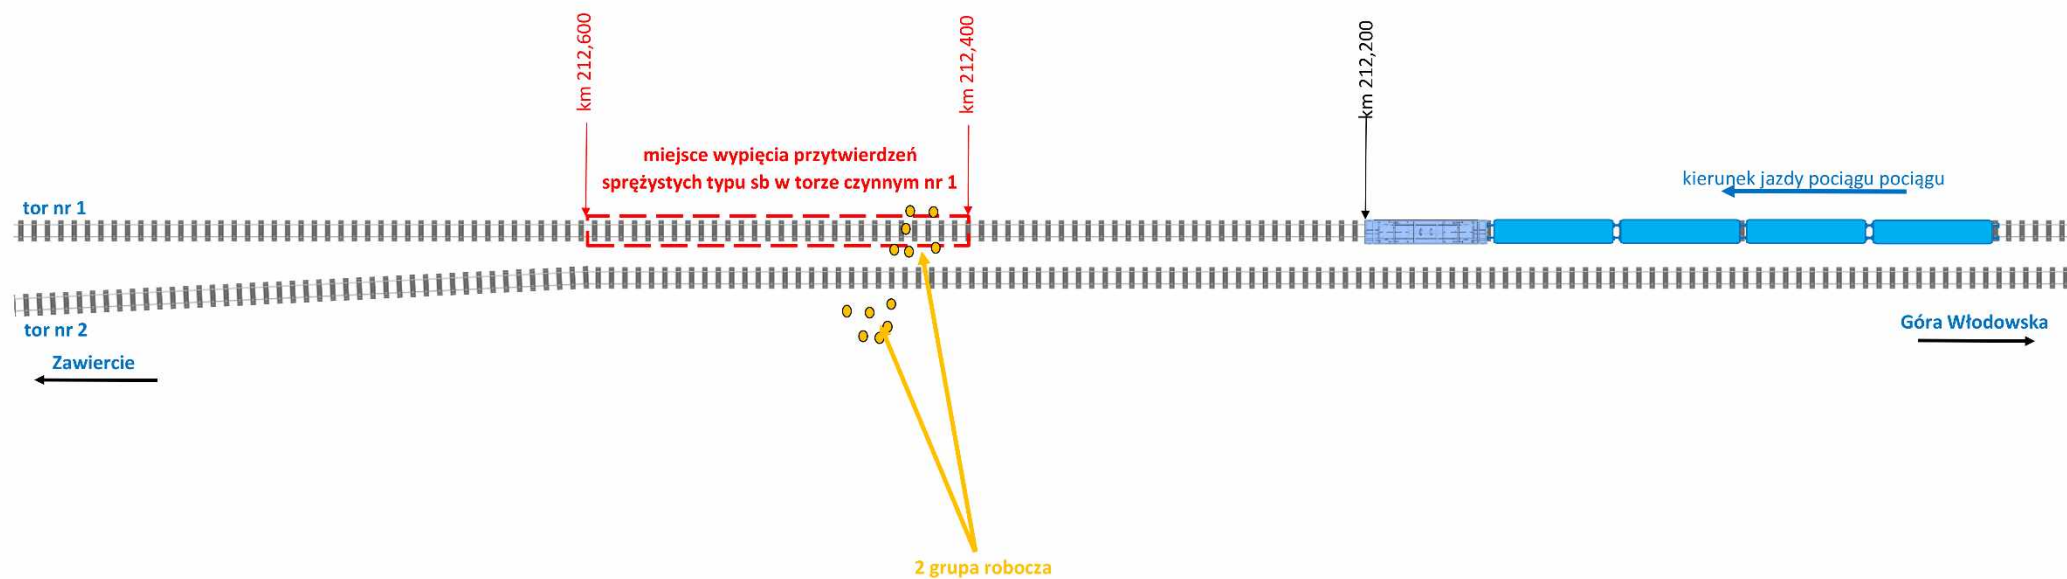
Figure3 - A sketch of the place of the incident

The occurrence concerned involved performance of works on active track no. 1 of the Góra Włodowska – Zawiercie route instead of track no. 2 which was closed for train traffic. Train no. 14001 stopped at km 212.200, ca. 200 m ahead of a work group. The occurrence did not result in injuries or damage to the infrastructure or rolling stock.

Approaching the work site from the side of track no. 1, group 2 (see Fig. 2) was the first to arrive and immediately, at 07:00 hrs, commenced dismantling (disengaging) the rail attachments in active track no. 1, instead of closed track no. 2. The work progressed in the direction of the line's ascending chainage. That group had managed to disengage ca. 200 m of track no. 1 when the third group arrived on site. Noticing that the second group was disengaging track no. 1, the supervisor of the third group notified the work organisation manager immediately by telephone, and the latter ordered the trackmaster in the second group by mobile phone to start re-engaging the rails in the track. Meanwhile, at 07:24 hrs, train no. 14001 departed the Góra
