**Railway Accident
Investigation Unit**

INVESTIGATION REPORT
Vehicle struck by train at Corraun level
crossing, XX024, Co. Mayo,
12th February 2014
RAIU Report No: R2015-001
Published: 30/04/2015

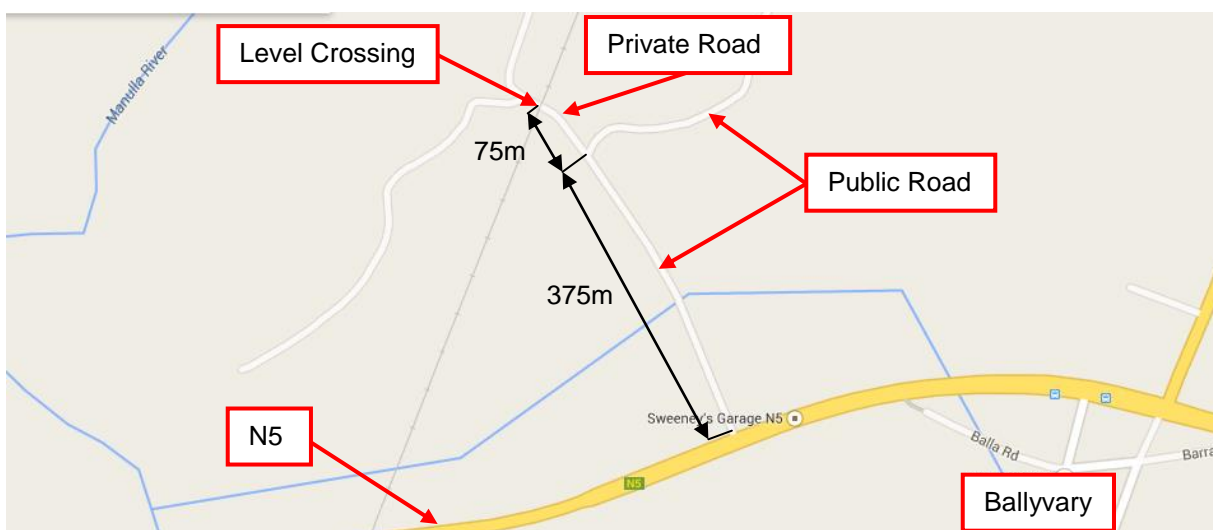
Figure 7 – Access roads to Level Crossing

43 The Level Crossing is located 450 m from the N5, the national road from Castlebar to Swinford, see Figure 7.

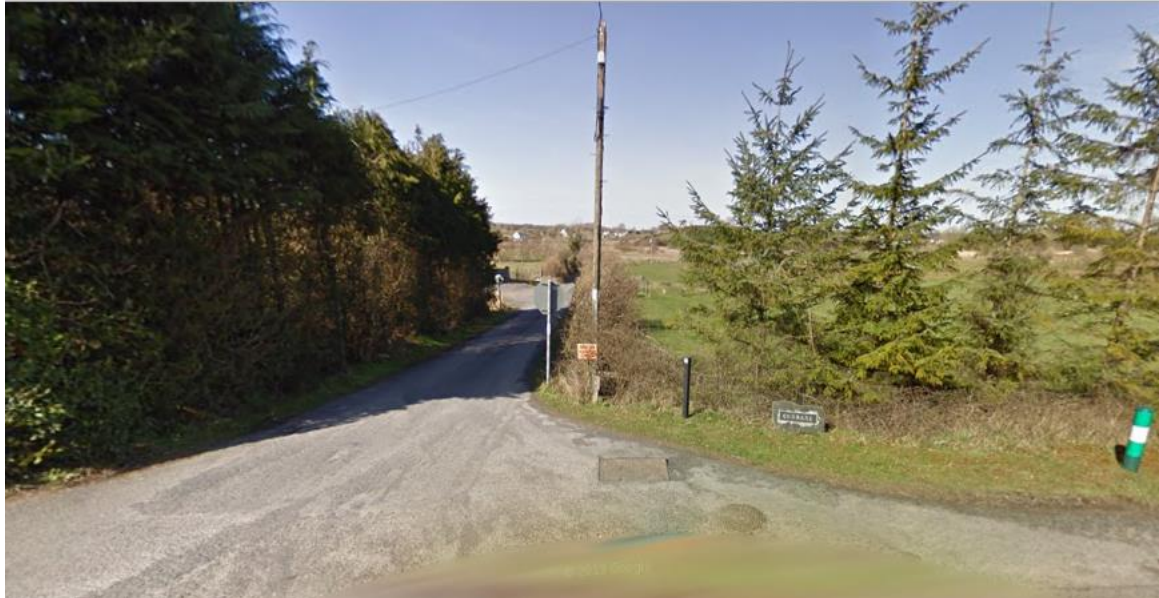
Figure 8 – View from National Road (N5) onto Third Class Public Road (Public Road)

- 44 The third class public road L57721 (identified as 'Public Road' in Figure 7) is accessed from the N5 National Road and runs a distance of 375 m to the access point of the private road (identified as 'Private Road' in Figure 7), see Figure 9.

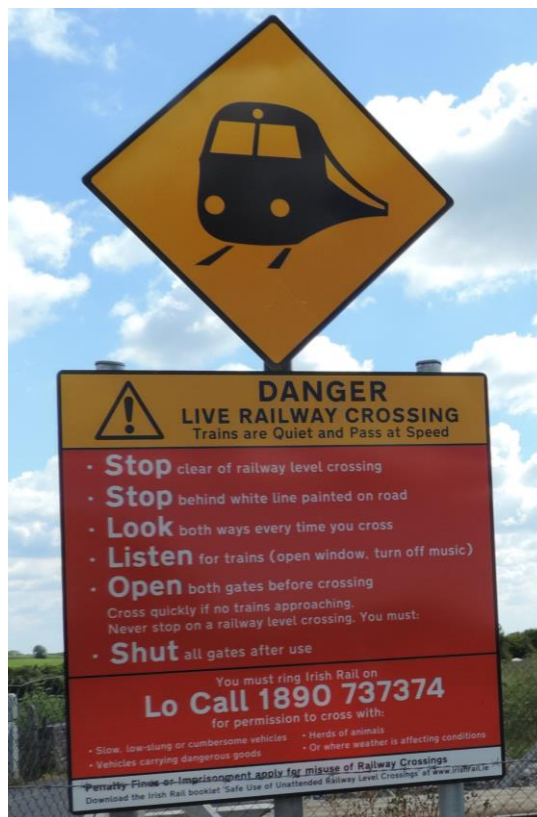
Figure 12 – New signage

59 On foot of the NTTX report, IÉ developed new signage in conjunction with their consultants (NTTX Ltd) in Figure 12. This signage is currently undergoing a trial period, at a number of level crossings, such as XM240. (The trial is still on going at the time of publication.)

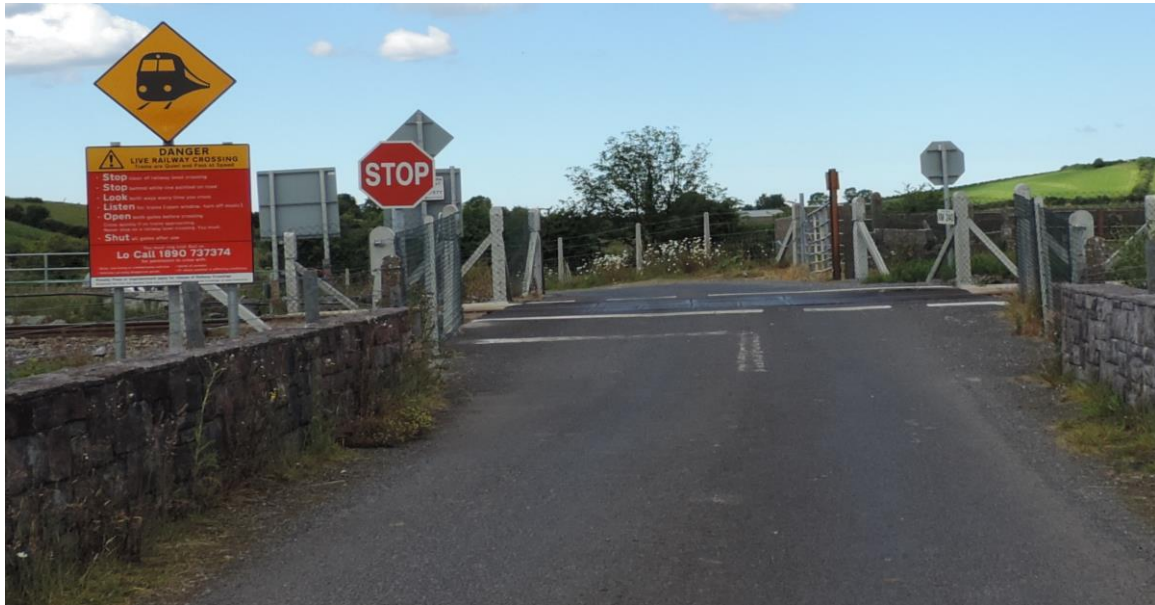
Figure 13 – New signage on trial at Level Crossing XM240

- 60 It can be seen that only the new signage and Stop sign is now present at the new type level crossings, see Figure 13.

- 61 As this signage is still undergoing its trial stage, the RAIU safety recommendation remains open by the Railway Safety Commission pending the outcome and assessment of the trial programme.
