**Railway Accident
Investigation Unit
Ireland**

INVESTIGATION REPORT

Wrongside Door Failure at Ashtown Station,

RAIU Report No: 2019 – R001

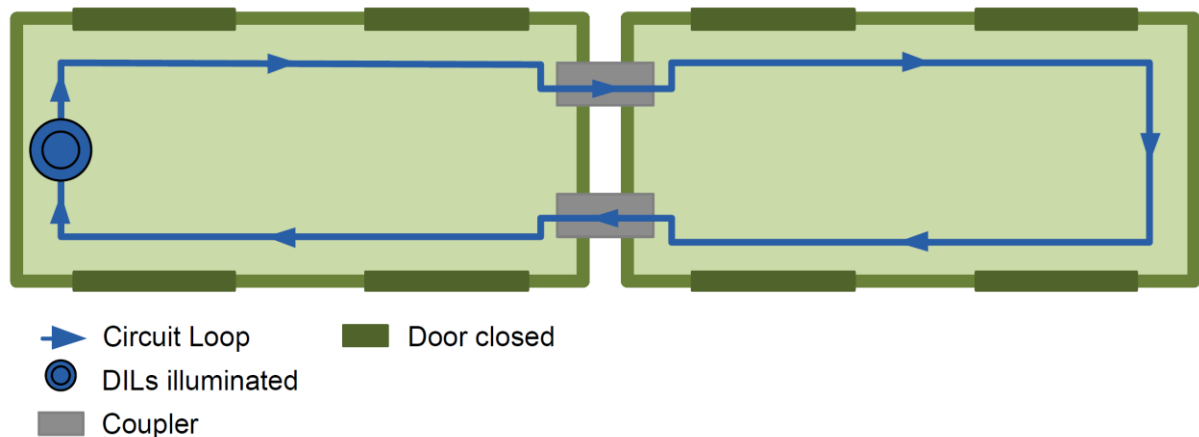
Figure 7 – Door Interlock Loop with illuminated DIL

- 37 When the passenger doors are closed on all the cars, the door interlock loop signal flows throughout the cars, completing the loop. This in turn illuminates the blue DILs in the driving cab (Figure 7) and extinguishes the external amber lights. This verification of the doors being closed energises the traction interlock relay, allowing the train driver to take power.

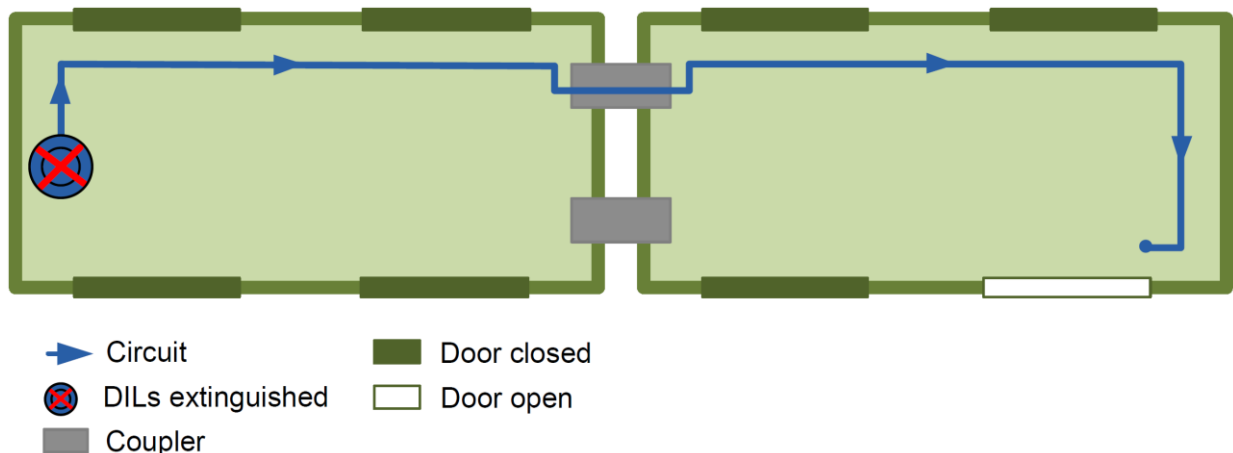
Figure 8 – Door Interlock Closed Circuit not returned with DILs remaining extinguished

- 38 Therefore, if a door remains open, the Door Interlock Circuit does not form a complete circuit, and the blue DILs remains extinguished in the driver's cab, see Figure 8.

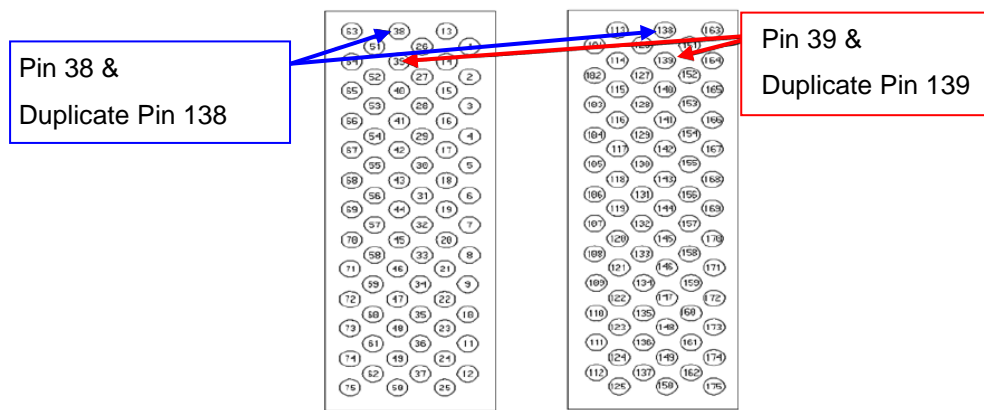
Figure 10 – Electrical Pin 38 & Pin 39 (and Pin 39 duplicate, Pin 139)

- 45 The electrical coupler heads operate in duplicate, i.e. there is a duplicate wire in the opposite coupler head for each pin. Figure 10 shows a front external view of the electrical coupler heads with the associated pins, Pin 38, Pin 39 (and an example of a duplicate pin, Pin 139).

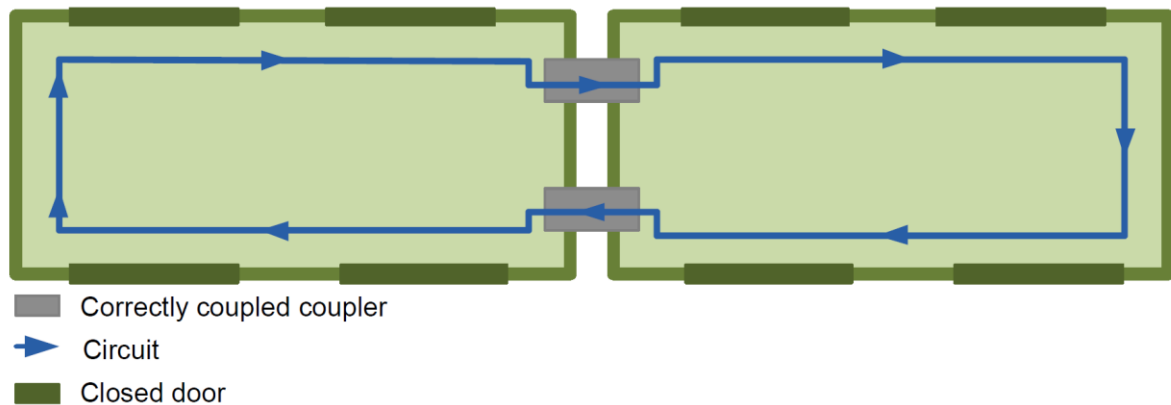
Figure 11 – Coupled units, with open contacts and Door Closed Indication Circuit

- 46 The joining of the electrical autocoupler heads, when coupled correctly, allows opposing pins to connect, which in turn opens the spring-loaded normally-closed contacts; allowing the current to flow through to the next carriage, see Figure 11; and throughout all the coupled cars.

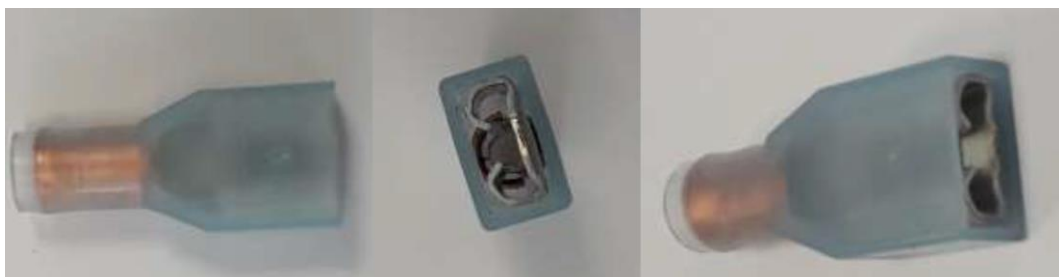
Figure 12 – Example of push-on crimp spades usually used on the 29000 DMU fleet

- 47 The rear of the electrical head contains male spades (to be referred to as spades for the remainder of the report) which allow the connection of female push-on crimps (to be referred to as crimps for the remainder of the report), see Figure 12. The crimps hold the cables, which feed the required circuits through the coupler.
