**Railway Accident
Investigation Unit
Ireland**

INVESTIGATION REPORT

**Dangerous occurrence involving a Double SPAD at
Clontarf Road Station,**

RAIU Investigation Report No: 2023-R001

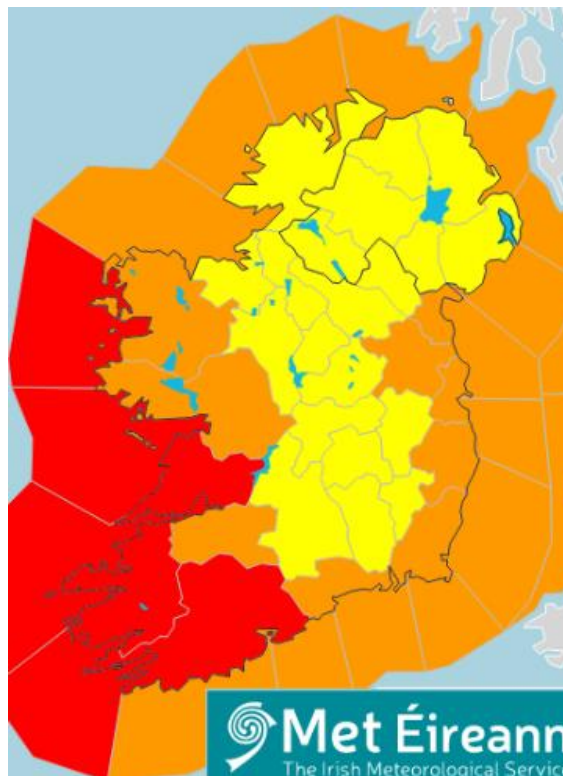
Figure 1 – Storm Barra weather warning

20 Storm Barra was travelling across the country with the worst hit counties to the south and west of Ireland, see Figure 1. There was a “Status Orange – Wind” warning for Dublin (meaning the weather conditions have the capacity to impact significantly on people in the affected areas. The issue of an Orange level weather warning implies that all recipients in the affected areas should prepare themselves in an appropriate way for the anticipated conditions).

24 The weather conditions were likely causal factor to the incident (CaF-02, see paragraph 188).

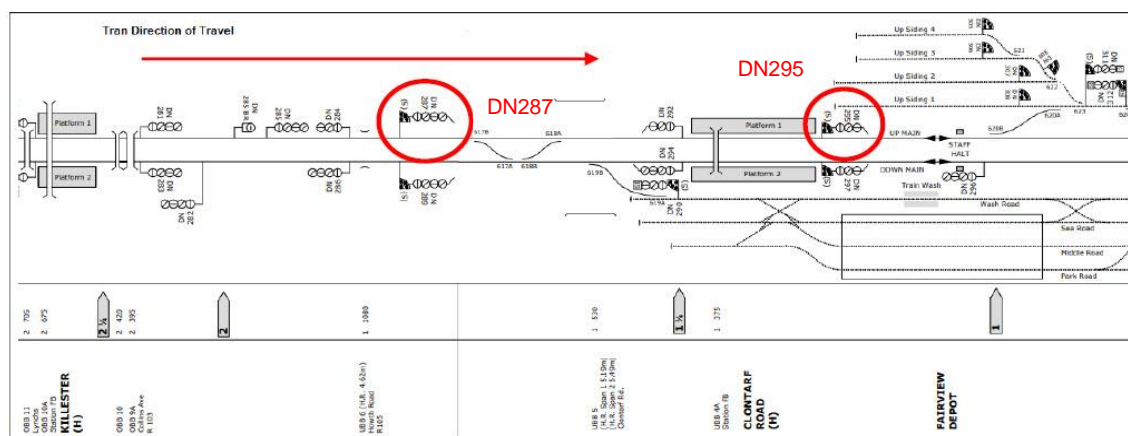
Figure 8 – Signal diagram

- 62 Figure 8 shows the signal diagram, note the direction of travel of Train E240.

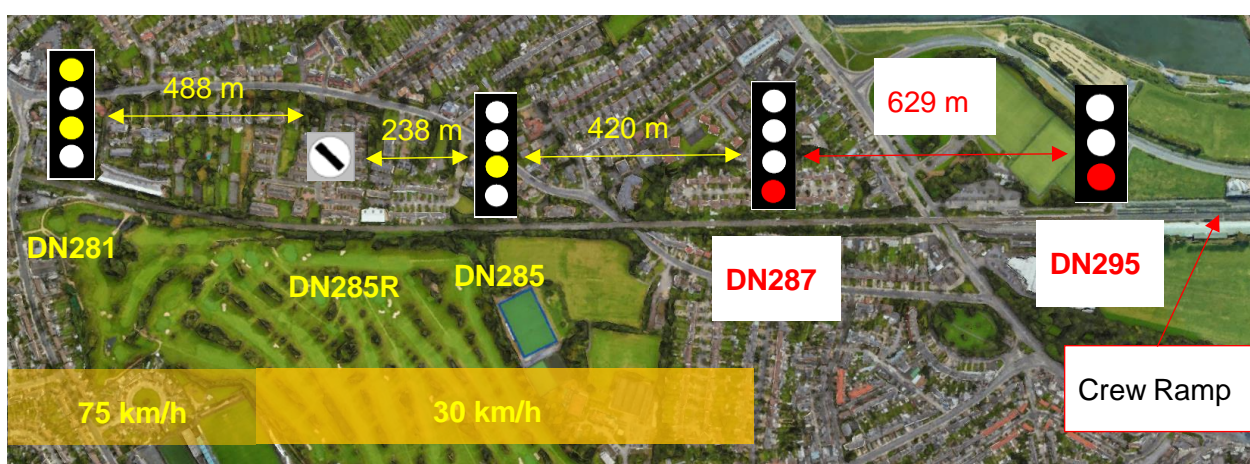
Figure 9 – Signal and speed locations

63 The signals passed at Stop (Signals DN287 and DN295) and the preceding signals located on the Up road between Killester and the Crew Ramp at Fairview are as follows (see Figure 9 for locations, note that the figure is for illustrative purposes only):

- Signal DN281 is the first signal after leaving Killester;
- Signal DN285R is the repeater³ for Signal DN285 and is located 488 m after Signal DN281;
- Signal DN285 is 238 m after Signal DN285R;
- Signal DN287⁴ is 420 m after Signal DN285 at the north end of Clontarf Road Station;
- Signal DN295⁵ is 629 m after Signal DN287 at the south end of Clontarf Road Station.

- 64 The DCCR layout change resulted in a reduction of 0.596 km in the position of the first cautionary aspect (Signal DN281) protecting a train stopped at Fairview Ramp and trains would now be permitted to travel at 75 km/h on a Double Yellow leaving Killester, compared to the previous 50 km/h for a single Yellow⁶ (see Figure 9).

- 65 The speed downgrade from 75 km/h to 30 km/h on approach to Signal DN285R (see Figure 9) complies with IÉ standards, I-SIG 2145, Calculation of Signal Spacing Distance, Issue 1, published in 2006).

- Safety Recommendation 2023001-06 – IÉ-IM Signalling, Electrical and Telecommunications (SET) should undertake a review of I-SIG-2145, Calculation of Signal Spacing Distance, to consider if the risk approaches identified in the standard are effective in relation to the calculation of the spacing of signal distances, in particular, in relation to sharp speed decreases on the approach to signals and consideration should be given to incorrect driving techniques (i.e. driving into the bonds). A review of the use of derogations should also be undertaken.

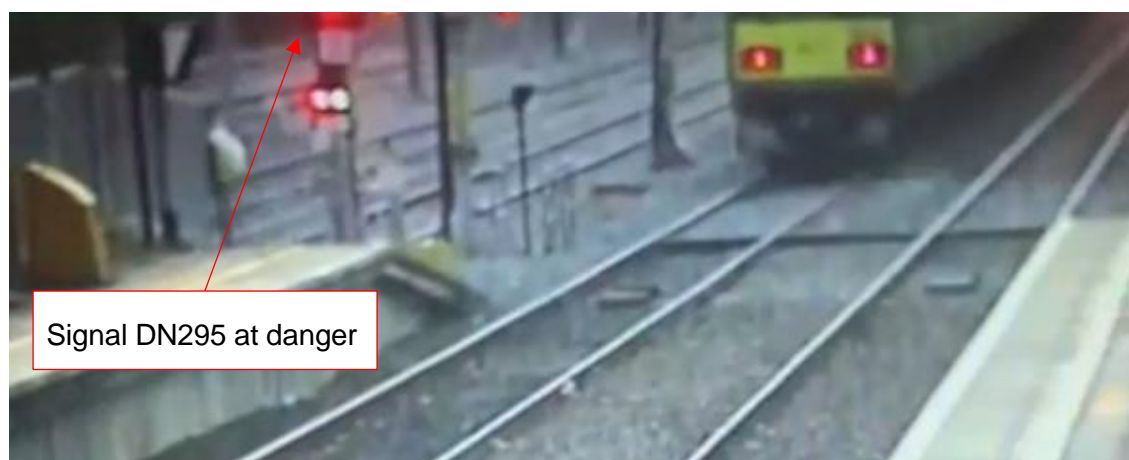
Figure 18 – Train E120 stationary at the Crew Ramp, Fairview

- 152 At 16:03 hrs Train E240 passed Signal DN287 at danger.
- 153 At 16:03 hrs, Train E120 was stopped at the Crew Ramp at Fairview (see Figure 18, the following figures are taken from Clontarf Road Station CCTV). Note Signal DN295 displaying at red aspect to protect Train E120.
