**Railway Accident
Investigation Unit**

INVESTIGATION REPORT
Vehicle struck by train at Cartron level
crossing, XM220, Co. Mayo,
17th August 2018

RAIU Report No: 2019 – R003
Report Published: 03/09/2019

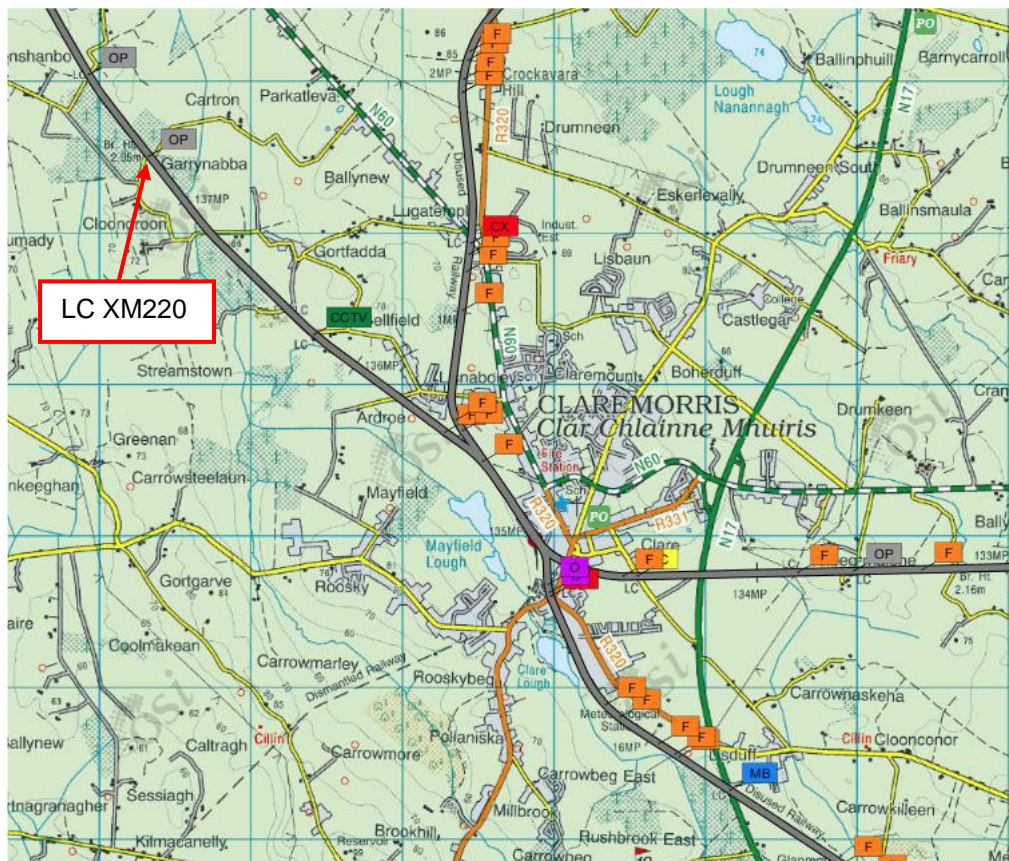
Figure 1 – Location of the accident

- 1 At approximately 08:47 hrs on Friday the 17th August 2018, an Isuzu Light-Duty Truck (to be referred to as a Truck for the remainder of the report) drove onto Cartron Level Crossing, XM220 (which will be referred to as the LC XM220 for the remainder of the report), see Figure 1. The Truck was on-hire by Mayo County Council and the driver (to be known as the Truck Driver for the remainder of the report) was an employee of Mayo County Council.

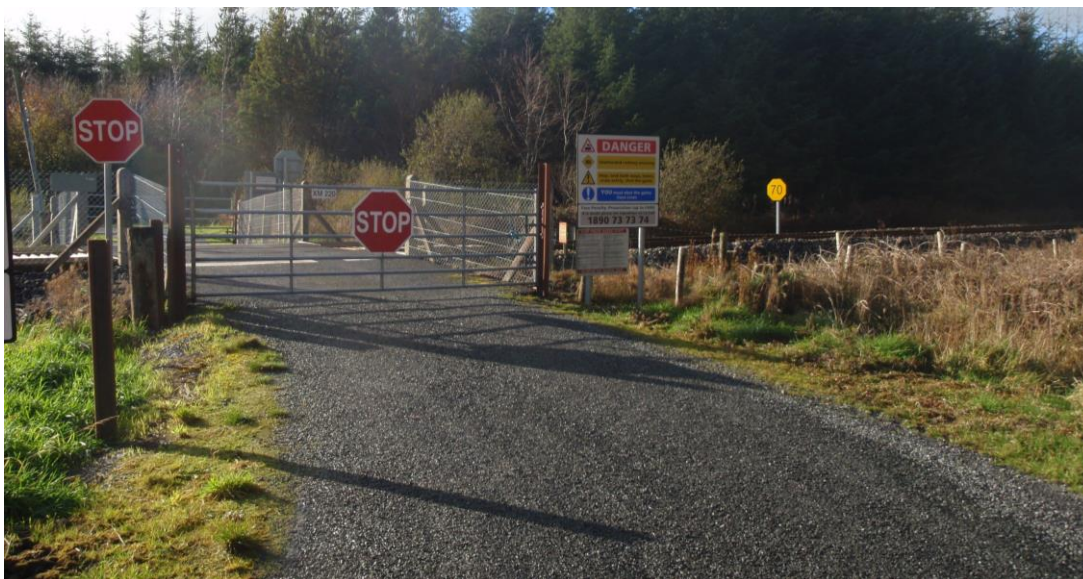
Figure 3 – Cartron Level Crossing, LC XM220

- 6 LC XM220 is situated approximately 2 miles and 373 yards (3.56 kilometres (km)) from Claremorris Station on the Down approach. The road access for LC XM220 is from an unrestricted third class public road, L55381, located off the N60 (Castlebar – Claremorris (County Mayo) adjacent to Lugatemple (County Mayo), to which the public have unrestricted access, see Figure 3. The third-class regional road has a speed limit of 80 kilometres per hour (km/h).

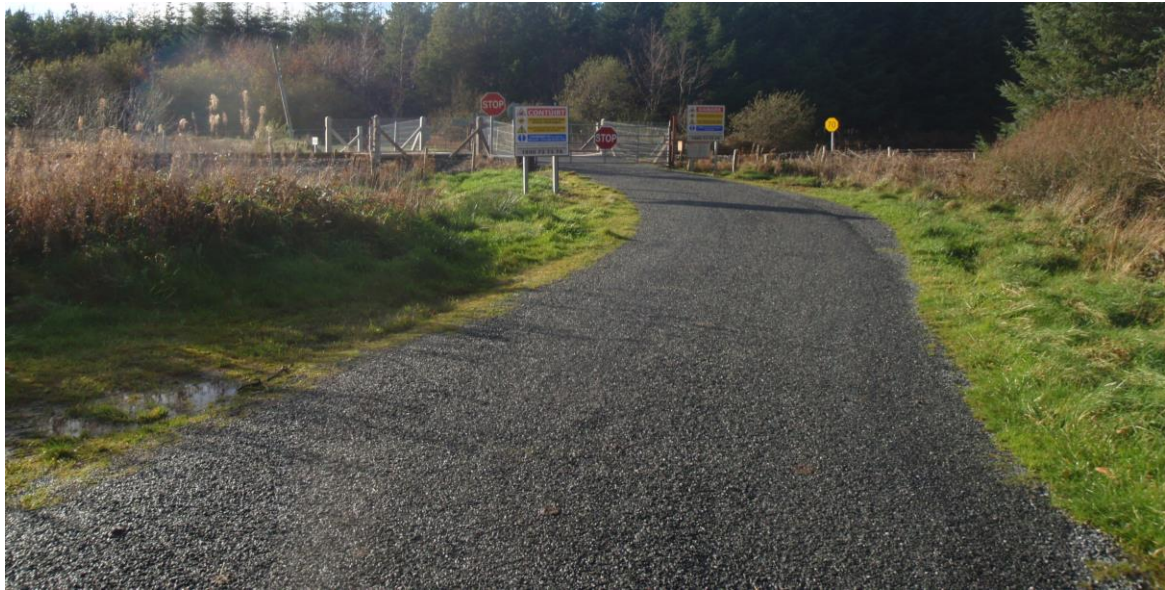
Figure 7 – View from public road L55381 on approach to XM220

- 40 LC XM220 is located on local road, L55381, which runs from the N60 to Streamstown and through Gortfadda. The road way where it meets the level crossing runs in a southwest direction with the railway line running north west to south east, see Figure 7.
- 41 The road has a tar and chip surface that was laid recently and has a speed limit of 80 km/h.

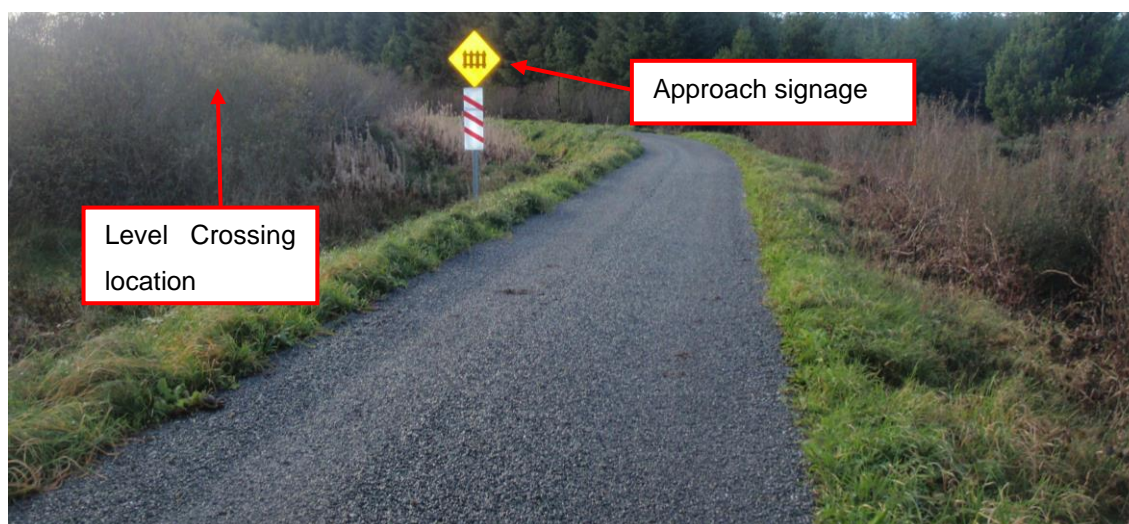
Figure 10 – Access to LC XM220 from L55381

- 46 The advance warning signage on the approach to LC XM220 is the responsibility of Mayo County Council in line with the Traffic Signs Manual (paragraph 44); and are verified to be in place, annually, by IÉ-IM. There are three advance warning signs on the approach at 100 m intervals, see Figure 10 for one of the signage posts 300 m in advance of LC XM220, where it can be seen there is no illustration of a train (unlike other level crossing signage (paragraph 45)).

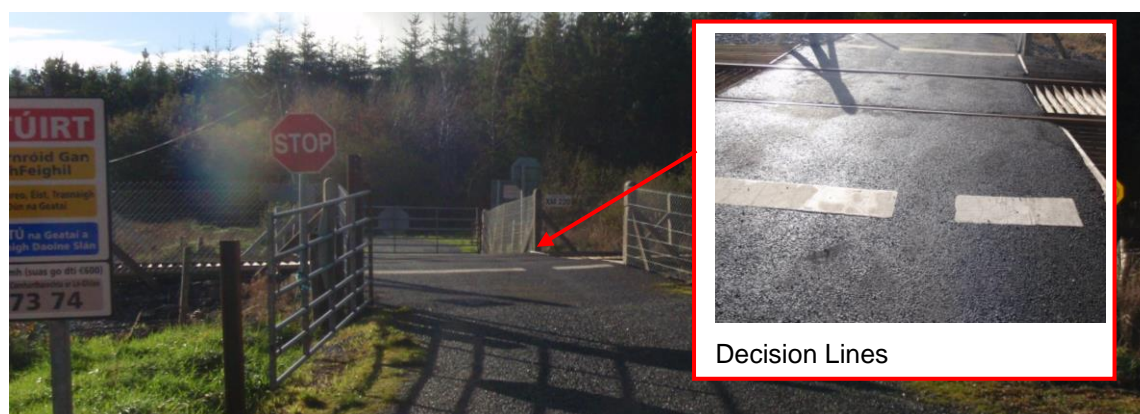
Figure 15 – Approach to XM220 with Decision Line

- 56 This Decision Line is a 300 millimetres (mm) continuous white line which is painted from the left edge to a point, two-thirds across the roadway. and continues as a broken white line to the right edge of the roadway. The line is located approximately 2 m from the running edge on each side of the level crossing road approaches, see Figure 15.

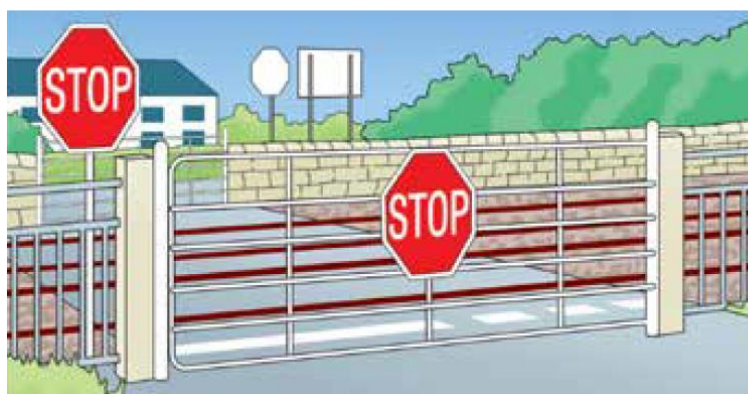
Figure 21 – Unattended Level Crossing Illustration

- 75 It is noted that the Rules of the Road illustration depicts the Decision Line but does not outline its purpose. No other signage (IÉ-IM signage) is depicted in the illustration.
- 76 The document states that “these unattended level crossings are found on minor roads. The railway is normally guarded by iron gates which must be kept shut – there is no other protection. The user has the responsibility to open and shut the gates. It's the law”. It continues: “These crossings can be dangerous to use, and drivers **should** use all available help to cross safely. It is preferable for drivers to use a bridge or an attended or automated level crossing where one is available”.
