# Safety Investigation Report

## Double overrunning of signals by an international train Antwerpen-Luchtbal - 1 November 2015

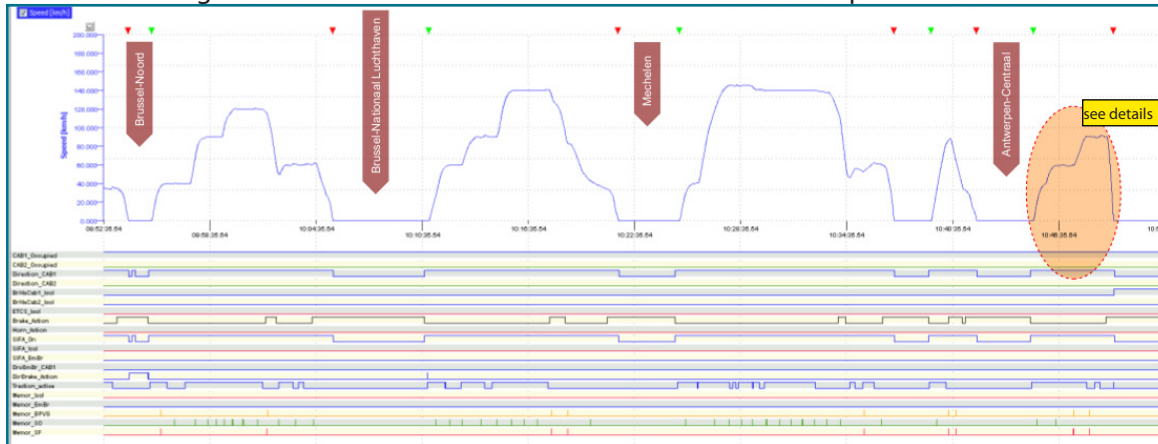
The data relating to the route of the train E9227 on 01/11/2015 are explained below:

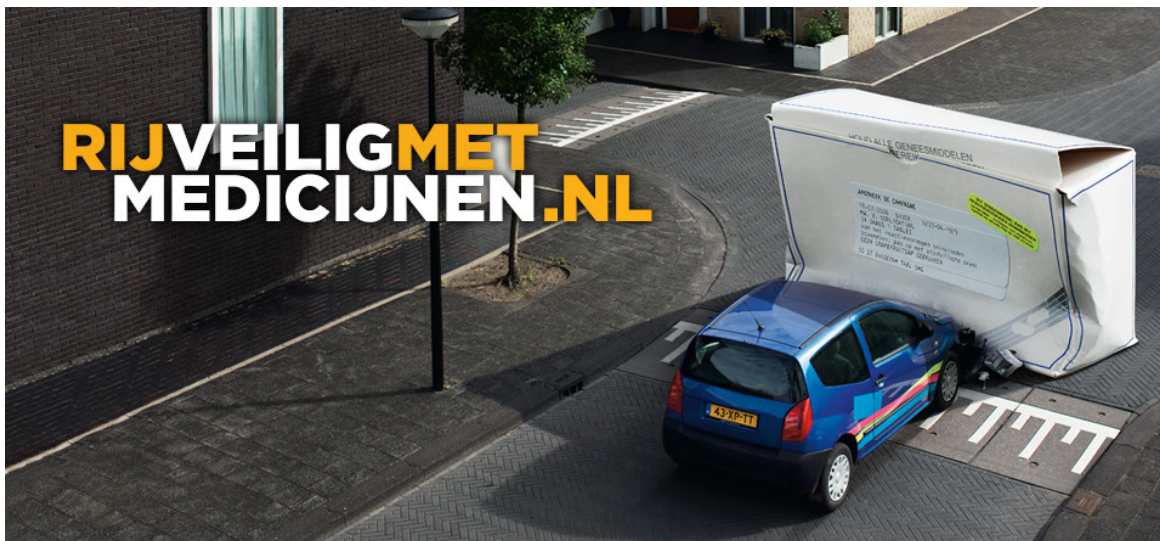
Information on the potential effects of medication on driving can be found in the directions for use included with the medication. In the Netherlands, it is possible to identify banned medications very simply: a yellow label (see photo) is affixed to the packaging of the medication concerned.

On 1st November 2015, the train driver took a medicine that was considered as safe by colleagues. What is more, on the instructions of the medication taken by the driver it is written:

***The DRSI should ensure that railway undertakings take into account the identified risk linked to the taking, prior to driving, of medicines not considered as unsafe but, which have an effect over a limited time, and which can nonetheless have a negative effect on driving.***
