# **Railway Accident Investigation Unit**

## **INVESTIGATION REPORT DART Wrongside Door Failure, Salthill & Monkstown Station, 10<sup>th</sup> August 2013**

**RAIU Report No: R2014 – 003  
Report published: 30<sup>th</sup> July 2014**

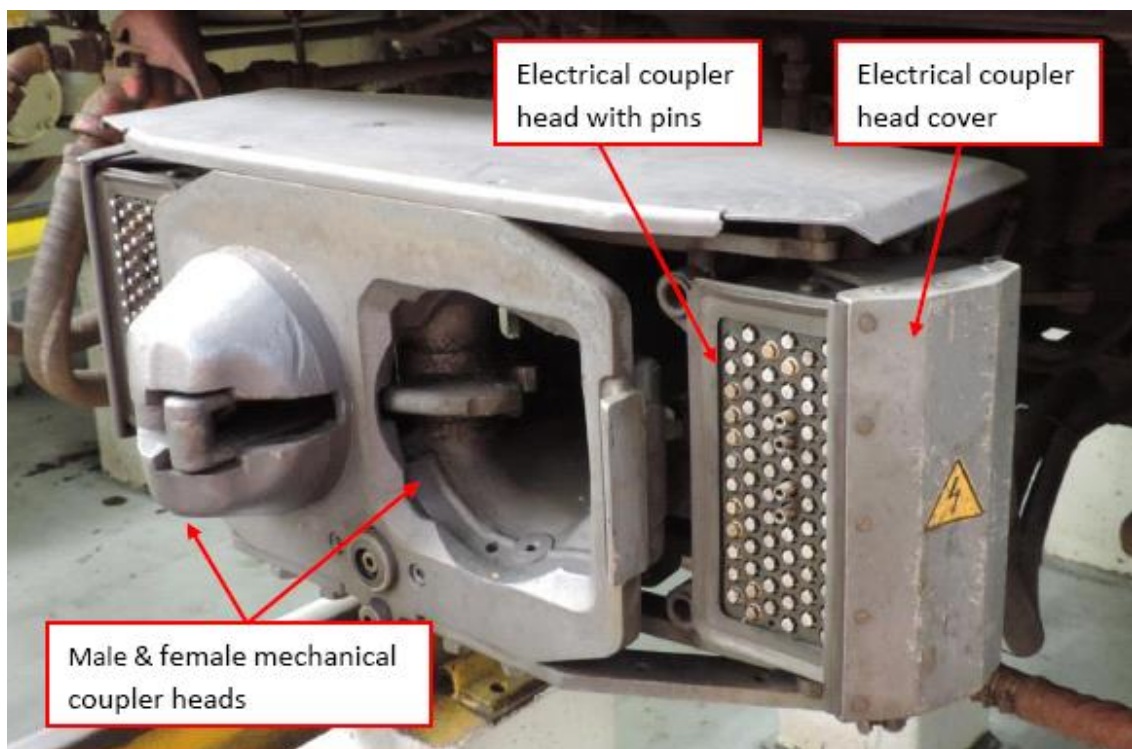
**Figure 4 – Scharfenberg autocoupler**

26 The autocoupler associated with the incident is the Scharfenberg autocoupler. To couple mechanically, the mechanical heads are moved towards each other, with mechanical coupling achieved when the mechanical heads engage. Simultaneously, pneumatic cylinders operate the electrical heads, allowing the electrical pins make contact with the opposing electrical coupler head pins to complete electrical coupling.

27 See Figure 4 for an example of the autocoupler involved in the incident, with the mechanical and electrical mating parts.

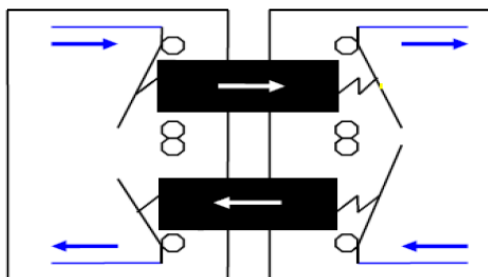
**Figure 7 – Correctly coupled autocoupler**

- 33 The CME FTS August 2012 Report includes the two diagrams below. Figure 7 shows that when the coupler heads are correctly coupled, the pins press together to open the normally closed contacts, which sends the circuit through to the next car. Figure 8 shows that when the coupler heads are uncoupled or incorrectly coupled, the pins do not press together, leaving the normally closed contacts closed; which returns the circuit signal to the leading/driving cab, omitting any connected carriages.

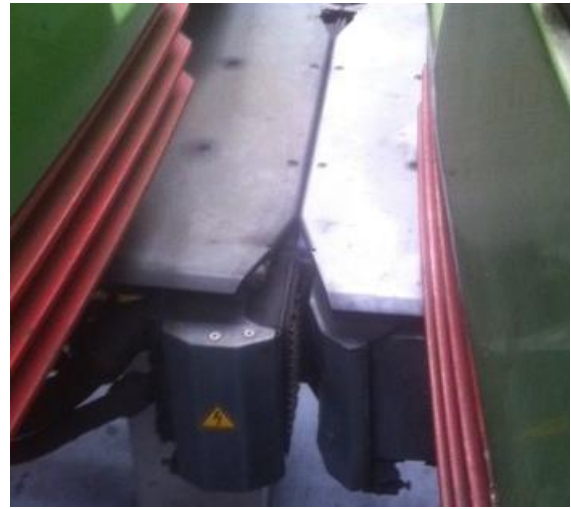
**Figure 10 – Closed electrical head cover**

- 49 The autocoupler was examined when returned to Fairview depot on the 10<sup>th</sup> August 2013. One of the electrical coupler head covers was damaged (Figure 9) which prevented the electrical coupler head from moving in either direction (Figure 10); this resulted in the opposing electrical pins not connecting, resulting in the autocoupler being incorrectly coupled.

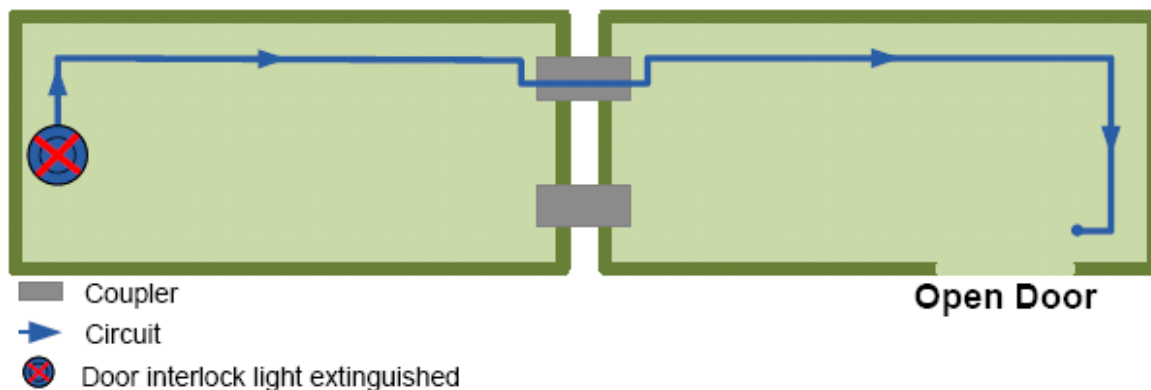
**Figure 16 – Doors Closed Circuit not returned with Door Interlock Light extinguished**

- 59 Section 12.2, 'Method of Operation' of the Drivers' Handbook notes that, the illumination of the blue Door Interlock Light is required to enable traction power to be taken by the driver and that the passenger door and traction control system are so interlocked that "power cannot be provided for traction purposes if doors are released or if any passenger door on the train is open".
- 60 Therefore, if a door remains open, the Door Interlock Circuit does not form a complete circuit, and the blue Door Interlock Light remains extinguished on the driver's console, see Figure 16.

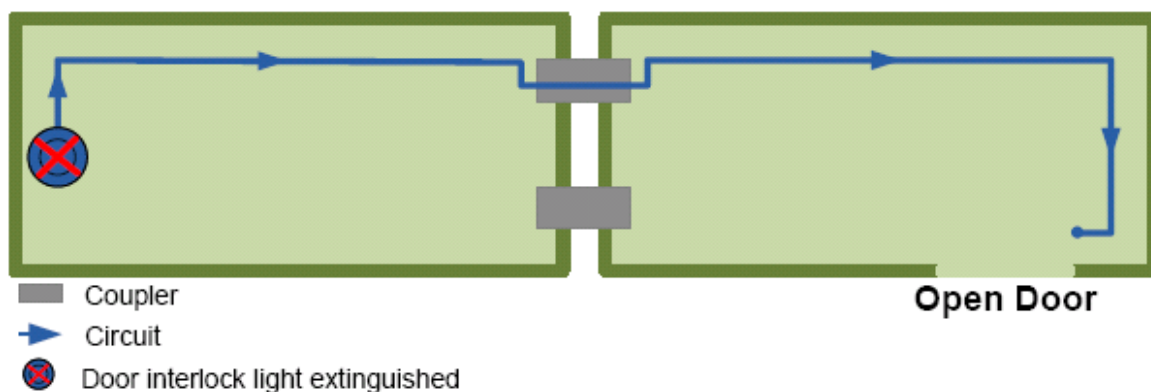
**Figure 25 – Open passenger door with extinguished blue Door Interlock Light**

- 98 When passenger doors are open, the Doors Closed Circuit is interrupted (incomplete) and the Door Interlock Light is extinguished, see Figure 25.

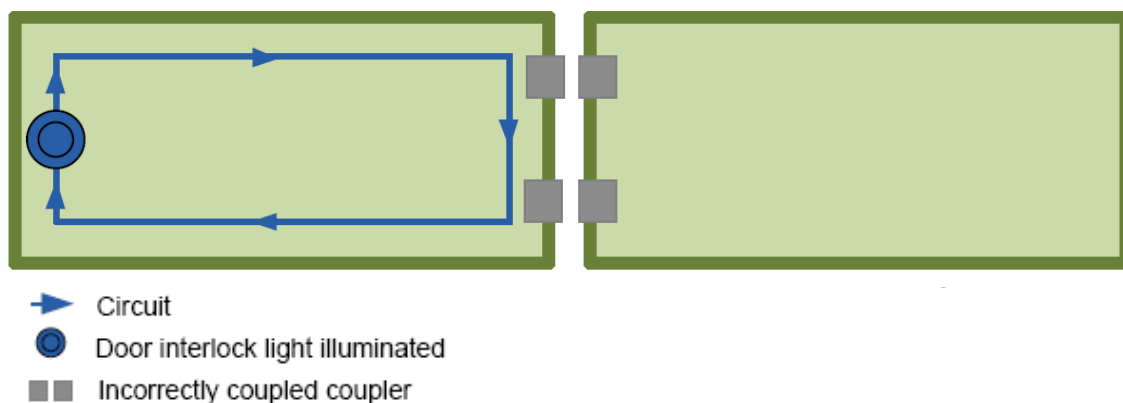
**Figure 27 – Uncoupled units, with blue Door Interlock Light illuminated**

100 This omission of the circuit not passing through the incorrectly coupled units, is similar to the units not being coupled, see Figure 27.

101 This ability of the blue Door Interlock Light to illuminate while the passenger doors are still open due the autocouplers being incorrectly coupled has been identified by the CME on four occasions since 2010, with the first incident recorded on the 26<sup>th</sup> August 2010 (paragraph 48).
