TITLE: LogBoard

AUTHOR: Renan R. Duarte

DATE: 15/10/2019 11:32

v1

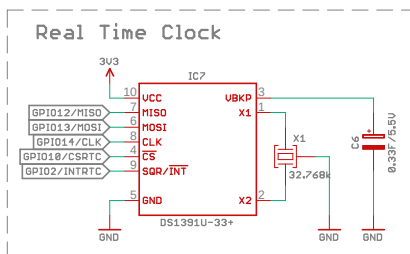
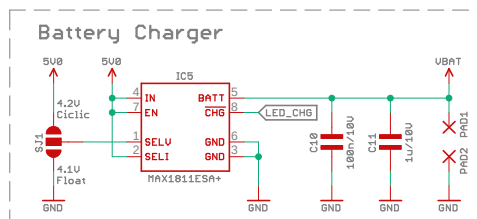
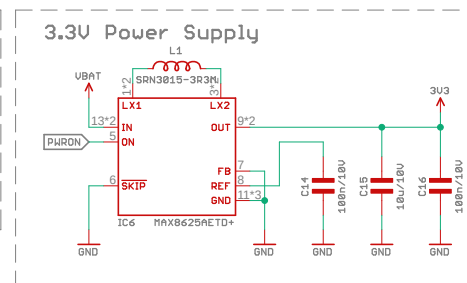
- USD CD was not connected
- RTC RST (DS1391) causes ESP not to boot. Disconnect this signal or use DS1390
- S2 footprint is wrong
