Lessons Learned from  
Accidents Involving  
Remotely Piloted and  
Autonomous Aircraft

# Crash Course

Peter W. Merlin

pages cm. -- (NASA SP ; 2013-600)

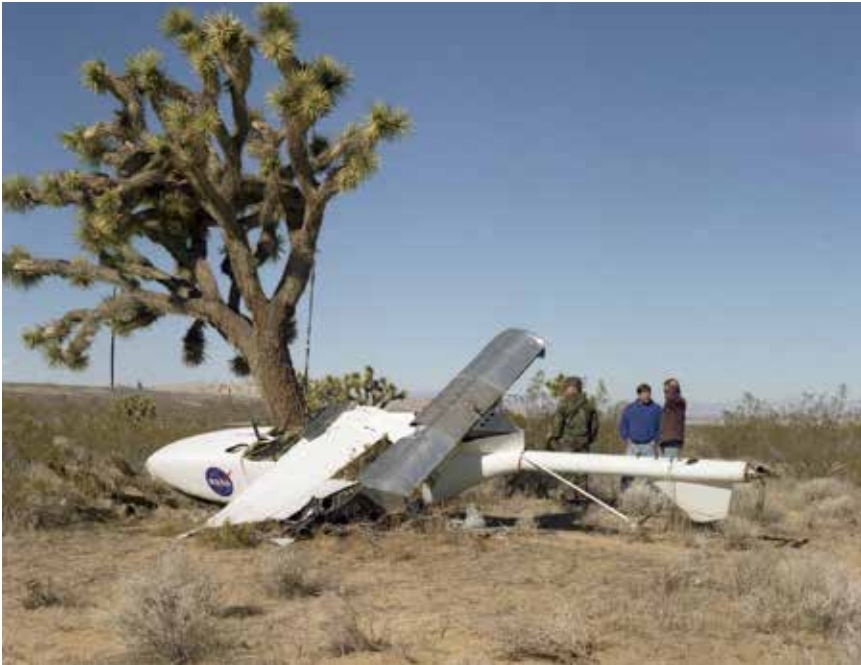
Members of the recovery crew examine the Perseus-A on the Edwards PIRA. NASA

The resulting pullout exceeded aircraft load limits, causing the structural failure of the wing assembly center panel. As both wings departed the vehicle,

A joint NASA-Aurora investigation determined that the failure resulted from a malfunctioning pitch gyroscope that fed anomalous attitude signals to the autopilot. The probable cause of the gyro failure was identified as an excessively worn brush assembly in the direct current (DC) spin motor.

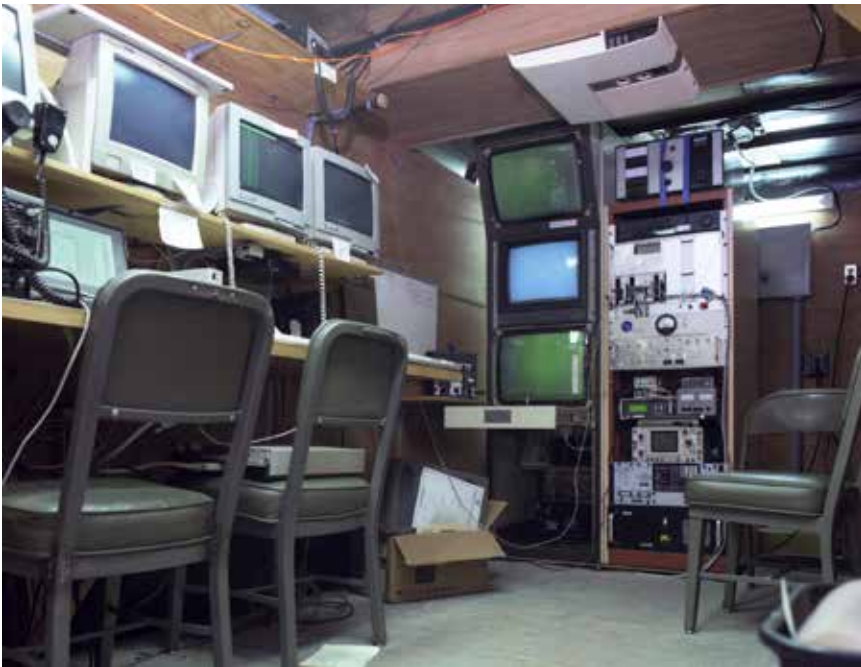
The Perseus GCS included positions for a pilot and several systems monitors. NASA

Several human factors contributed to the mishap. These were related to deficiencies in the design of the GCS as well as GCS team training.

First, displays in the GCS provided poor situational awareness. This precluded adequate mission monitoring and led to the test team's inability to detect the gyro failure. The control panel featured a very limited set of caution and warning annunciators and no autopilot-mode annunciation. Caution and warning indicators were primarily focused on catastrophic engine failures. None were used to indicate sensor failures. Although telemetry data were available to both the test director and flight-test engineer, the data were presented in a tabular format only, on one of 10 selectable pages. System limits were not indicated by these displays. Operating autopilot modes had to be determined by examination of the autopilot switches. At the time of the mishap, the test director was unable to see these switches due to the GCS layout and was unaware that the airspeed-hold autopilot had been switched back on.<sup>11</sup>
