## Thrust-reverse system

## Details about the design features of the aircraft

From Frankfurt, Germany to Warsaw, Poland  
Airbus A320-211

From Pardubice, Czech Republic to Moscow, Russia  
Tupolev Tu-204-100

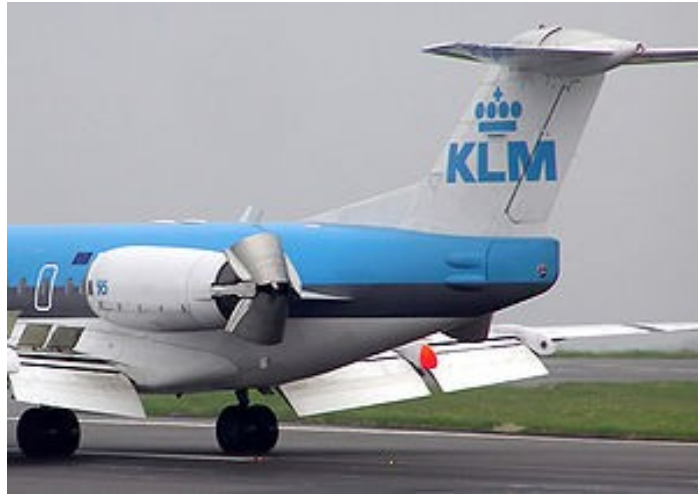
A KLM Fokker 70 rolling out with **flaps** fully extended, **spoilers** raised, and **reverse thrust** selected. The two reverse thrust buckets behind each engine can be seen in the deployed position, diverting the engine exhaust gases forward.

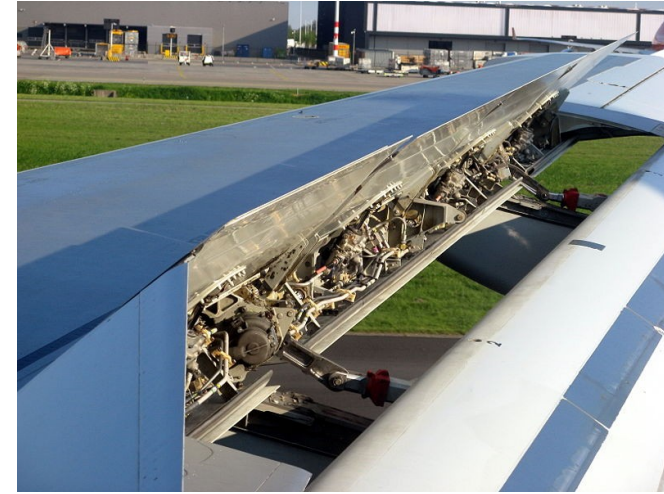
A close look at the inner workings of spoilers in lift dump deployment during the landing of an Airbus A320.

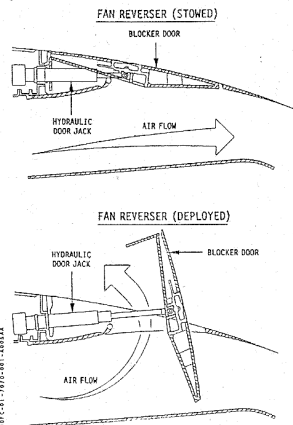
Reverse thrust is obtained by deflecting the fan airstream using four pivoting blocker doors on each engine.

Each door is actuated by a hydraulic door jack:  
— ENG 1: Green circuit  
— ENG 2: Yellow circuit
